**International  
Aero Engines**

**NACELLE — POWERPLANT — LATCH BRACKET, NO. 1, LOWER, THRUST REVERSER —  
REPLACEMENT OF**

**V2500-D5**

**V2500-NAC-78-0157**

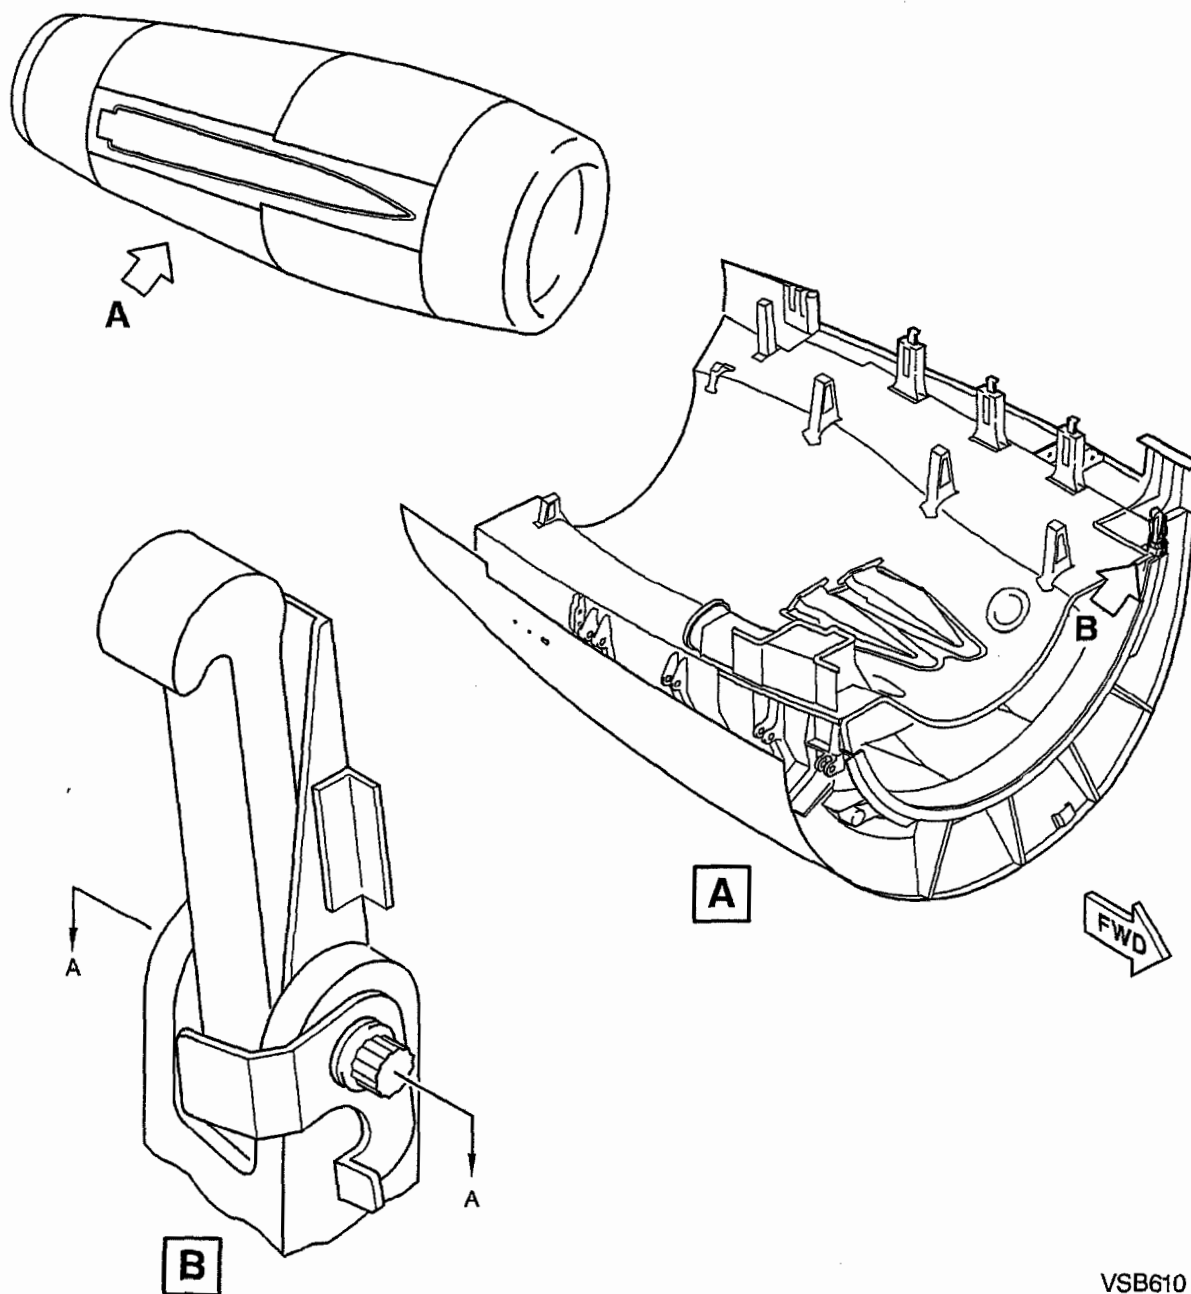
Lower Thrust Reverser No. 1 Latch Bracket Replacement  
Figure 1 (Sheet 1)

The current clamping design of the lower thrust reverser No. 1 latch bracket installation can potentially prevent the bracket from easily rotating through the full range of travel.

- B. Remove nut, bolt, washers, 290-0287-503 bushings, and the 290-0281-507 (290-0287-508) bracket. Discard the bushings and the bracket. Refer to Figure 1.
