**International
Aero Engines**

V2500 Propulsion System — Nacelle

**NACELLE - EXHAUST - HOIST POINT, TRANSLATING SLEEVE -
MODIFICATION OF**

V2500-NAC-78-0158

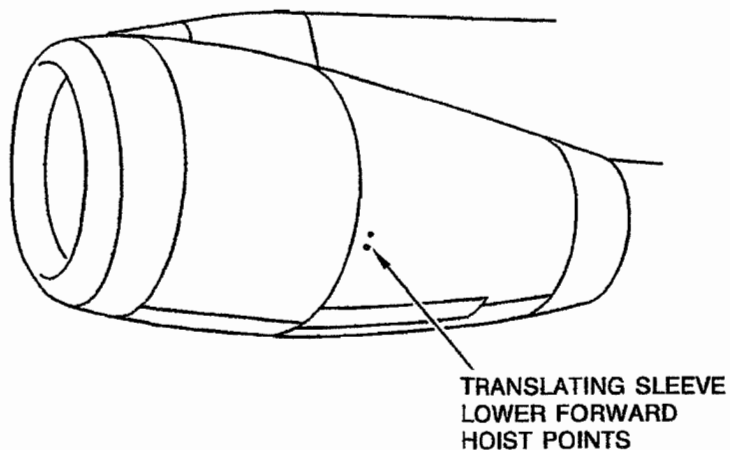
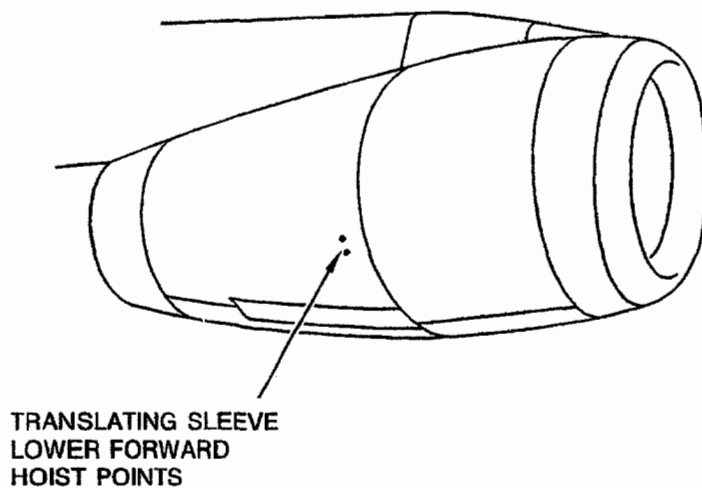
Translating Sleeve Hoist Point Modification
Figure 1

The lower forward hoist point of the translating sleeve can get damaged.

Operators have experienced damage to the lower forward hoist point of the translating sleeve.

Sealant is put into the lower forward translating sleeve hoist point to prevent vibration of and damage to the floating insert.

- (1) Remove the NAS1081C4A4 setscrew from the hoist point.

- (2) Apply release agent (CoMat 02-158) to the NAS1081C4A4 set screw and install the setscrew in the hoistpoint.

- (3) Mix the sealant (CoMat 08-033). Refer to the manufacturer's instructions.
- (4) Put sealant the space between the body of the hoist point and the floating insert.
- (5) Cure the sealant (CoMat 08-033). Keep the setscrew in the center of the hoist point while the sealant is cured. Refer to the manufacturer's instructions.
