NACELLE - EXHAUST - COMMON NOZZLE ASSEMBLY, STRUT ATTACH BOLTS - REPLACEMENT OF

V2500-D5

V2500-NAC-78-0165

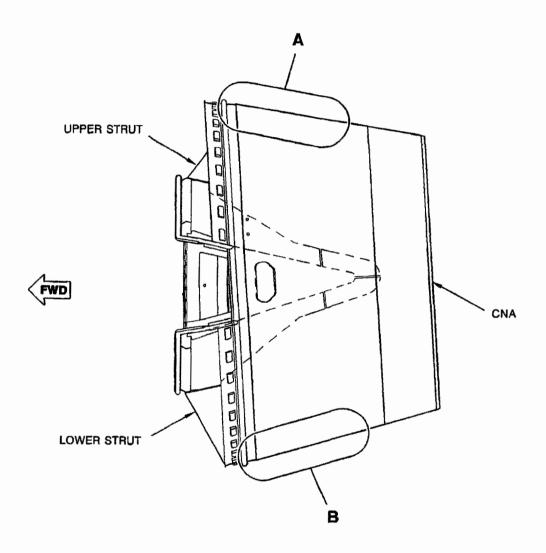
CNA Strut Attach Bolt Replacement Figure 1 (Sheet 1)

Operators have found loose CNA struts and damage to the CNA inner and outer skins caused by the strut attach bolts.

The CNA strut attach bolts can be too long and interfere with an internal part of the struts and/or the shanks of the bolts can interfere with and damage the strut nutplates. This can result in a loose strut even though the attach bolts are properly tightened.

- (1) Remove the four NAS8704U23 or NAS8704U24 CNA strut attach bolts from the top and bottom of the CNA. Refer to Figure 1.
- (2) Find the proper length CNA strut attach bolt(s).

- (a) Install one NAS8704U22 bolt in each of the struts. Torque the bolts to 50 to 60 inlb (5,7 to 6,8 Nm). Refer to Figure 1.
 - (b) Measure the distance (dimension X) from the surface of the CNA outer skin to the nutplate at each of the attach bolt locations that do not have bolts installed. Refer to Figure 1.

- 1 If the distance is 1.348 to 1.394 inch (34.24 to 35.41mm), use a NAS8704U22 bolt.
 - 2 If the distance is 1.395 to 1.478 inch (35.43 to 37.54 mm), use a NAS8704U23 bolt.
