# V2500 Propulsion System - Nacelle **SERVICE BULLETIN**

Subject: Transmittal of Revision 1 to Service Bulletin Number V2500-NAC-78-0166

NACELLE - EXHAUST – LOCKOUT FEATURE, AFT CASCADE SUPPORT RING, THRUST  
REVERSER, - INSPECTION/REWORK

# **V2500-NAC-78-0166**

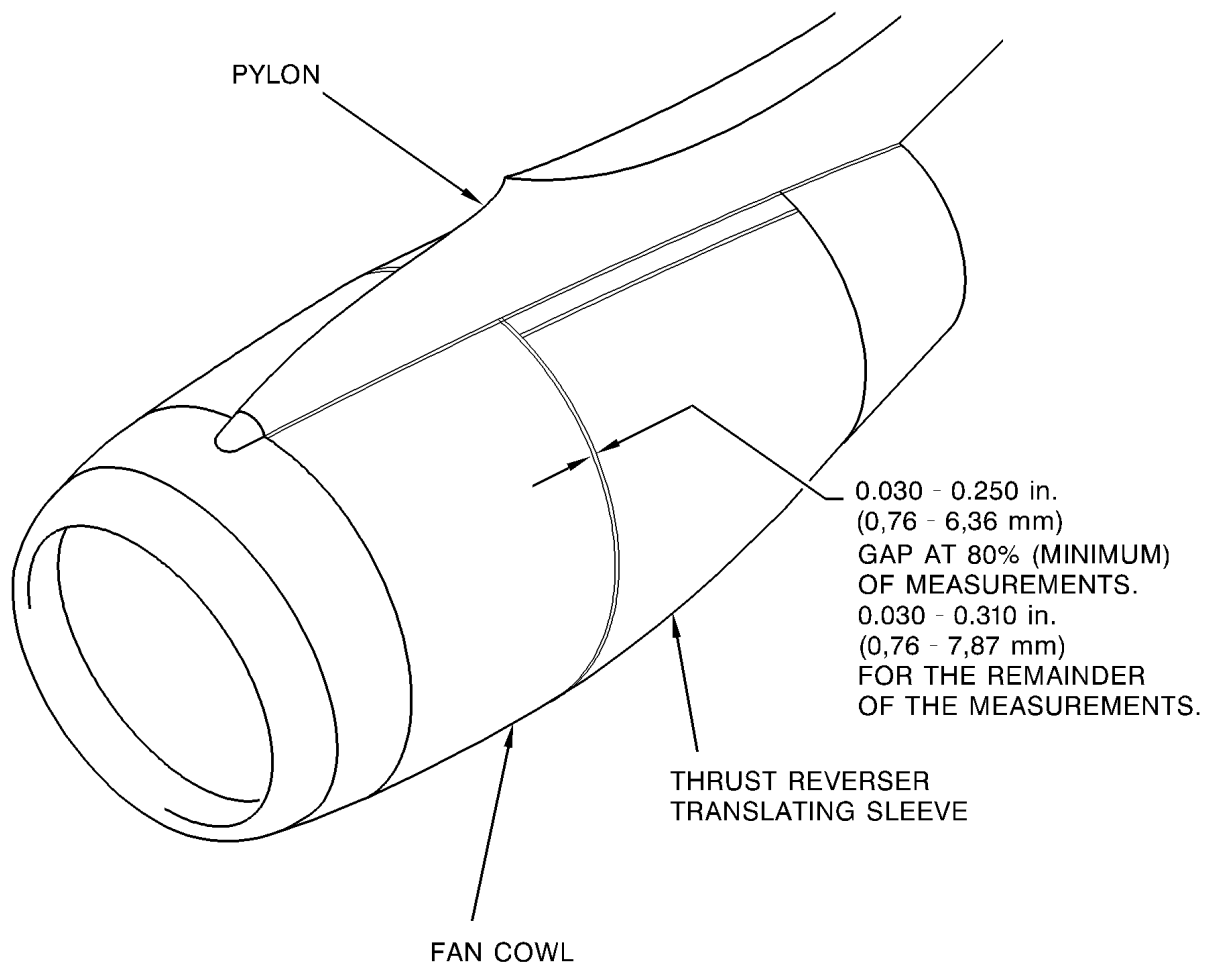
Thrust Reverser Translating Sleeve Rigging Check Dimensions  
Figure 1

- (5) Check the dimension (gap) between the translating sleeve and the fan cowl as shown in Figure 1.
  - (a) Measure the gap between the translating sleeve and the fan cowl at 8 to 10 places equally spaced around the circumference.

- (a) If the gaps are within the limits in Figure 2, go to step 3.B.(8).
  - (b) If the gaps are not within the limits in Figure 2, you must adjust the thrust reverser actuator and translating sleeve rigging. Refer to the Aircraft Maintenance Manual, Chapter 78-30-00, Page Block 501 then go to step 3.B.(6).

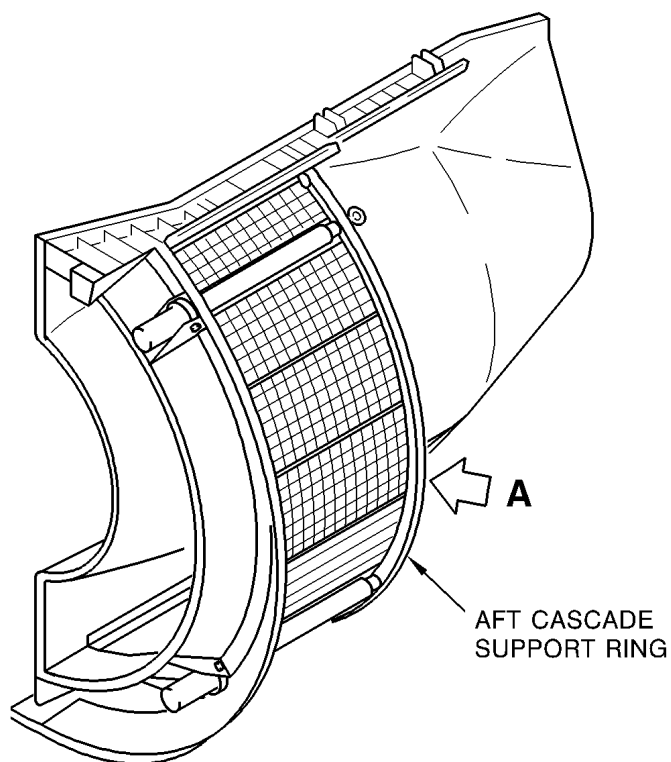
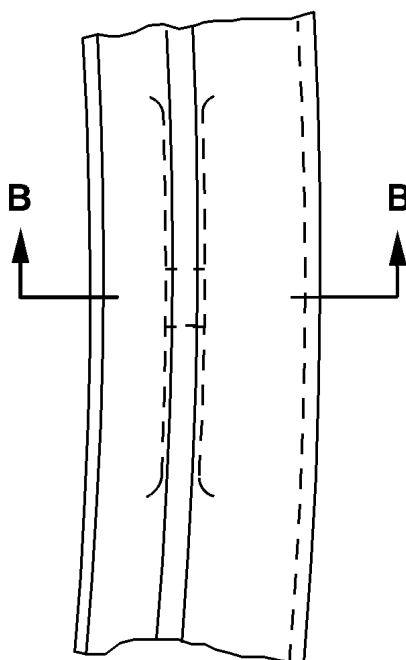
Aft Cascade Support Ring Lockout Feature Lug Dimension Check and Pin Hole Enlargement  
Figure 2 (Sheet 1)

Because of engineering tolerance stack-up it is possible for the lockout pin feature in the aft cascade support ring to be located 0.25 inch too far forward. This results in misalignment with the lockout pin features in the translating sleeve outer panel and inner acoustic panel.

- (7) Attempt to install the thrust reverser lockout pin.
  - (a) If you can install the lockout pin, go to step 3.C.
  - (b) If you can not install the lockout pin go to step 3.B.(8).
- (8) Remove the translating sleeves. Refer to the Aircraft Maintenance Manual, Chapter 78-32-46 (78-32-76), Page Block 401.
- (9) Check the thickness of the aft cascade support ring lockout lug as shown in Figure 2.
  - (a) If the thickness is within the limits in Figure 2, go to step 3.B.(10).
  - (b) If the dimension is not within the limits in Figure 2, contact your IAE or BFGoodrich representative.
- (10) Make the hole in the aft cascade support ring lockout lug larger as shown in Figure 2.
