IAE Propulsion System NON-MODIFICATION SERVICE BULLETIN

Subject: Transmittal of Revision 2 to Service Bulletin Number V2500-NAC-78-0167

V2500 Propulsion System - Nacelle
SERVICE BULLETIN

NACELLE - EXHAUST – LATCH ACCESS DOOR, THRUST REVERSER – SEALING IMPROVEMENT

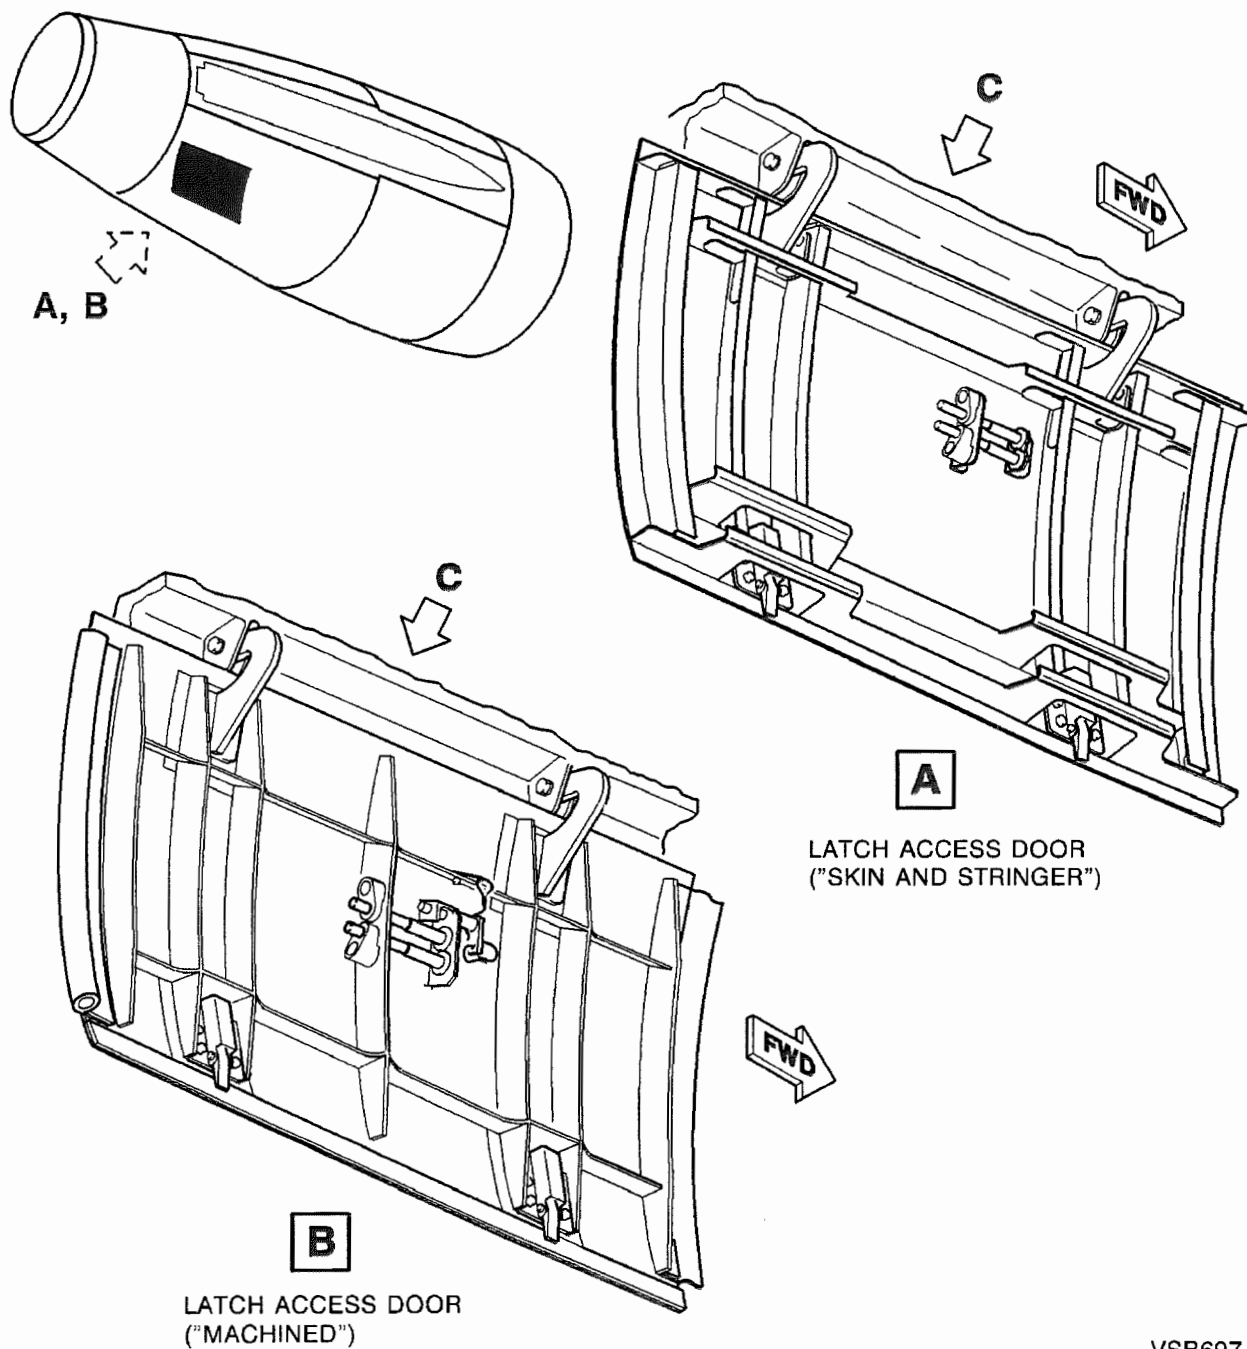
Latch Access Door Hinge Point Attach Hardware
Figure 2 (sheet 1)

CAUTION: EXCESSIVE LOOSENESS OR "FREE-PLAY" AT THE LATCH ACCESS DOOR ATTACH POINTS MAY CAUSE PREMATURE WEAR OF THE DOOR AND/OR THE LATCH LAND AND IMPAIR DOOR FUNCTION.

- (21) Repair the external paint on the latch access door. Refer to the MD-90 Structural Repair Manual, Chapter 54-30-03, External Paint repair VRS2404.
- (22) Examine the upper outboard track beam latch access door hinge point bushings. Replace any damaged or missing bushings. Refer to Figure 2.

- (a) If there is excessive looseness or "free-play", check for proper installation of the attach hardware and replace any worn, damaged, or missing bushings. Refer to Figure 2.
- (3) Adjust the latch access door aft seal. Refer to Figure 1 (sheets 1 and 2).
- (a) Move the 290-0038-23 aft seal until it is compressed 10% to 30% against the translating sleeve when the latch access door is closed.
- (b) Torque the MS21042L08 nuts to 12 to 16 inlbs.

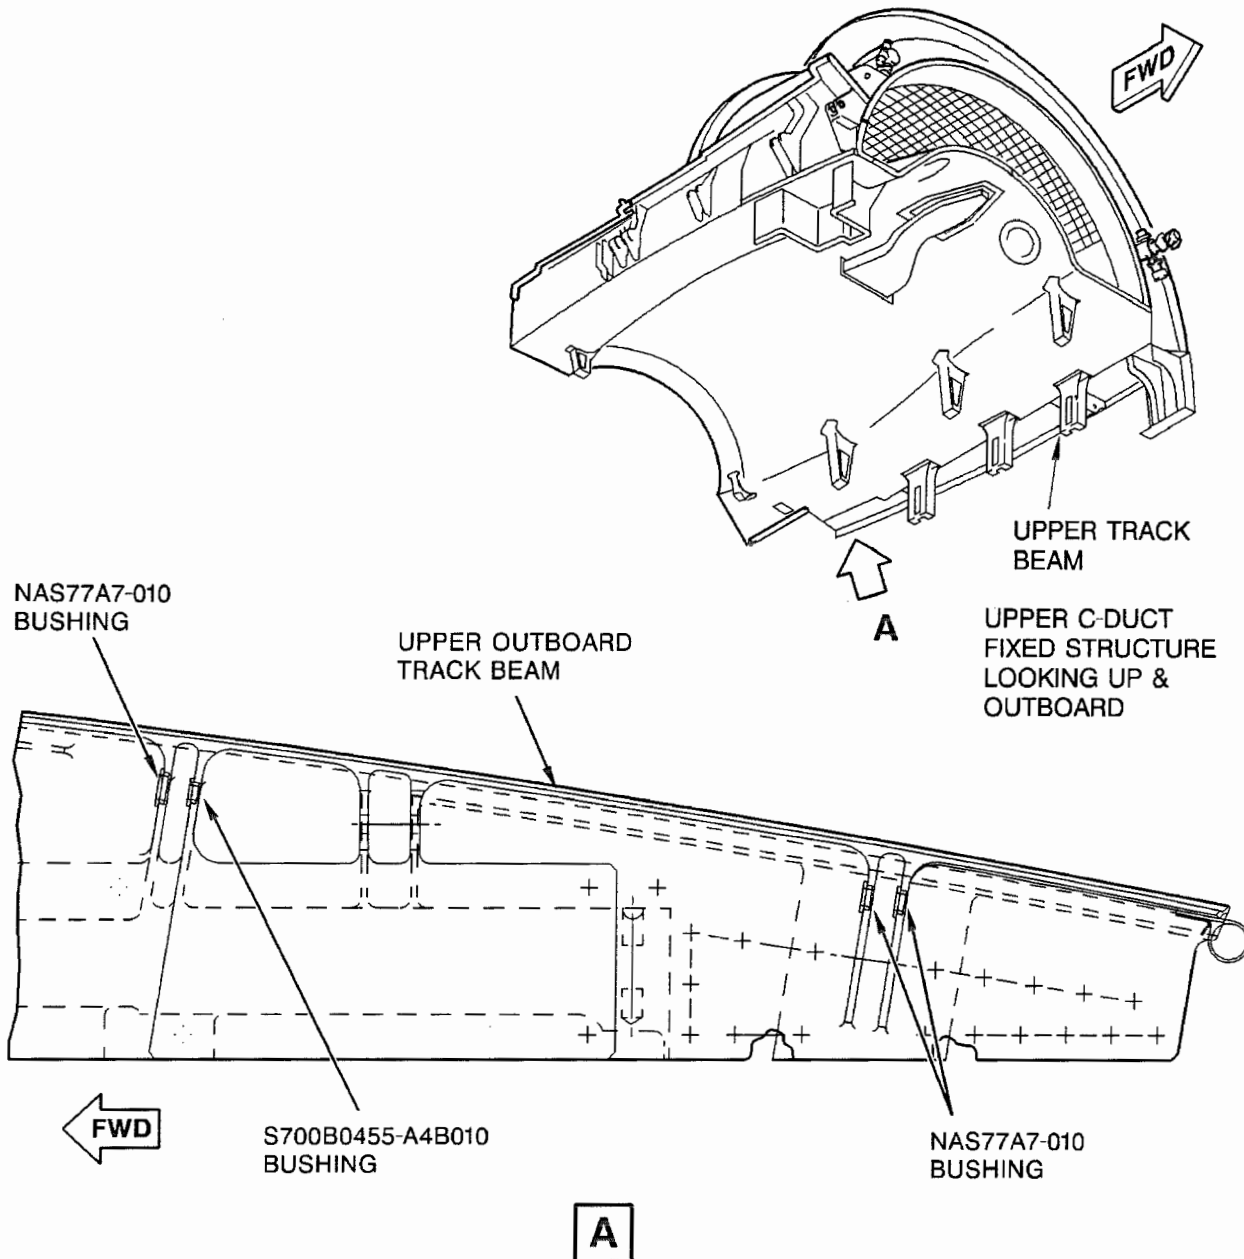
Upper Outboard Track Beam Latch Access Door Hinge Point Bushings
Figure 3

NOTE: The track beam latch access door hinge point bushings are press fit installed by the manufacturer but may have become loose in service. If you find the bushings are loose, this is acceptable and will be the subject of a subsequent service bulletin or repair. If you find the bushings are missing, install the replacement bushings supplied with the service bulletin kit. If the bushing holes in the track beam have become larger or are not round, this is acceptable and will be the subject of a subsequent service bulletin or repair.
