V2500 Propulsion System - Nacelle **SERVICE BULLETIN**

NACELLE - EXHAUST - ACTUATOR, THRUST REVERSER, - REPLACEMENT OF

V2500-NAC-78-0173

ENGINE - INNER ACTUATOR TY1801-03

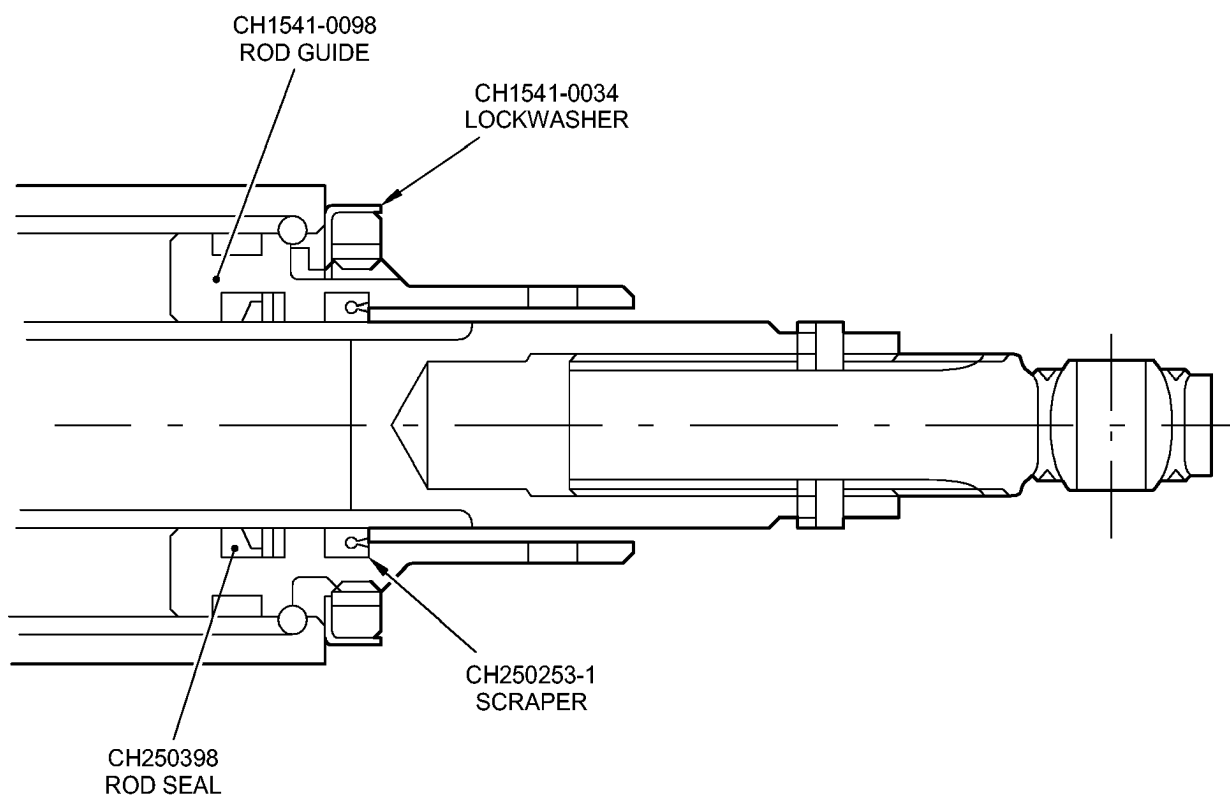
Pre Mod L1801-04
Figure 1

Cases have occurred where actuators have exhibited reduced reliability due to excessive external leaks from the piston rod seal. This modification introduces an improved piston rod/piston rod guide interface.

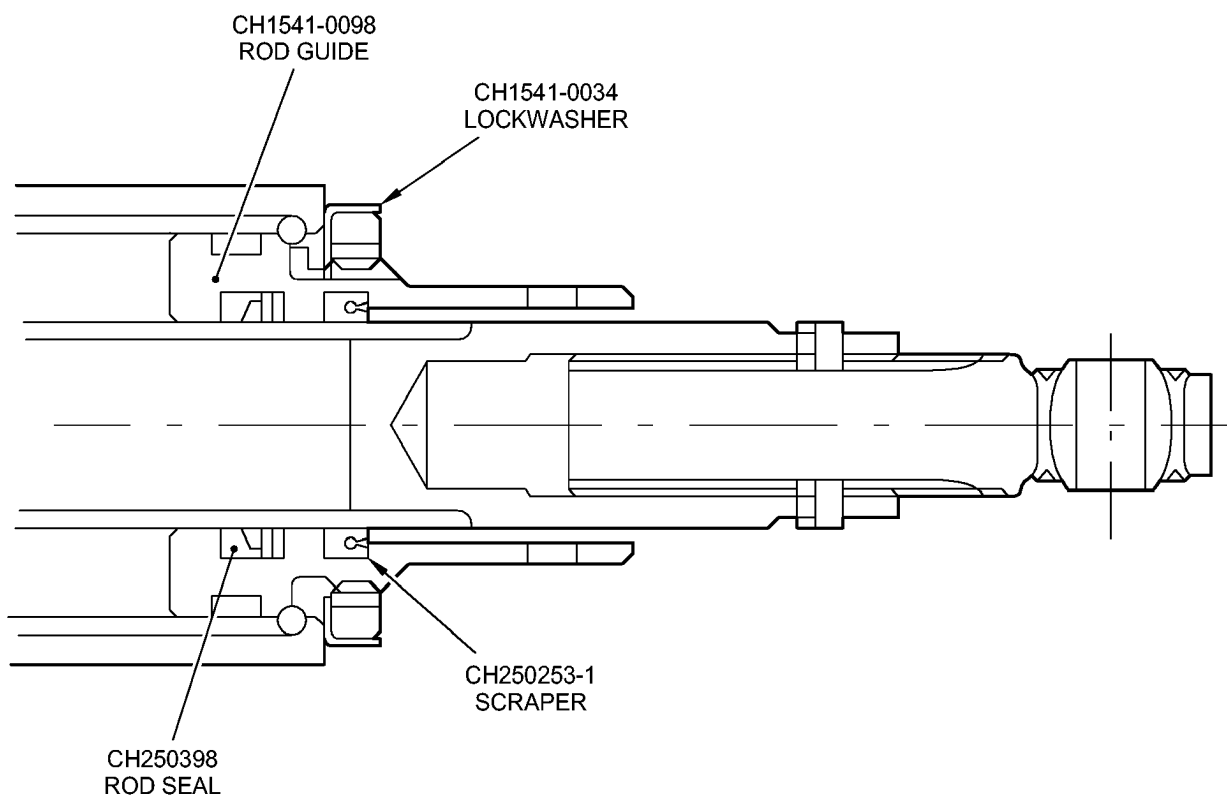
Pre Mod L1802-08
Figure 1

Cases have occurred where actuators have exhibited reduced reliability due to excessive external leaks from the piston rod seal. This modification introduces an improved piston rod/piston rod guide interface.
