V2500 Propulsion System - Nacelle **SERVICE BULLETIN**

NACELLE - EXHAUST – DRAIN MAST, THRUST REVERSER – MODIFICATION

October 5, 2000

V2500-NAC-78-0180

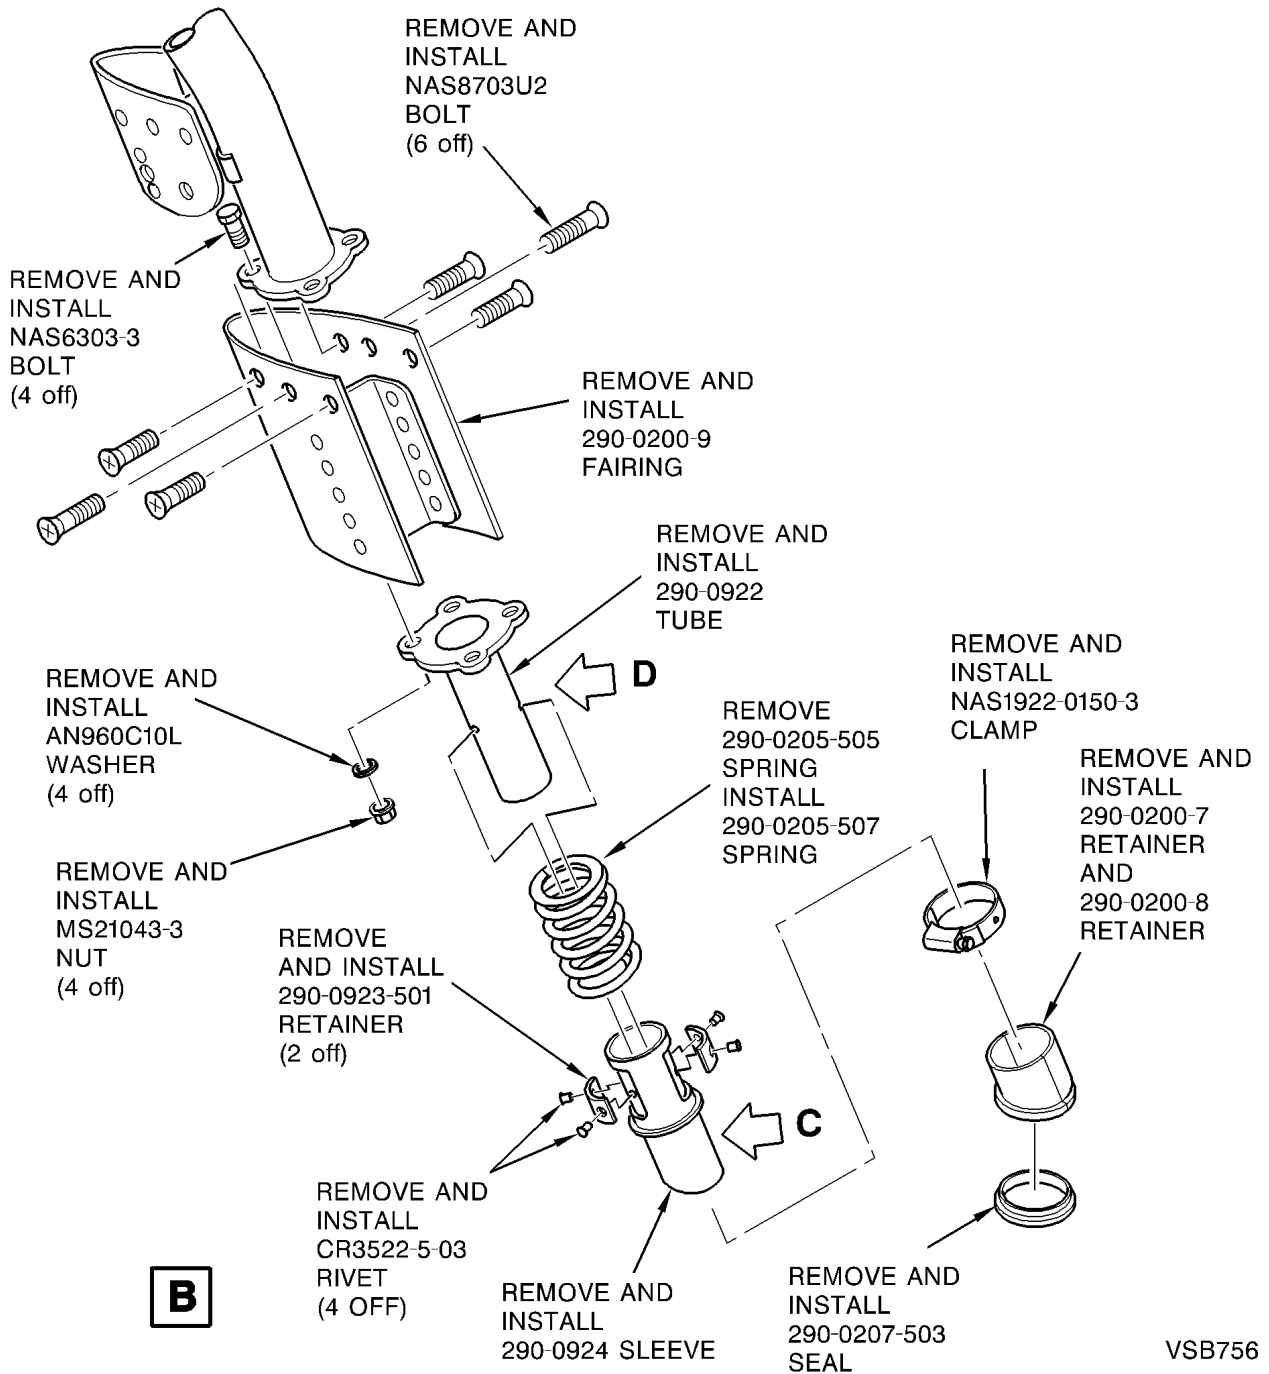
Thrust Reverser Drain Mast Subassembly Modification
Figure 1 (Sheet 2)

Operators have found thrust reverser drain mast components with wear.
- (2) Background

Components of the thrust reverser drain mast can chafe against one another and cause wear.
- (3) Objective

- (1) Move the translating sleeves 8 to 10 inches (20,0 to 25,4 cm) from the stowed position to get access to the thrust reverser drain mast. Refer to the MD-90 Aircraft Maintenance Manual, Chapter 78-32-00, page block 201.
- (2) Remove the nuts, washers, and drain mast subassembly. Refer to Figure 1 (sheet 2).

B. Disassemble the drain mast subassembly. Refer to Figure 1 (sheet 2).

- (1) Remove the clamp, seal retainer, and seal from the subassembly.
- (2) Remove the rivets and the retainers from the sleeve. Discard the rivets.
- (3) Remove the sleeve and the spring from the tube. Discard the spring.

- E. Assemble the drain mast subassembly. Refer to Figure 1 (sheet 2).

- (1) Install the sleeve and spring on the tube. Use the retainers and rivets.
- (2) Install the seal, seal retainer, and clamp on the tube.

- (1) Install the drain mast subassembly with the nuts and washers. Refer to Figure 1 (sheet 2).
- (2) Move the translating sleeves to the stowed position. Refer to the MD-90 Aircraft Maintenance Manual, Chapter 78-32-00, page block 201.
