Subject: Transmittal of Revision 2 Service Bulletin Number V2500-NAC-78-0183

Number: V2500-NAC-78-0183

SUBJECT: THRUST REVERSER OUTER V-BLADE - APPLICATION OF DRY FILM LUBRICANT

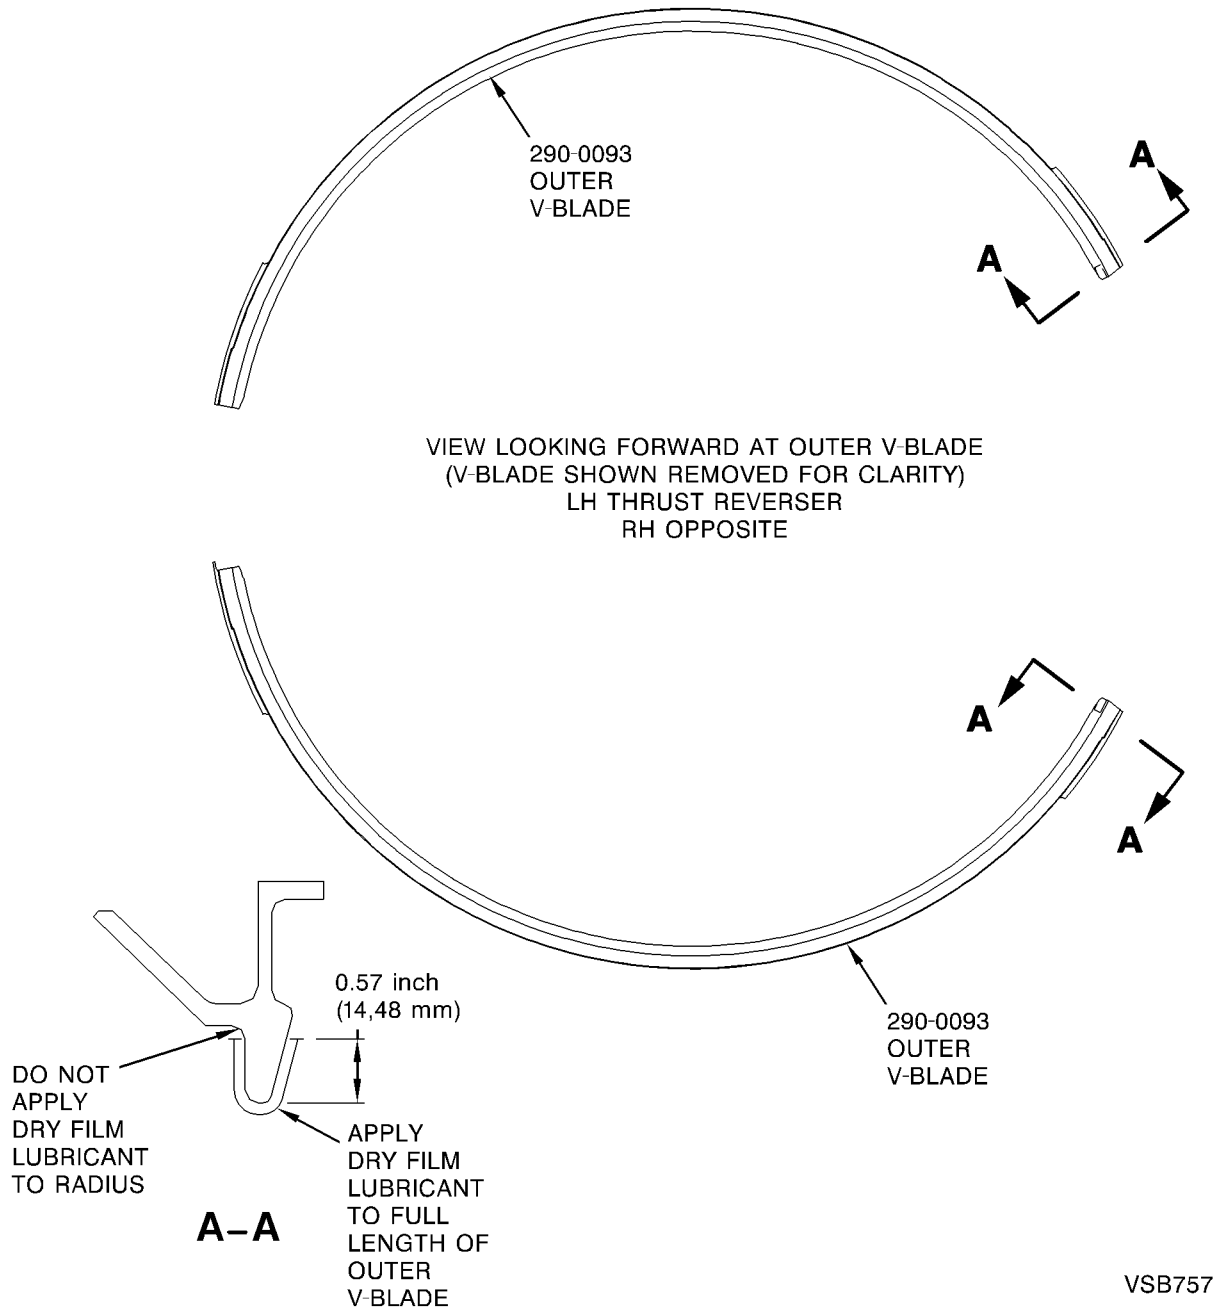
Thrust Reverser Outer V-Blade Modification
Figure 1 (Sheet 1)

Thrust reversers have been found with cracks in the outer v-blade.

- (1) Problem
 - (a) Thrust reverser outer v-blades have been found with cracks in service.
- (2) Cause
 - (a) The root cause is still under investigation.
- (3) Background
 - (a) Until this time, 5 thrust reverser outer v-blades have been found with cracks.
- (4) Objective
 - (a) The changes in configuration recommended in this Service Bulletin are intended to maintain reliability of the thrust reverser by reducing wear/fretting of the outer v-blade.

- (2) Apply dry film lubricant (CoMat 10-005) to the entire length of the v-blade. Do not apply dry film lubricant to the radius of the v-blade. Refer to Figure 1.

NOTE: It is important to avoid application of dry film lubricant to the radius of the v-blade. Dry film lubricant in the radius will interfere with inspection of the v-blade.

NOTE: To ease application of the lubricant to installed v-blades, use a paint roller. Modify the roller to get the required coverage and avoid application of the lubricant to the radius of the v-blade. Refer to Figure 1.

- a. Protect the areas to which you do not want to apply dry film lubricant.
- b. Apply four layers of dry film lubricant to the v-blade. Allow the lubricant to cure for a minimum of 10 minutes after you apply each layer.
- c. Cure the dry film lubricant.
 1. Allow the dry film lubricant to become dry-to-touch. Cure may be accelerated with a heat gun or heat lamp at 200 degrees F.
