Number: V2500-NAC-78-0191

Date: April 24, 2001

SUBJECT: "MODIFICATION SERVICE BULLETIN" - "NACELLE - EXHAUST - THRUST
REVERSER OPENING ACTUATOR SAFETY PINS - REPLACEMENT OF"

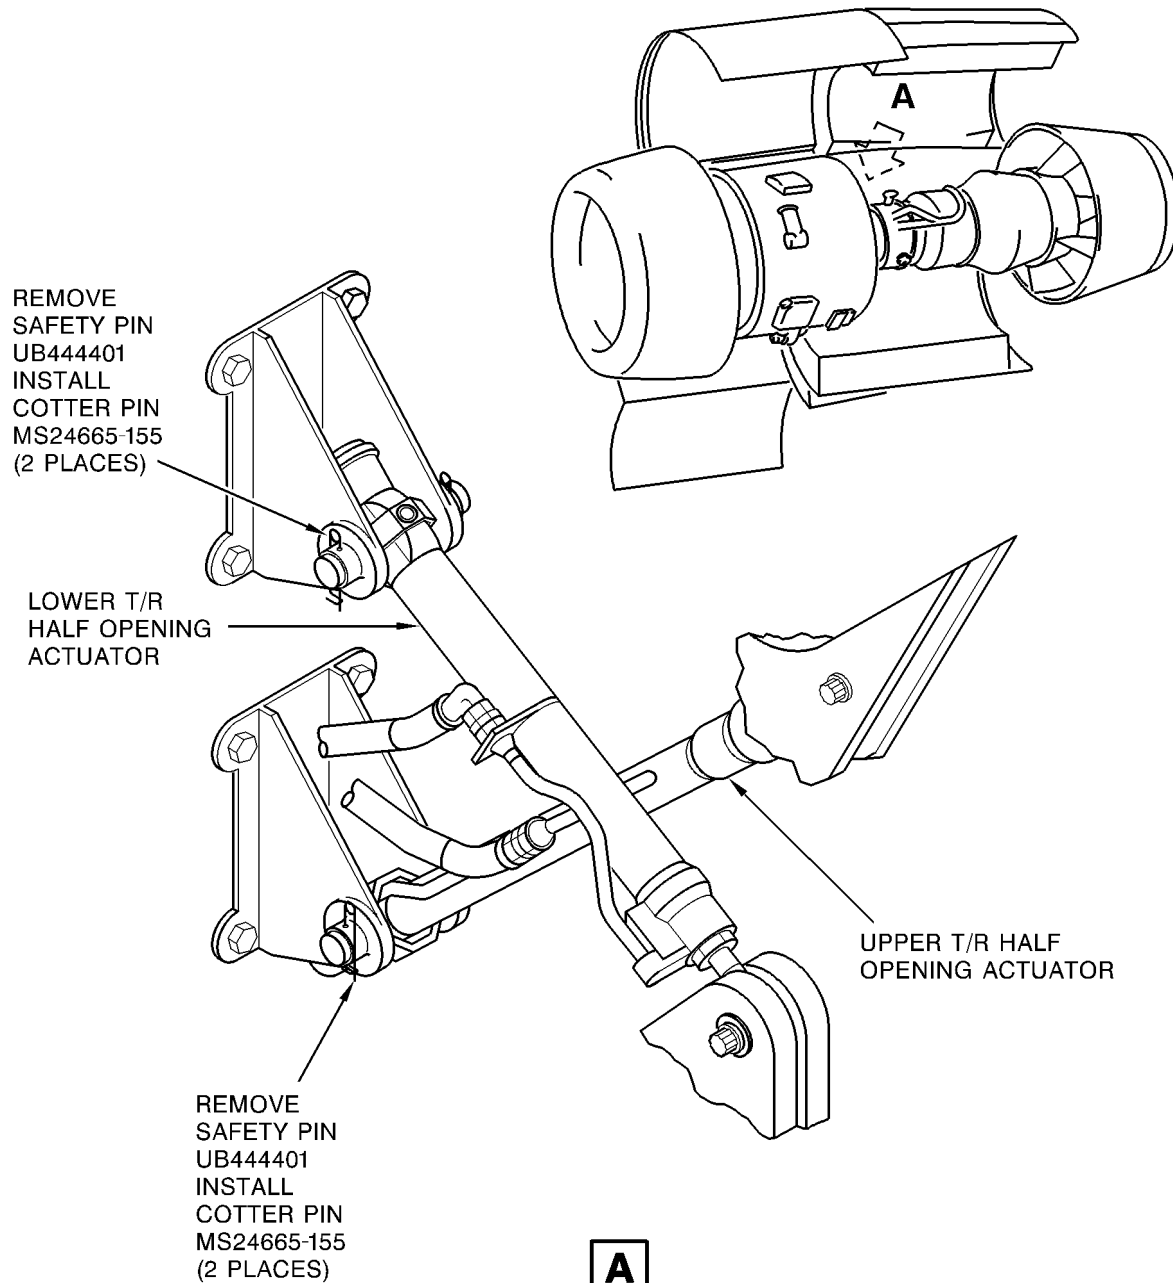
Thrust Reverser Opening Actuator Safety Pin Replacement
Figure 1

(a) Thrust reverser opening actuator safety pins have been found damaged or missing in service. This can allow the actuator pins to disengage and result in the lower thrust reverser half swinging free when the thrust reverser is opened.

B. Replace the thrust reverser opening actuator safety pins. Refer to Figure 1.

(1) One at a time, remove the UDB444401 safety pins and install MS24665-155 cotter pins.
