Number: V2500-NAC-78-0192

Date: April 12, 2001

SUBJECT: "MODIFICATION SERVICE BULLETIN" - "NACELLE - EXHAUST - THRUST
REVERSER COMPRESSION STRUT - ADDITION OF PROTECTIVE SLEEVE"

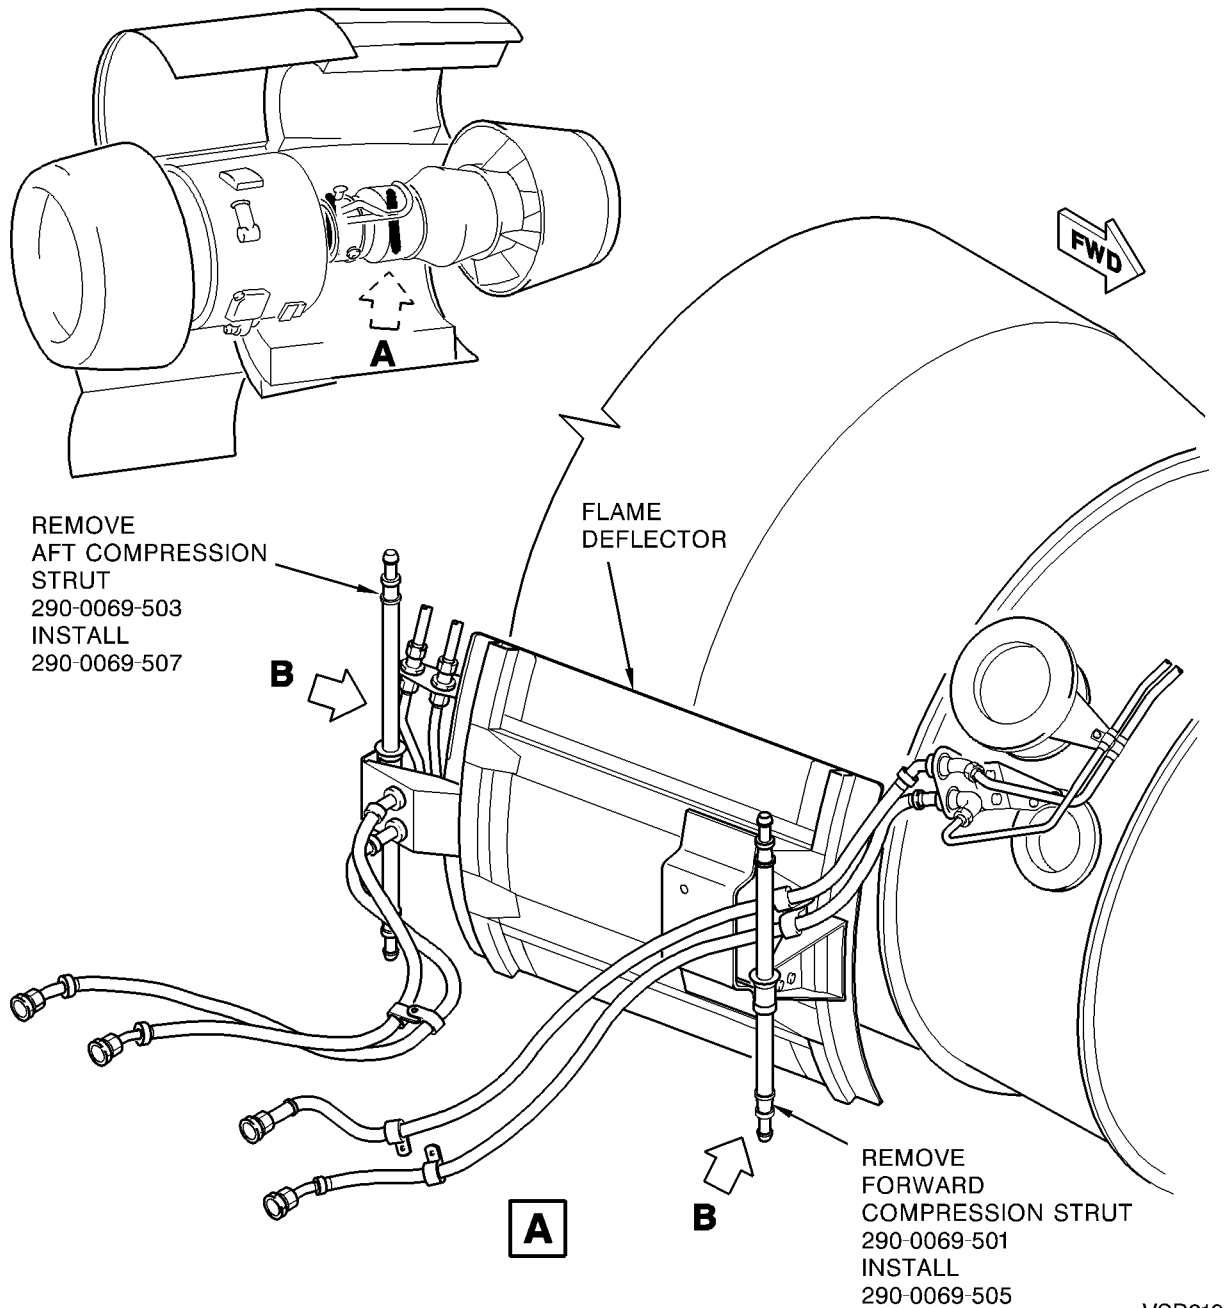
Thrust Reverser Compression Strut Protective Sleeve
Figure 1 (sheet 1)

(a) The thrust reverser compression struts can become chafed in service.

(a) Chafing between the compression strut and the mounting clips on the flame deflector.

- A. For compression struts that are installed, open the thrust reverser halves. Refer to the MD-90 Aircraft Maintenance Manual.
- B. For compression struts that are installed, remove the thrust reverser compression struts from the flame deflector. Refer to Figure 1.

- D. Install the protective teflon sleeve on the compression struts. Refer to the manufacturer's instructions. Refer to Figure 1.
- E. Re-identify the 290-0069-501 strut as the 290-0069-505. Re-identify the 290-0069-503 strut as the 290-0069-507. Use rubber stamp and metal marking ink. Refer to the IAE V2500 Standard Practices/Processes Manual (SPP-V2500-1AE), Chapter 70-09-00.

- F. Install the thrust reverser compression struts on the flame deflector. Make sure the "UP" mark on the compression strut is at the upper end of the strut. Refer to Figure 1.
