V2500-D5 SERIES NACELLE SERVICE BULLETIN

V2500-NAC-78-0196

COMMON NOZZLE ASSEMBLY (CNA) – OUTER BARREL – MODIFICATION TO PREVENT ELONGATION OF
UPPER AND LOWER STRUT ATTACH HOLES

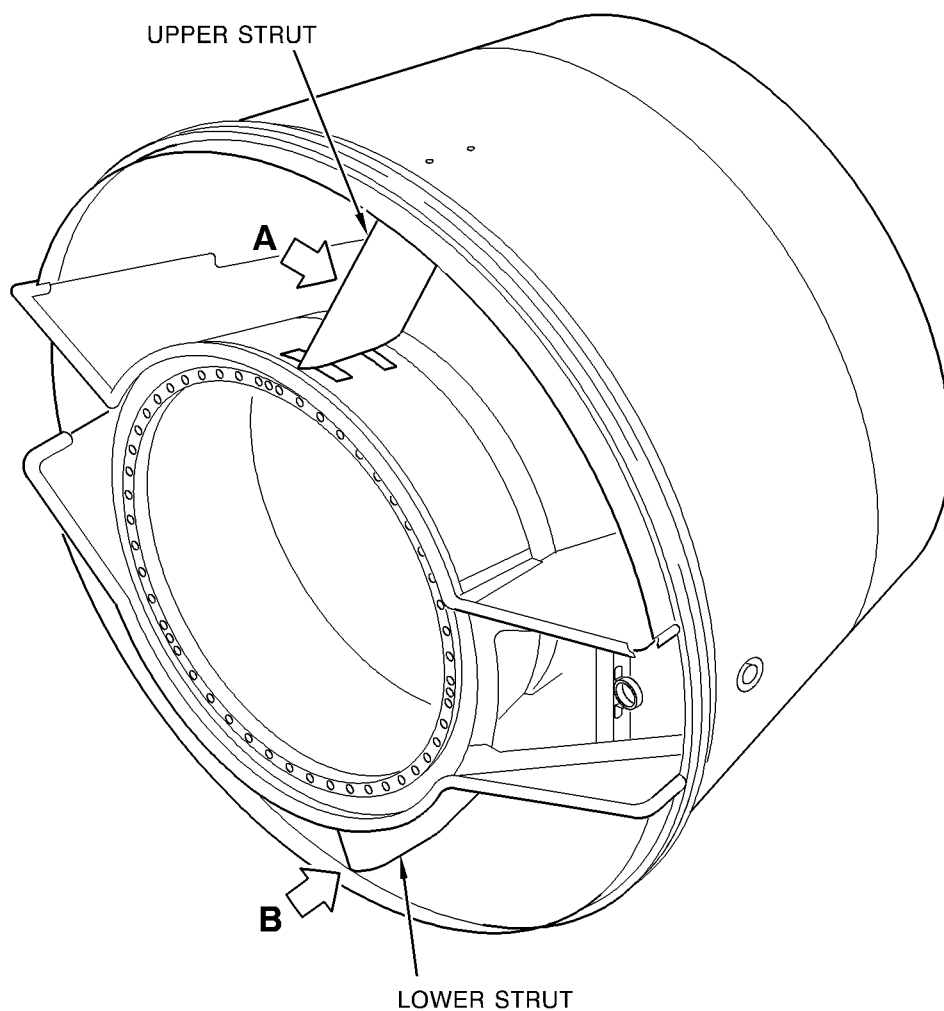
CNA - Strut Skin and Outer Fitting Modification
Figure 1 (sheet 1)

- (a) The upper and lower strut attach bolt holes in the inner skin of the outer barrel can become elongated.
- (b) The strut attach bolts can interfere with the strut skins.

- (1) Clean the strut skins with a lint free cloth (CoMat 02-099) made moist with solvent (CoMat 01-438). Wipe the surfaces dry before the surfaces become dry.
- (2) Remove material from the strut skins. Refer to Figure 1.
- (3) Clean the modified areas with a lint free cloth (CoMat 02-099) made moist with solvent (CoMat 01-438). Wipe the surfaces clean and dry before the solvent becomes dry.
