Number: V2500-NAC-78-0197

Date: November 6, 2001

ATA System: 78-30

SUBJECT: COMMON NOZZLE ASSEMBLY (C.N.A.) - APPLICATION OF ABRASION RESISTANT COATING TO THE INBOARD SIDE

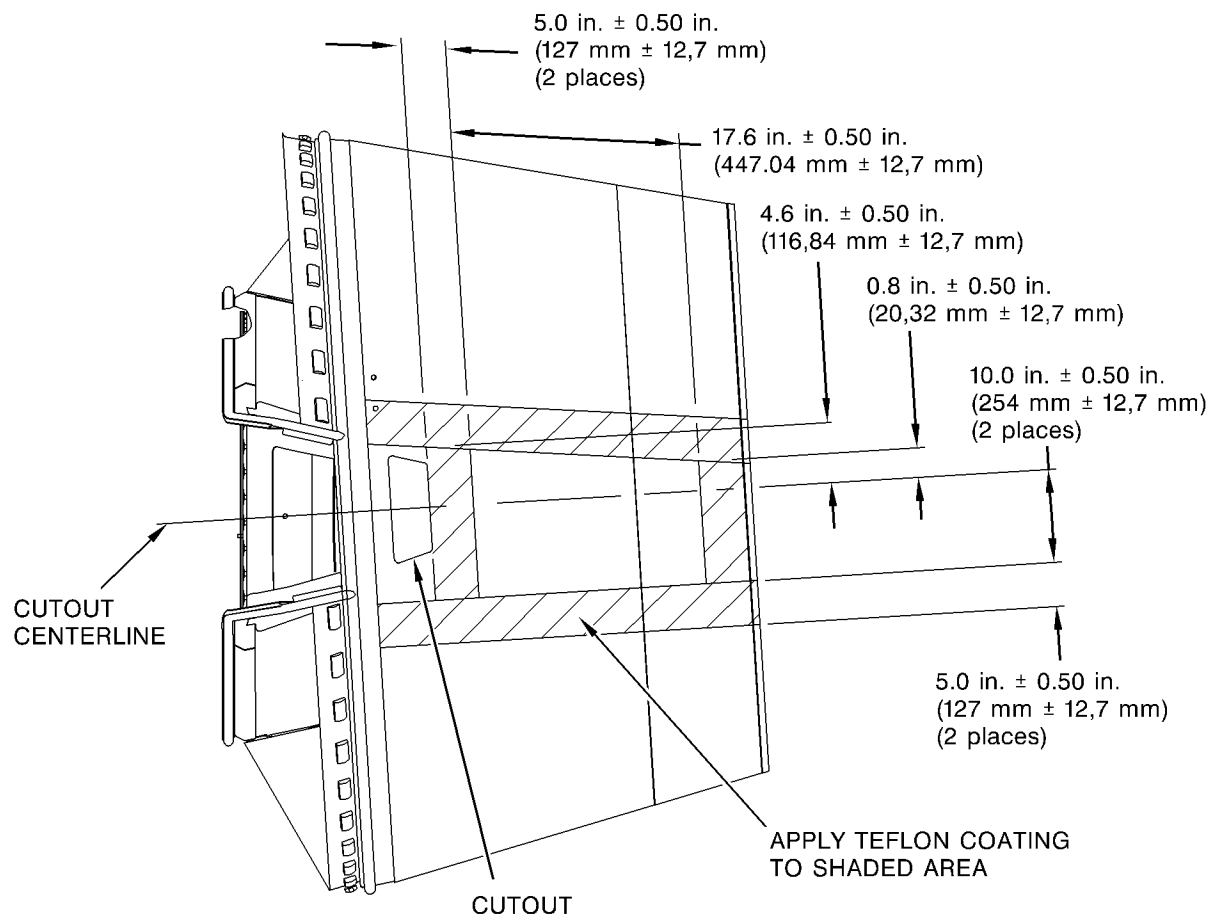
CNA - Application of Abrasion Resistant Coating
Figure 1

CNAs have been found with damage to the inboard side caused by chafing against the pylon seal.

- (1) Problem
 - (a) CNA inboard surface can become worn in service.
- (2) Cause
 - (a) Chafing between the CNA inboard surface and the pylon seal.
- (3) Background
 - (a) CNAs have been found with worn inboard surfaces.
- (4) Objective
 - (a) The changes in configuration recommended in this Service Bulletin are intended to maintain reliability of the CNA by application of a abrasion resistant paint to the inboard side of the CNA.
- (5) Substantiation
 - (a) Not applicable.
- (6) Impact of Bulletin on Workshop Procedures
 - (a) Removal/Installation

- (1) Mix the 23-T3-105 base and PC-216 catalyst. Refer to the manufacturer's instructions.
- (2) Apply the teflon coating to the inboard side of the CNA. Refer to Figure 1. Refer to the manufacturer's instructions.
