Number: V2500-NAC-78-0198

Date: May 14, 2001

SUBJECT: NON-MODIFICATION SERVICE BULLETIN" - "NACELLE - EXHAUST - THRUST
REVERSER - BLOCKER DOOR LINKS - INSPECTION OF

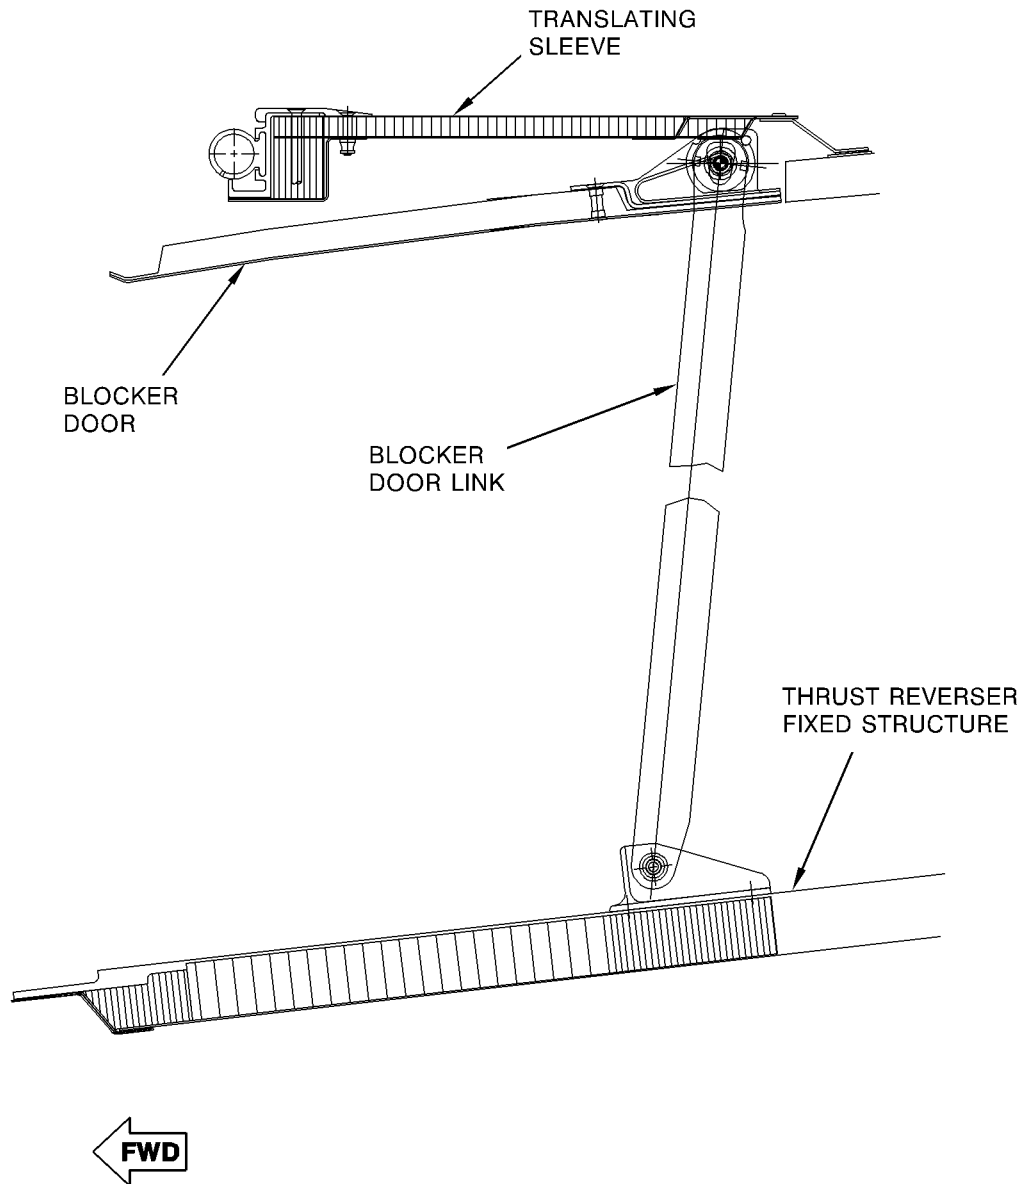
Thrust Reverser Blocker Door Link Inspection
Figure 1

(a) Bearings out of position at the fixed structure end of the
links.

B. Inspect the blocker door link as instructed in the MD-90/V2500-D5 Thrust Reverser Assembly Component Maintenance Manual (CMM-TR-V2500-3IA), Chapter 78-32-21 and take any necessary corrective actions. Give particular attention to the bearing at the thrust reverser fixed structure end of the link.

- (1) Remove the blocker door link. Refer to the MD-90 Aircraft Maintenance Manual.

- (1) Install the blocker door link. Refer to the MD-90 Aircraft Maintenance Manual.
