Number: V2500-NAC-78-0203

Date: September 30, 2002

SUBJECT: THRUST REVERSER ASSEMBLY - BLOCKER DOOR - REPLACE THREADED BEARINGS
WITH SWAGED BEARINGS

"MODIFICATION SERVICE BULLETIN" - "NACELLE - EXHAUST - THRUST REVERSER
ASSEMBLY - BLOCKER DOOR - REPLACE THREADED BEARINGS WITH SWAGED
BEARINGS"

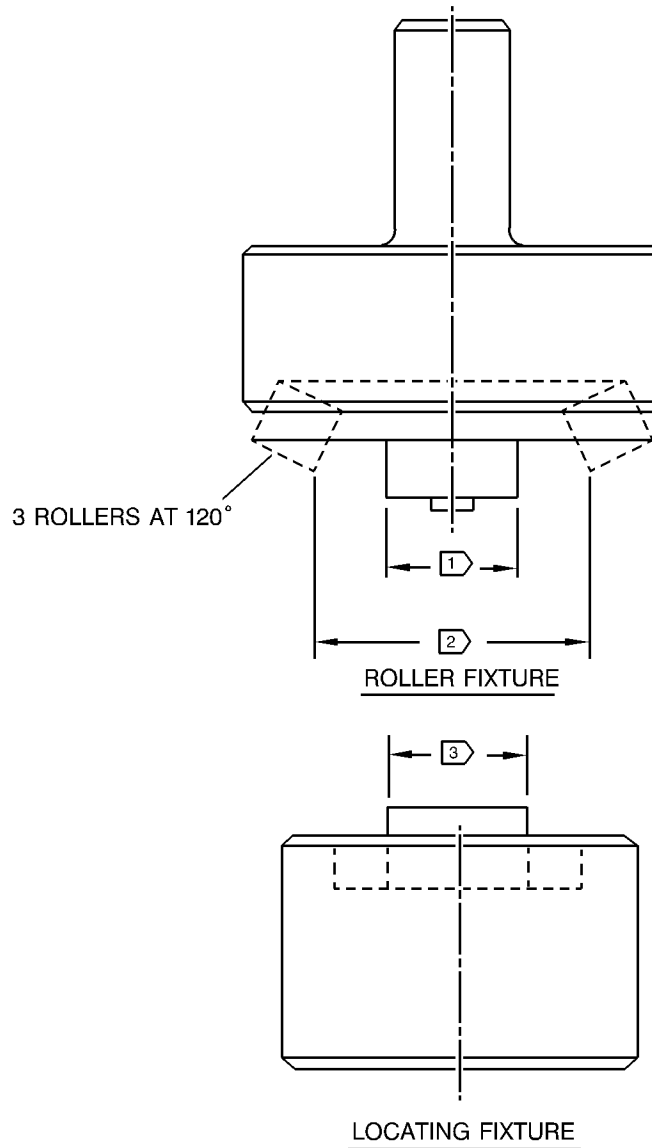
Blocker Door Modification
Figure 2 (sheet1)

- 1 PILOT DIAMETERS: 0.0015 in. (0,038 mm) MINIMUM CLEARANCE WITH BEARING BORE.
- 2 PITCH DIAMETER: MAXIMUM SWAGING GROOVE PITCH DIAMETER
+0.010 in. (0,25 mm), -0.005 in. (0,127 mm)
- 3 OTHER DIMENSIONS TO SUIT BEARING SIZE.

(11) Install the new one-piece bearings in the blocker door. Refer to Figure 2.

1. Apply primer to the inner surface of the bearing holes in the blocker door.
2. Press the bearing into the blocker door hole. Apply force evenly over the entire circumference of the outer race. Do not press on the inner race. Do not apply impact force to the bearing. Refer to Figure 2.
3. Check the bearing outer race to make sure it is even with the surface of the lug or no more than 0.010 inch (0,25 mm) above or below the surface of the lug.
4. Swage the bearing into the lug. Use roller swaging tool RST4183. Refer to Figure 2.
 - (a) If you use a power tool to operate the swaging tool, set the speed of the power tool to a speed of approximately 100 RPM or less. Do not exceed 100 RPM.
 - (b) Use the minimum force required to swage the grooved lip of the bearing over the lug.
 - (c) The swage is complete when the swaged lip of the bearing is in contact with the lug chamfer.

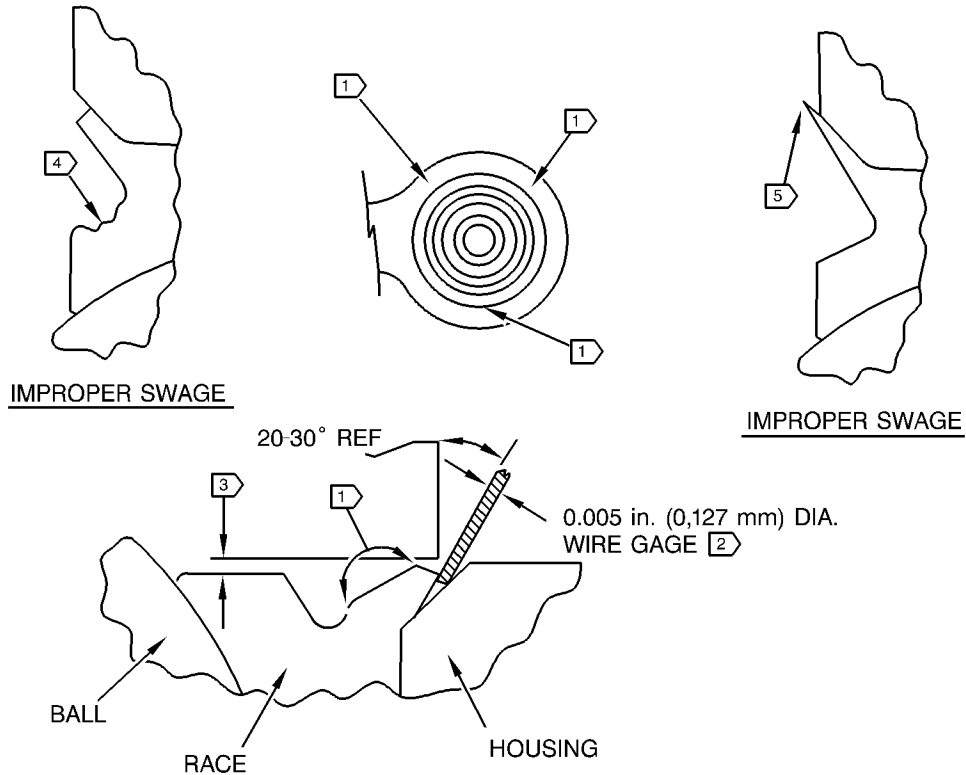
Blocker Door Modification
Figure 2 (sheet 2)

INSPECTION OF SWAGED V-GROOVE
BEARINGS SHALL BE AS FOLLOWS:

- 1 VISUALLY INSPECT THIS CIRCUMFERENTIAL AREA FOR CRACKS AND SEPARATIONS.
- 2 INSPECT CIRCUMFERENCE OF THE GAP IN THE SWAGED LIP AS SHOWN WITH 0.005 in. (0,127 mm) FEELER GAGE. A PROPERLY SWAGED BEARING IN AN OPTIMALLY PREPARED HOUSING WILL NOT ACCEPT THE FEELER GAGE, HOWEVER, NO MORE THAN 40% OF THE CIRCUMFERENCE MAY ACCEPT THE GAGE.
- 3 BEARING RACE FACE TO BE FLUSH WITH HOUSING +0.000/-0.010 in. (+0,00/-0,25mm)
- 4 VISUALLY INSPECT INNER FACE OF BEARING GROOVE TO ASSURE THERE IS NO EVIDENCE OF ROLLER CONTACT DURING THE SWAGING OPERATION.
- 5 VISUALLY INSPECT THE SWAGED PORTION OF THE SWAGED LIP TO ASSURE THAT OVER-SWAGING HAS NOT OCCURRED.

5. Examine the bearing installation. Refer to Figure 2.
- (a) Visually examine the blocker door lug for cracks. Do a liquid penetrant inspection if cracks are suspected (refer to ASTM E 1417). Reject any door with cracked lugs.

- (b) Make sure the ball of the bearing turns freely after swaging. Reject any bearings that do not have a ball that turns freely. If you reject the bearing, repeat the installation procedure with a new bearing.

- (c) Visually examine the swaged portion of the bearing for galling or cracks. Any crack or galling is cause for rejection of the installation. If you reject the installation, repeat the installation procedure with a new bearing.

- (d) Measure the gap between the swaged portion of the bearing and the lug. A 0.005 inch (0,127 mm) gap is permitted in 40% or less of the swaged circumference. Too much gap is cause for rejection of the installation. If you reject the installation, repeat the installation procedure with a new bearing.
