V2500-A1/A5 SERIES NACELLE SERVICE BULLETIN

This document transmits Revision 1 to Service Bulletin NV2500-78-0218 and Revision 1 to the Supplement

V2500-NAC-78-0218

EXHAUST – THRUST REVERSER – RIGHT THRUST REVERSER HALF – FIXED STRUCTURE – 7TH STAGE
BLEED PORT MODIFICATION

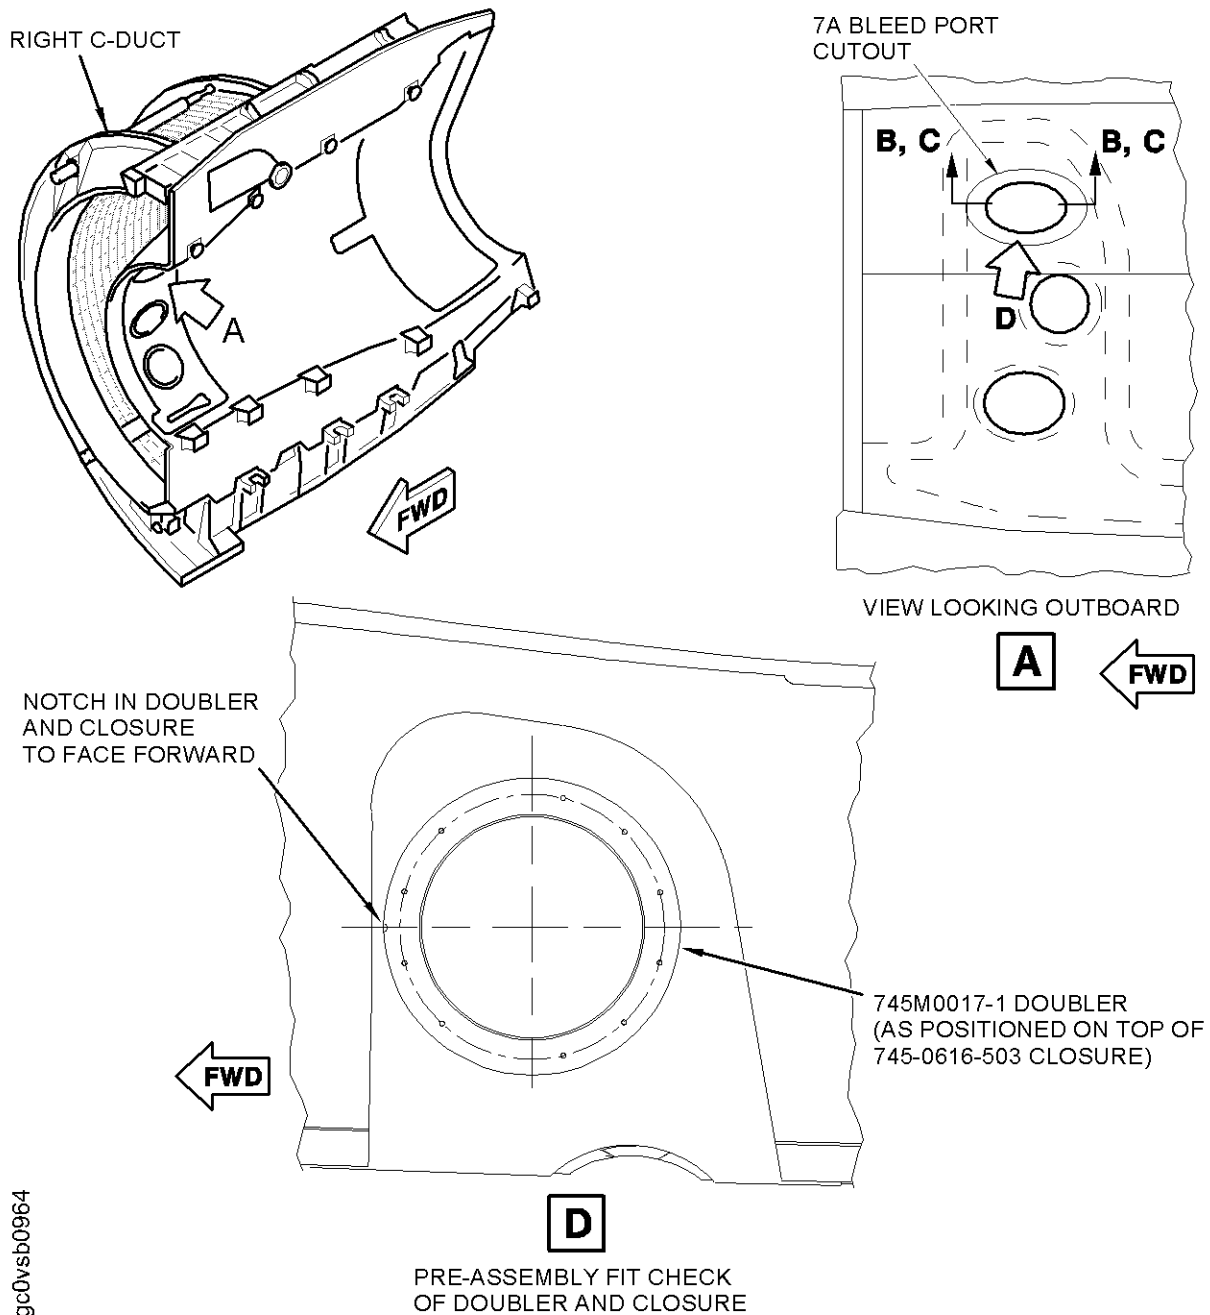
Installation of 7A Bleed Port closure and doubler
Figure 1 (sheet 1 of 2)

- (a) The right hand thrust reverser half fixed structure inner bond panel can become damaged in the area surrounding the 7A bleed port.

- (a) Operators have reported damage to the right thrust reverser half fixed structure inner barrel at the 7A bleed port location. Damage found has varied from skin discoloration to delamination and missing areas of the skin and honeycomb at the aft edge of the 7A bleed port cutout.

This service bulletin provides instructions for installation of a closure and a doubler with mechanical fasteners to the 7A bleed port cut-out area of the inner bond panel of the R/H thrust reverser.

B. Install closure and doubler on the 7A bleed port cutout.

- (5) Position 745-0616-503 inner closure onto its mounting surface (over the existing seal land which is integral to the bond panel assembly). Rotate the part as required to insure the flange sits correctly on the mating surface and is centered within the 7A bleed port cutout. An alignment mark (notch) is on the part to aid installation – the notch indicates the forward edge. Use CoMat 02-002 masking tape secure closure into place.

- (6) Position the 745M0017-1 doubler on top of the 745-0616-503 closure. An alignment mark (notch) is on the part to aid installation – the notch indicates the forward edge. Use CoMat 02-002 making tape to temporarily secure parts in proper orientation.

- (7) Drill 10 pilot holes as located on the 745M0017-1 doubler through the doubler, closure, seal land and inner bond panel skin. Use a No. 30 drill (0.129 – 0.132 in. dia (3,28 mm – 3,35 mm dia). Make 100 degree countersink in the holes on the doubler.

- (15) Install ten CR3524-4-02 blind rivets in the ten previously drilled holes through the 745M0017-1 doubler, 745-0616-503 closure, seal land and inner bond panel skin.

- R (16) Fill the gap between the 745-0616-503 inner closure and the edge of the
bond panel cutout with (CoMat 08-092) sealant (DC 93-076) mixing and
curing of the sealant per the manufacturer's instructions.
