V2500 A1/A5 SERIES PROPULSION SYSTEM SERVICE BULLETIN

This document transmits Revision 1 to Service Bulletin NV2500-78-0219

V2500-NAC-78-0219

NACELLE – FIXED DUCT ASSEMBLY – LOWER BIFURCATION SEAL LAND GAP INSPECTION

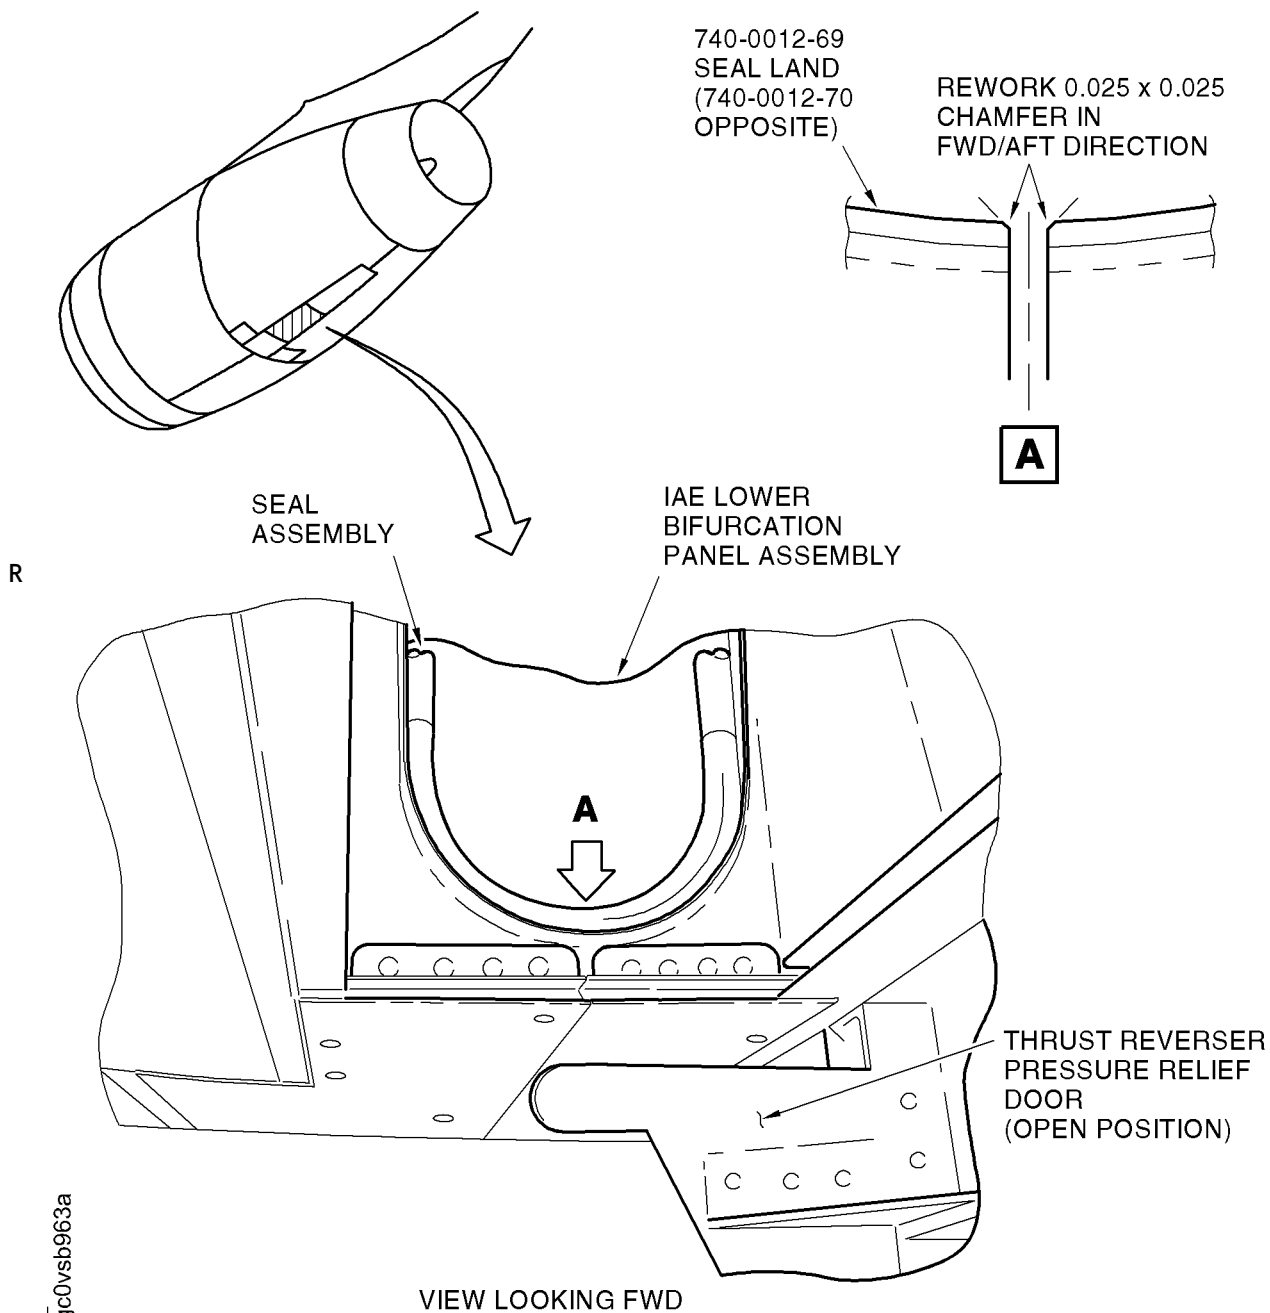
Lower Bifurcation Seal Land Area Gap Inspection
Figure 1

Since the incorporation of the Oil in the Turbine Modification, the new lower bifurcation panel seals (PN ARM1317) have been damaged in production on C-duct closure. This is due to minimal gap and sharp edges between the seal land abutment faces. On C-duct closure, the bifurcation seal can get dragged causing the bottom section of the seal to get trapped between the seal land of the opposing C-ducts.

- (1) Inspect the lower bifurcation seal land area for damage to the seal on the bifurcation panel assembly (PN 6A7930). Refer to Figure 1. If seal is damaged, refer to VRS6669 for repair/replacement instructions.

R (b) Use local handtools to remove equal amounts of material from each seal land (P/Ns 740-0012-69 and 740-0012-70) to achieve an 0.080 - 0.120 inch (2,032 mm to 3,048 mm) gap.

R (c) Rework each C-duct half by adding a 0.025 x 0.025 inch chamfer in the forward/aft direction to the seal land. Remove all burrs and sharp edges to achieve a 125 microfinish using Comat 05-074 Aluminimu Oxide abrasive paper (180 grit).
