# SERVICE BULLETIN REVISION NOTICE

NACELLE – EXHAUST – LUG, THRUST REVERSER LOWER OUTBOARD TRACK ASSEMBLY  
LANYARD ATTACH – MODIFICATION OF

Turbojet Engine Service Bulletin No. V2500-NAC-78-0225 Revision No. 1 dated May 9, 2017

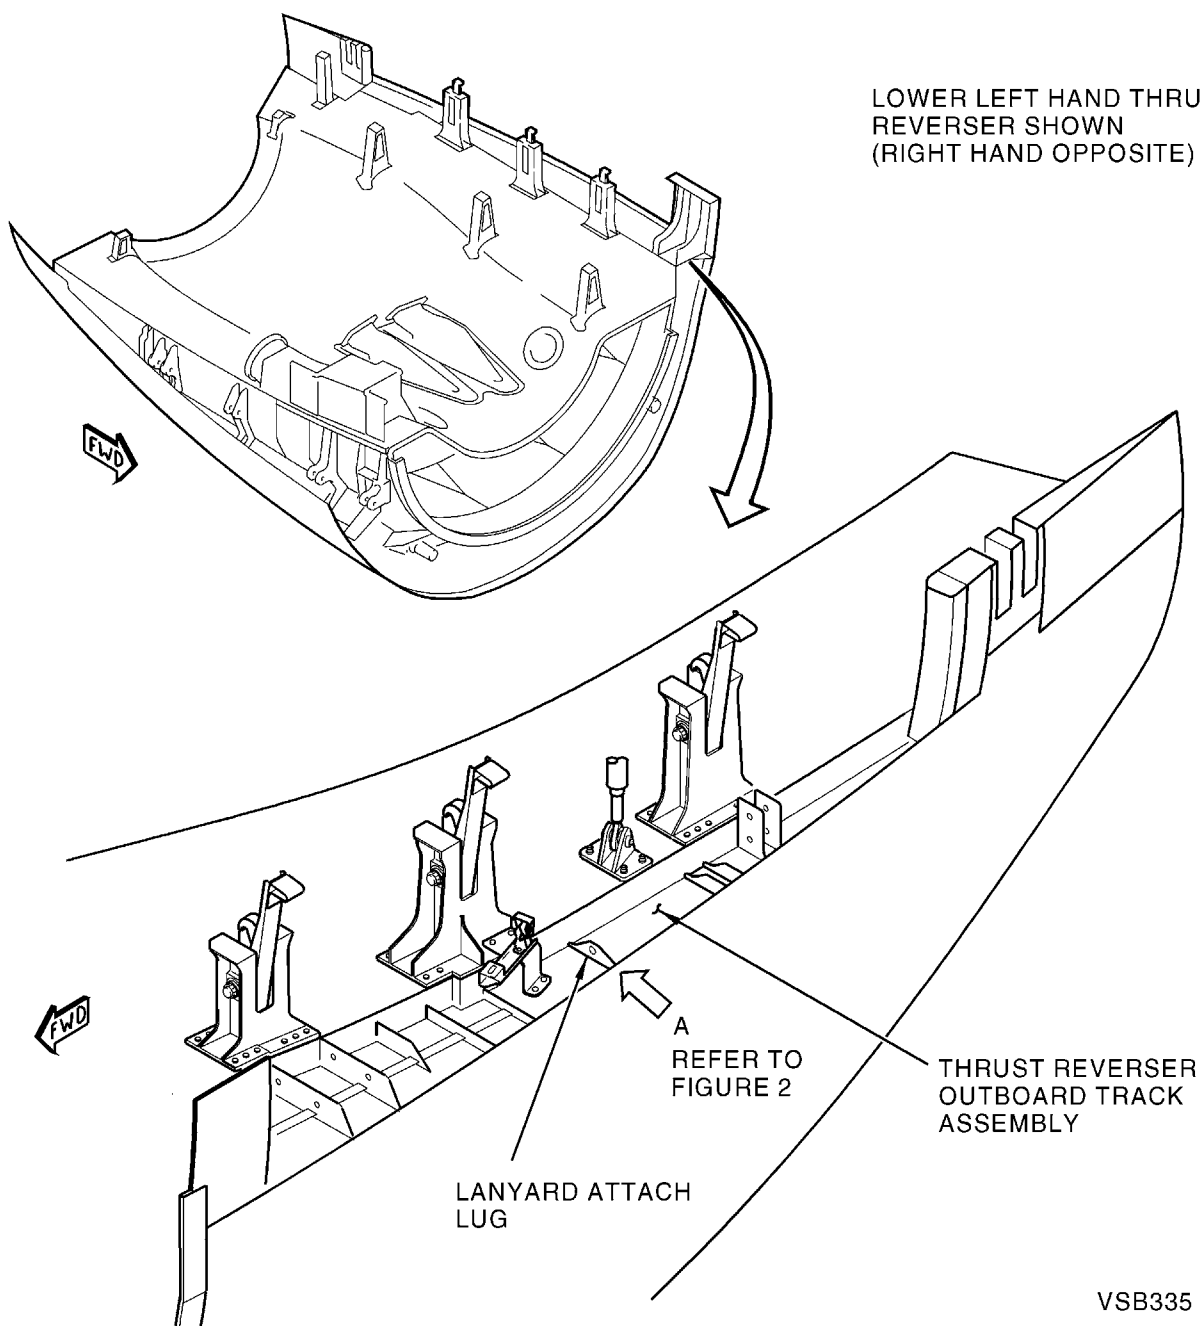
OUTBOARD TRACK ASSEMBLY LANYARD ATTACH LUG  
Fig.1

The lower thrust reverser outboard track assembly lanyard attach lug may exhibit cracking in service.

Repetitive openings of pressure relief door may reduce fatigue life of integral track lanyard attach lug.

- (a) Carefully pull back insulation blanket on outboard track assembly of left hand lower thrust reverser to get access to rework area. Refer to Figure 1.
- (b) If installed, remove S700B0116-5C8 or S700B0116-5C16 bushing. Refer to Figure 2. Discard bushing.
- (c) If installed, remove 94-B043600-M angle bracket. Discard bracket.
- (d) Remove material from track assembly as shown in Figure 2.
- (e) Clean away metal chips or other unwanted material with dry air supply.
