## V2500-D5 SERIES PROPULSION SYSTEM NON-MODIFICATION SERVICE BULLETIN

# V2500-NAC-78-0232

NON-MODIFICATION SERVICE BULLETIN – NACELLE – THRUST REVERSER – BLOCKER DOOR LINK  
ASSEMBLY – INSPECTION OF CHAMFER

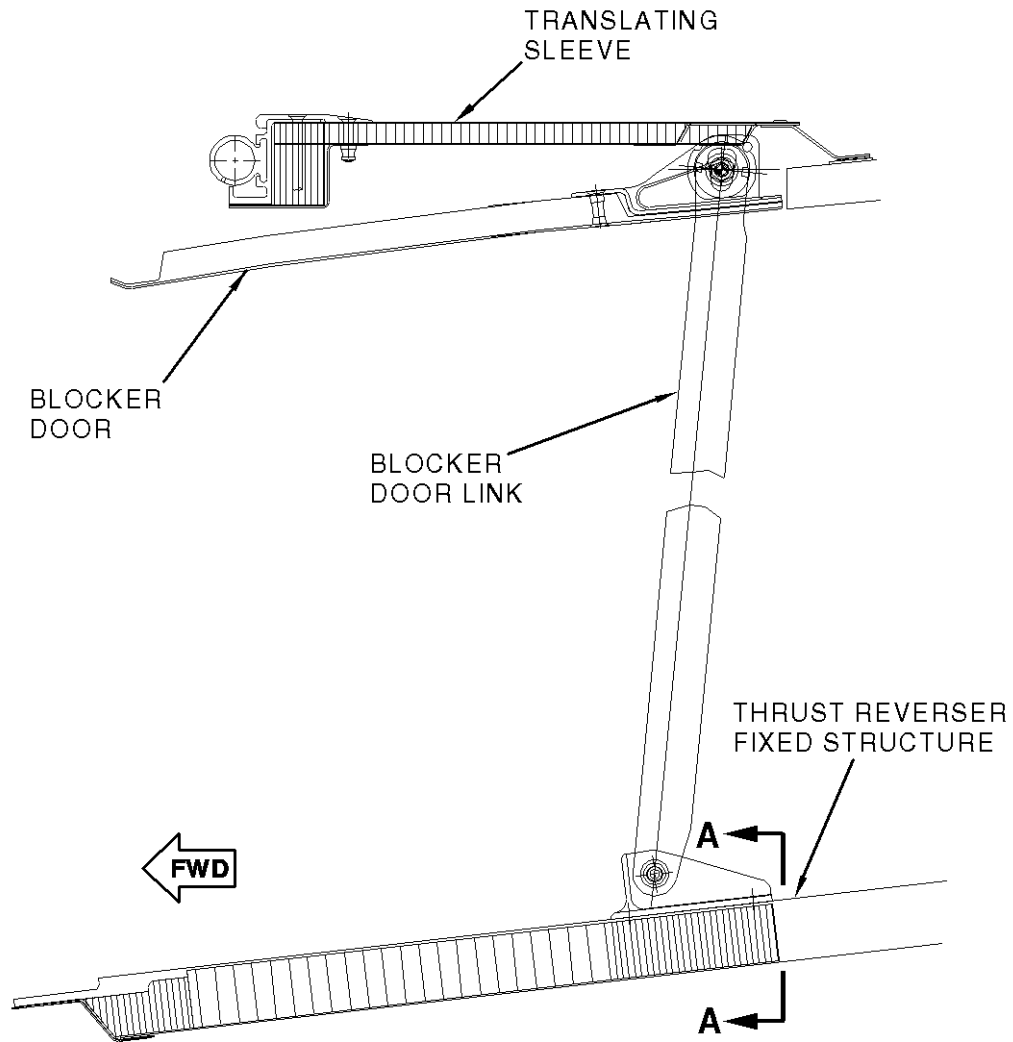
Blocker Door Link, Installed  
Figure 1

Thrust reversers have been found with damaged blocker door links. The bearings migrate out of position at the fixed structure end of the links and can fail in fatigue if left unnoticed for an extended period of time.

- C. For links removed in section 3.B., measure as accurately as possible, the outside diameter of the chamfer (link end common to TR fixed structure). See Figures 1 and 2 for details.

- (1) If the measured chamfer diameter falls within the provided tolerance, then no further action is required for that link.
- (2) If the measured chamfer diameter falls outside the tolerance range, rework the chamfer by removing the bearing per CMM Task 78-30-00-300-038, beginning with Subtask 78-30-00-350-084.

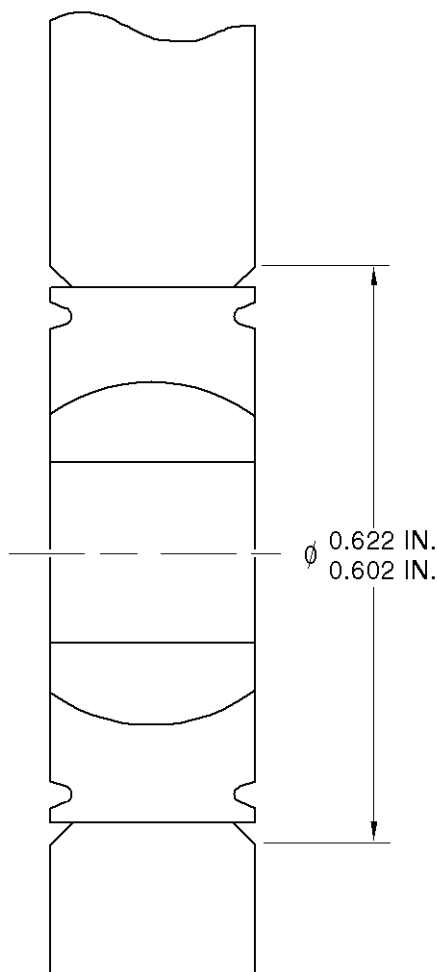
Figure 2

Cross-section of link end with bearing, pre-swaged condition.  
Measure indicated dimension to outer diameter of chamfer.
