V2500-D5 SERIES PROPULSION SYSTEM NON-MODIFICATION SERVICE BULLETIN

V2500-NAC-78-0233

NON-MODIFICATION SERVICE BULLETIN – NACELLE – COMMON NOZZLE ASSEMBLY – EXIT NOZZLE
INNER SKIN – INSPECTION OF RIVETS

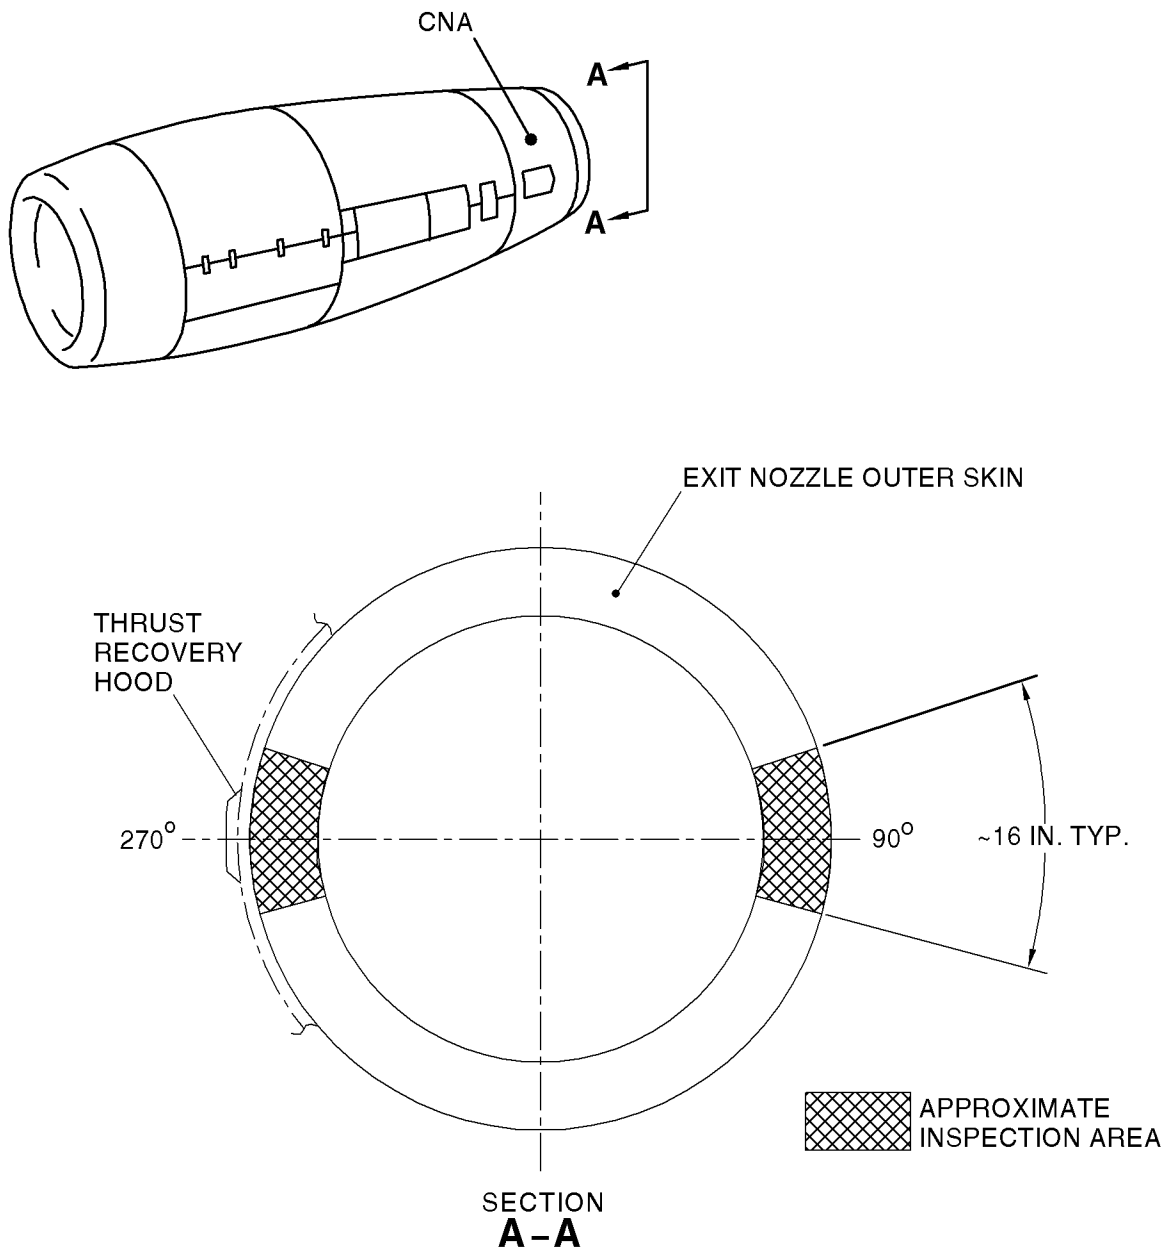
Figure 1
Exit Nozzle Outer Skin Inspection Location

If the Service Bulletin V2500-NAC-78-0119 is not incorporated, visually inspect the outer skin of the exit nozzle at the 90° and 270° radial locations for signs of heat damage and/or distortion. See Figure 1 for locations.

If heat damage or distortion of the skin is witnessed, it is recommended that Service Bulletin V2500-NAC-78-0119 be incorporated.

If the subject Service Bulletin V2500-NAC-78-0119 cannot be incorporated at the time of inspection, contact Goodrich for disposition. It is recommended Service Bulletin V2500-NAC-78-0119 be incorporated at the CNA's next shop visit

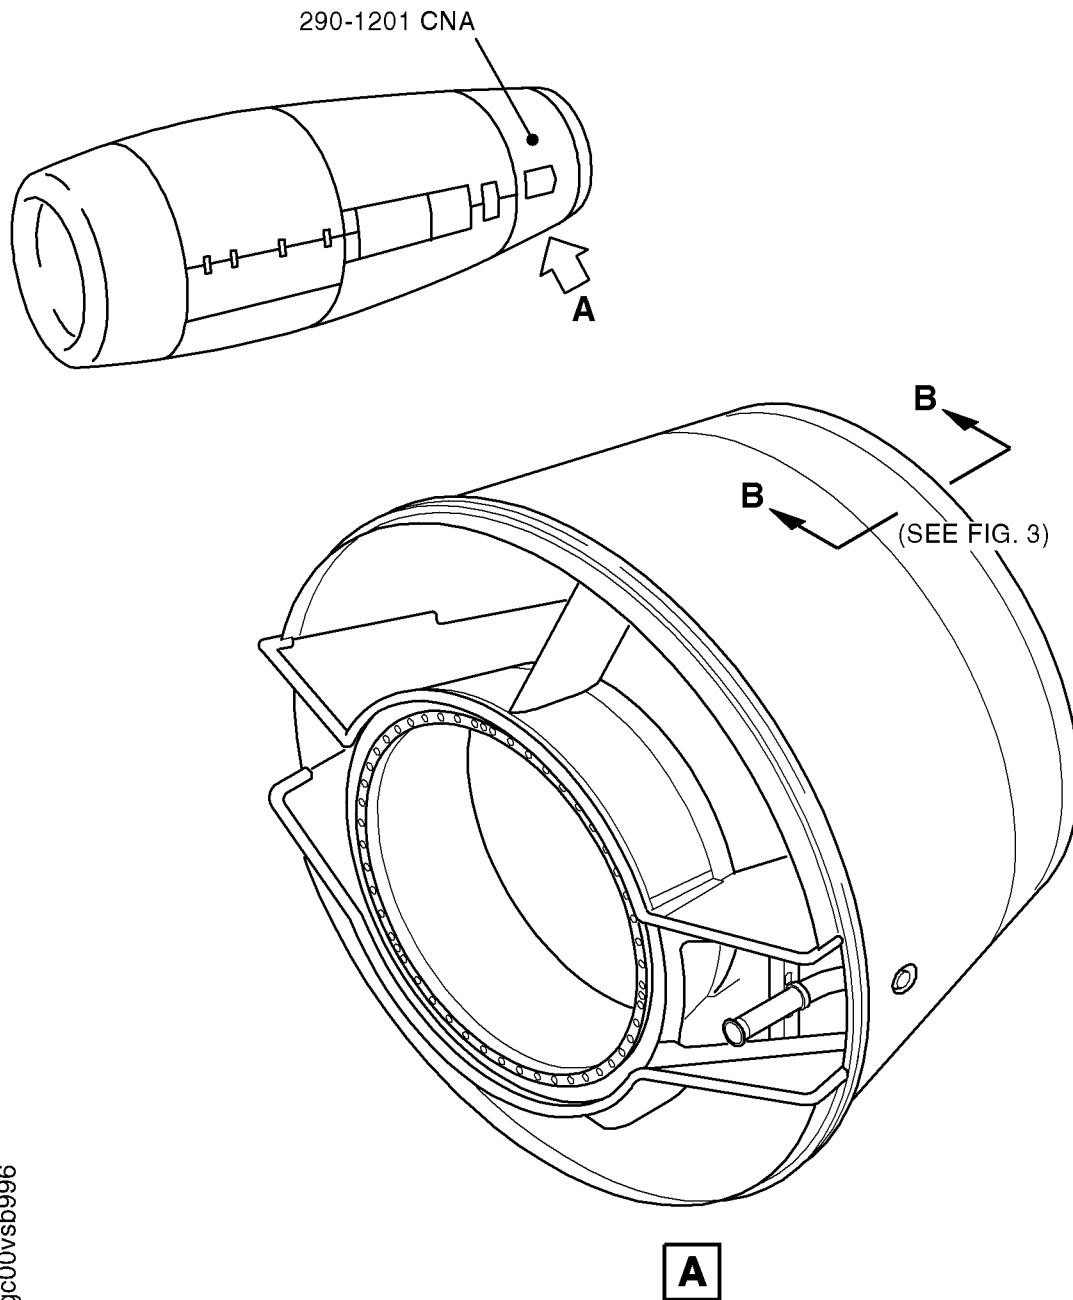
Figure 2
Common Nozzle Assembly Exit Nozzle Location

- B. Visually inspect for any missing rivets in the CNA exit nozzle inner skin forward circumferential pattern. Circle the locations with ink marker or equivalent for future fastener replacement and instructions called out in this Non-Modification Service Bulletin. See Figure 2 and 3 for location. Fill out the Proforma Data Sheet provided in this Non-Modification Service Bulletin.

- C. Visually inspect for any missing rivets in the CNA exit nozzle inner skin aft circumferential pattern. Circle the locations with ink marker or equivalent for future fastener replacement and instructions called out in this Non-Modification Service Bulletin. See Figure 2 and 3 for location. Fill out the Proforma Data Sheet provided in this Non-Modification Service Bulletin.

- D. Visually inspect for loose rivets on the CNA exit nozzle inner skin forward circumferential pattern (see Figure 2 for location) in the following manner. Use a screwdriver, punch or equivalent to put light side pressure on the head of the rivet. Any movement of the fastener head during this operation is considered loose. Circle the loose locations with ink marker or equivalent for future fastener replacement and instructions called out in this Non-Modification Service Bulletin. Fill out the Proforma Data Sheet provided in this Non-Modification Service Bulletin.

- G. Replace all missing and loose rivets identified in 3.B. through 3.F. of this Non-Modification Service Bulletin per Boeing MD-90 SRM Section 51-30-00, Vol. 2.

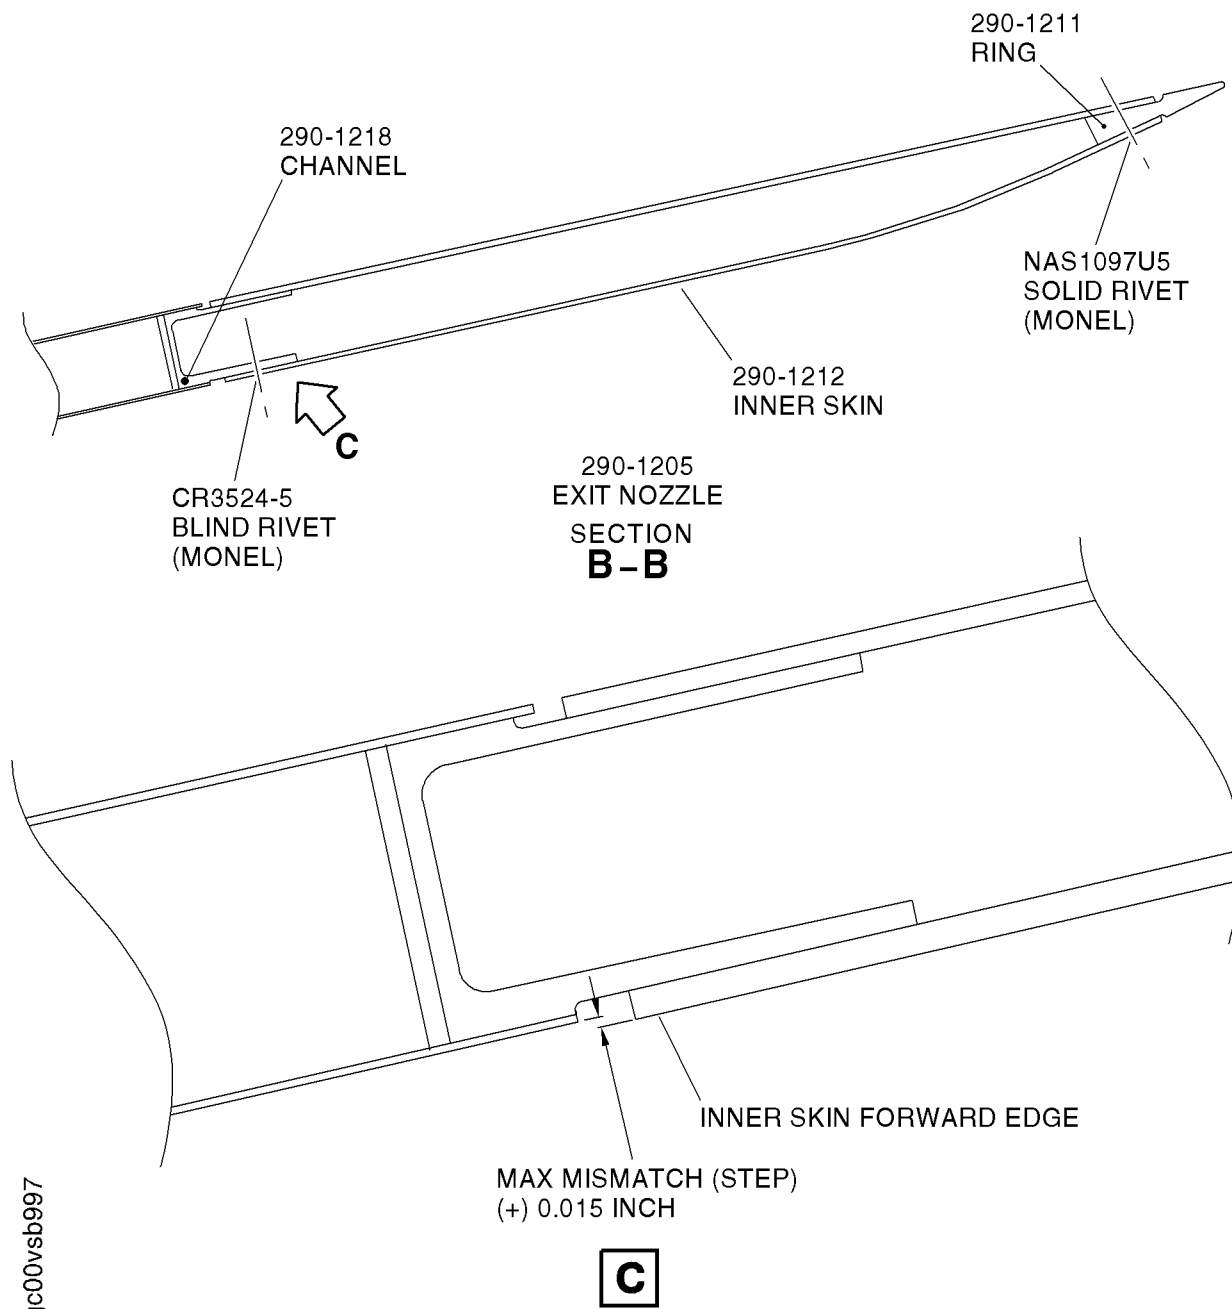
Figure 3
Exit Nozzle Inner Skin Inspection Locations

- E. Visually inspect for loose rivets on the CNA exit nozzle inner skin aft circumferential pattern (see Figure 2 and 3 for location) in the following manner. Use a screwdriver, punch or equivalent to put light side pressure on the head of the rivet. Any movement of the fastener head during this operation is considered loose. Circle the loose locations with ink marker or equivalent for future fastener replacement and instructions called out in this Non-Modification Service Bulletin.

- H. Once all missing and loose rivets have been replaced, visually inspect the CNA exit nozzle inner skin forward edge mismatch (step) with respect to the outer barrel inner skin at locations where loose or missing fasteners were identified. See Figure 3 for mismatch requirements. Please contact Goodrich for disposition for areas falling outside mismatch (step) tolerances shown in Figure 3.
