# International Aero Engines

Subject: Transmittal of Revision 4 to Alert Service Bulletin Number V2500-NAC-78-A0182

NACELLE - EXHAUST - OUTER V-BLADE, THRUST REVERSER - INSPECTION FOR CRACKS  
AND/OR MISSING PIECES

**V2500-NAC-78-A0182**

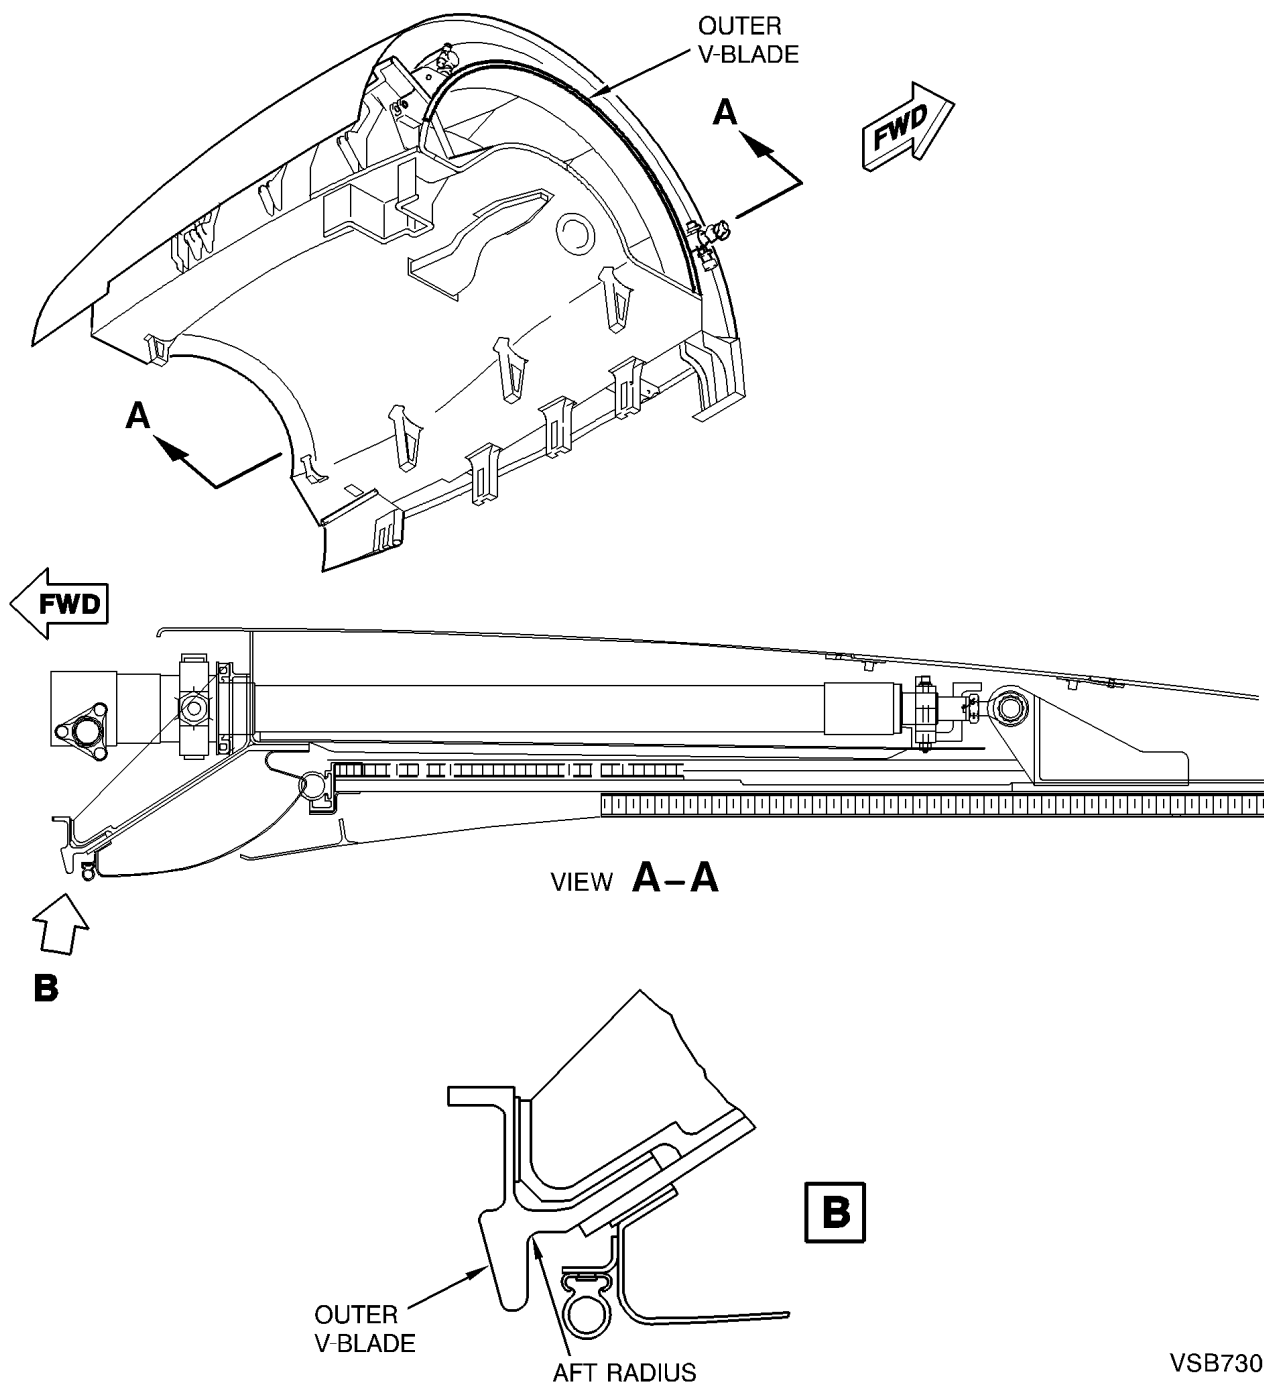
Thrust Reverser Outer V-Blade Inspection  
Figure 1

The thrust reverser outer v-blade can crack in service.

Four thrust reversers have been found with cracks in the outer v-blade. One of these was found with a 12 inch (304.8 mm) piece missing.

- (1) Clean the outer v-blade at the aft radius location with a clean lint free cloth (CoMat 02-099) and solvent (CoMat 01-438) or equivalent.
- (2) Visually examine the outer v-blade of each thrust reverser half for cracks or missing pieces. Use 10X magnification. Give special attention to the ends and the aft radius of the v-blade. If you suspect a crack, you must do a local high or ultra-high sensitivity penetrant inspection of the area. Refer to the IAE Standard Practices/Processes Manual (SPP-V2500-1IA), TASK 70-23-05-230-501. Refer to Figure 1.

**CAUTION:**    CRACKS OR MISSING PIECES ARE ALLOWED IN ONLY ONE END OF THE OUTER V-BLADE OF EACH THRUST REVERSER HALF. CRACKS OR MISSING PIECES MAY EXTEND NO MORE THAN 11 INCHES (279,4 MM) FROM THE END OF THE V-BLADE. IF YOU FIND CRACKS OR MISSING PIECES IN BOTH ENDS OF THE V-BLADE OF ANY THRUST REVERSER HALF, OR THE CRACKS OR MISSING PIECES EXTEND MORE THAN 11 INCHES (279,4 MM) FROM THE END OF THE V-BLADE, YOU MUST REPLACE THAT HALF.

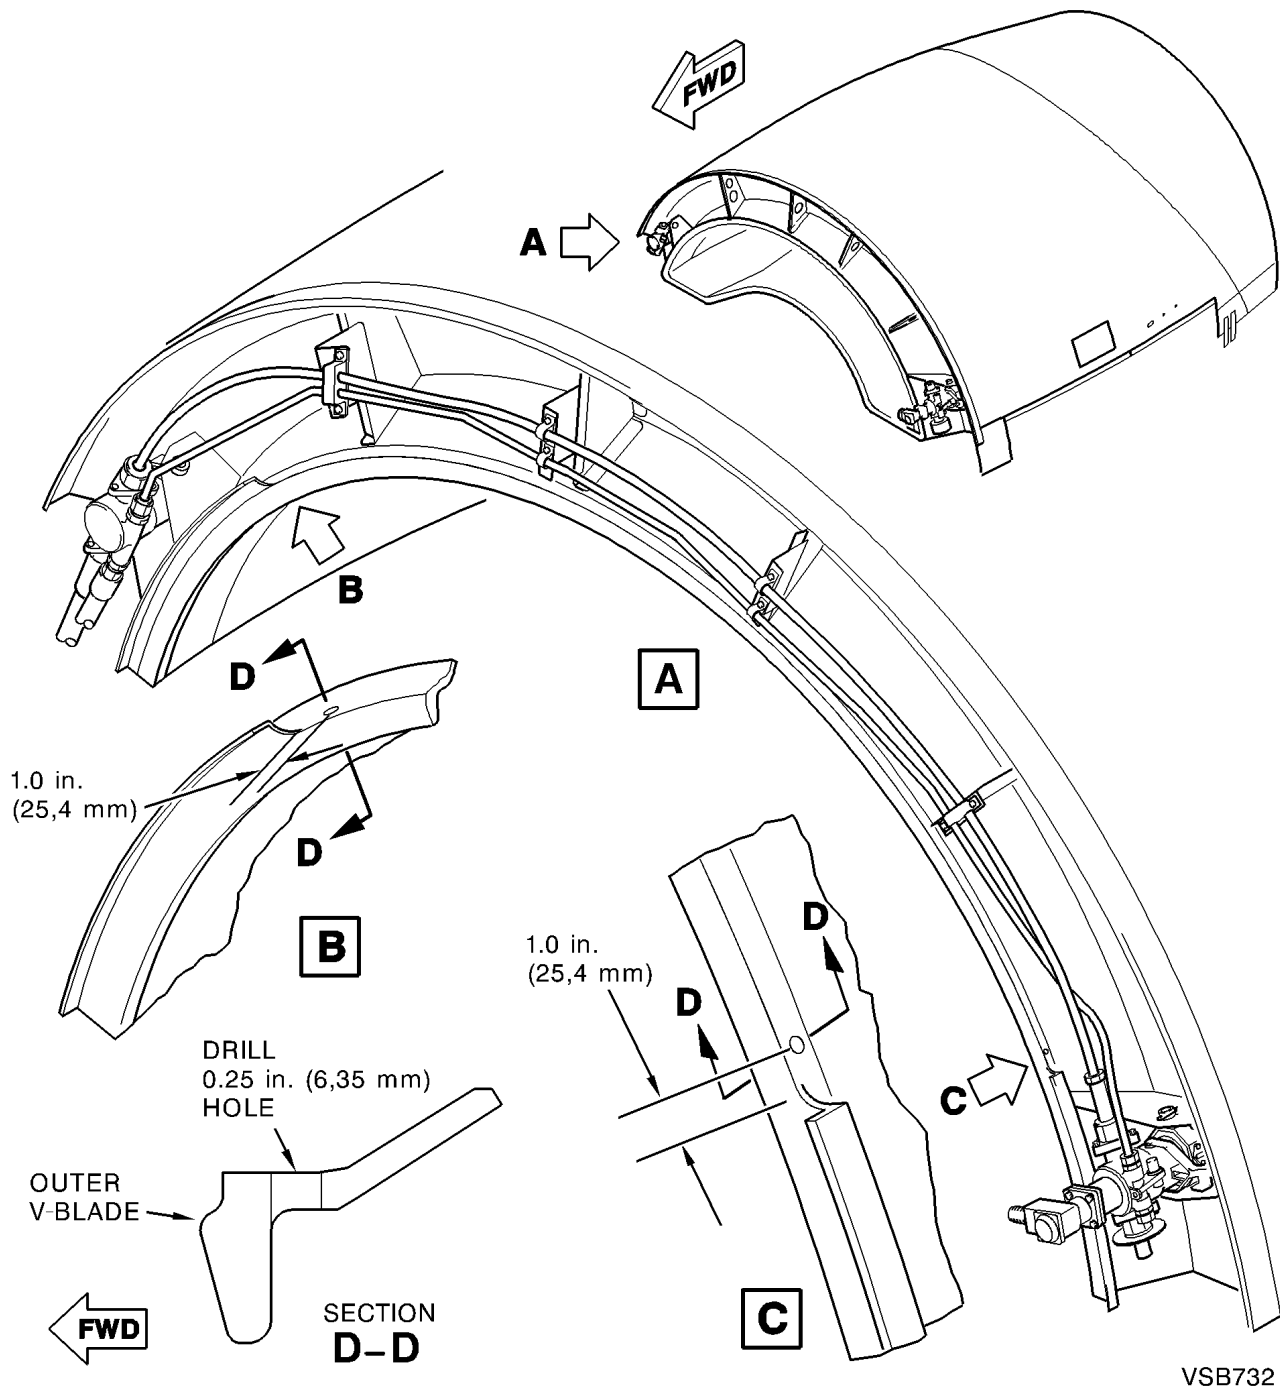
Outer V-Blade Crack or Missing Piece Stop Drill  
Figure 2

- (a) If you find cracks or missing pieces in only one end of the outer v-blade of the thrust reverser half and the cracks or missing pieces extend no more than 11 inches (279,4 mm) from the end of the v-blade, you must:

- 1 Immediately stop drill the crack. Refer to Figure 2.
    - a Make a pilot hole then drill a 0.25 inch (6,35 mm) hole as shown in Figure 2 or, if the crack or missing piece extends beyond the specified hole location, drill the 0.25 inch (6,35 mm) hole one inch beyond the end of the crack or missing piece. Remove the burrs from the finished hole.

- R 5 If the replacement thrust reverser half has a crack or missing piece, you must:
- a Make a pilot hole then drill a 0.25 inch (6,35 mm) hole as shown in Figure 2 or, if the crack or missing piece extends beyond the specified hole location, drill a 0.25 inch (6,35 mm) hole one inch beyond the end of the crack or missing piece. Remove the burrs from the finished hole.

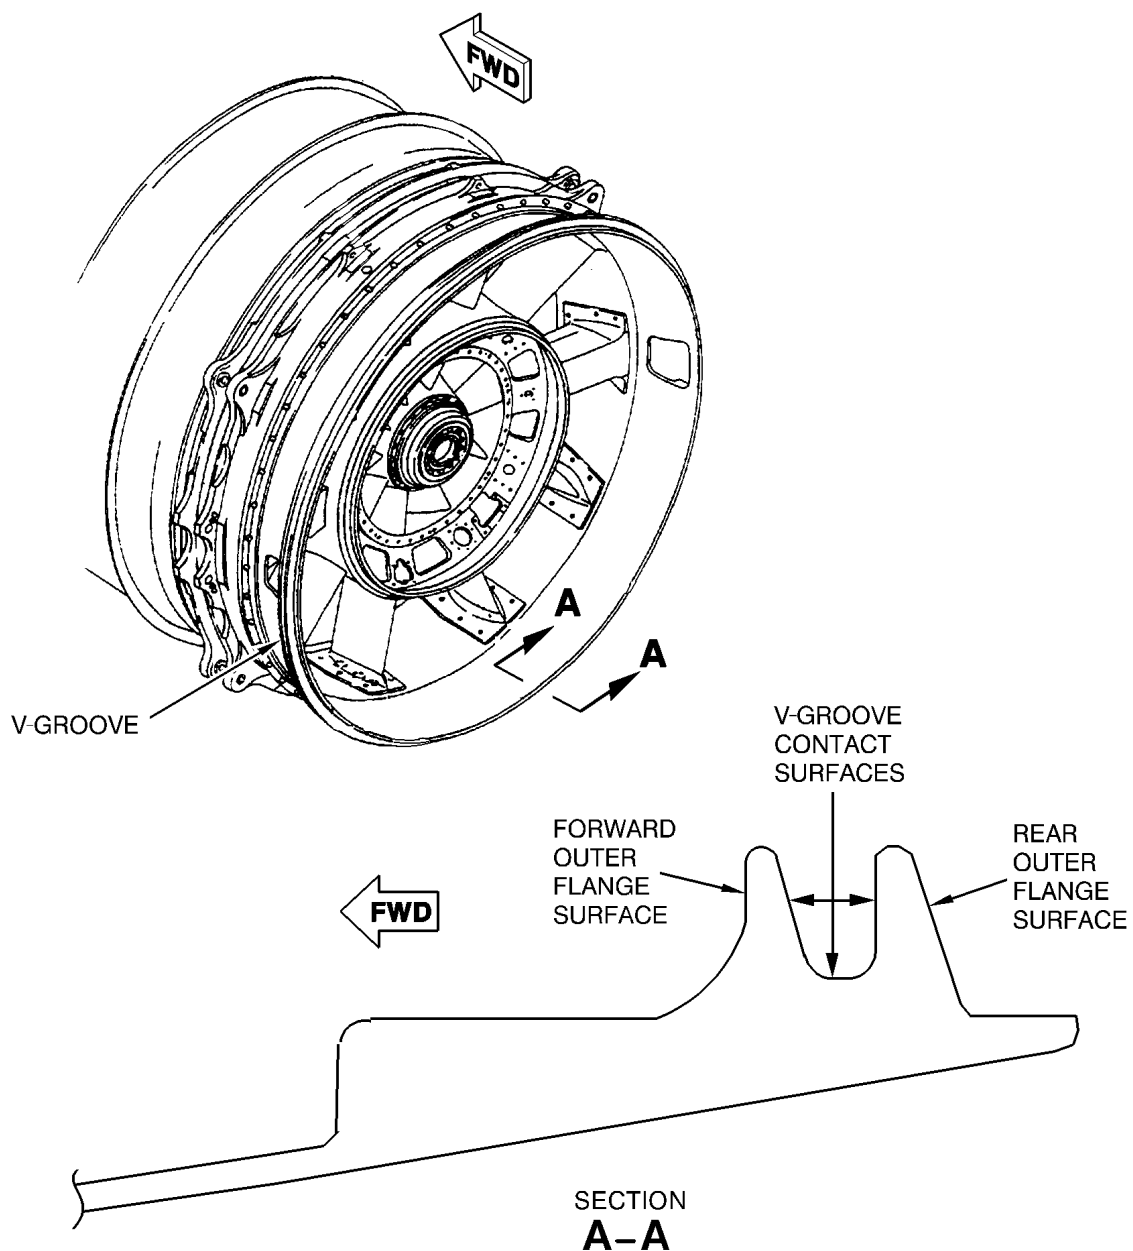
Fan Case Rear Extension Inspection  
Figure 3

R The fan case rear extension v-groove outer flange surface (refer to Figure 3) is examined for cracks. If any cracks are found, their length and location are reported to IAE for disposition.

D. Examine the fan case rear extension v-groove outer flange surfaces for cracks.

- (1) Clean the v-groove outer flange surfaces with a lint free cloth (CoMat 02-099) and solvent (CoMat 01-438) or equivalent.
- (2) Visually examine the outer flange surfaces of the v-groove for cracks. Use 10X magnification. If you suspect a crack, you must do a local high or ultra-high sensitivity penetrant inspection of the area. Refer to the IAE Standard Practices/Processes Manual (SPP-V2500-1IA), TASK 70-23-05-230-501. Refer to Figure 3.
  - (a) If you find a crack or damage in the v-groove or on the flange abutment faces of the fan case rear extension, you must contact IAE for disposition. Refer to the Report Form at the back of this service bulletin.

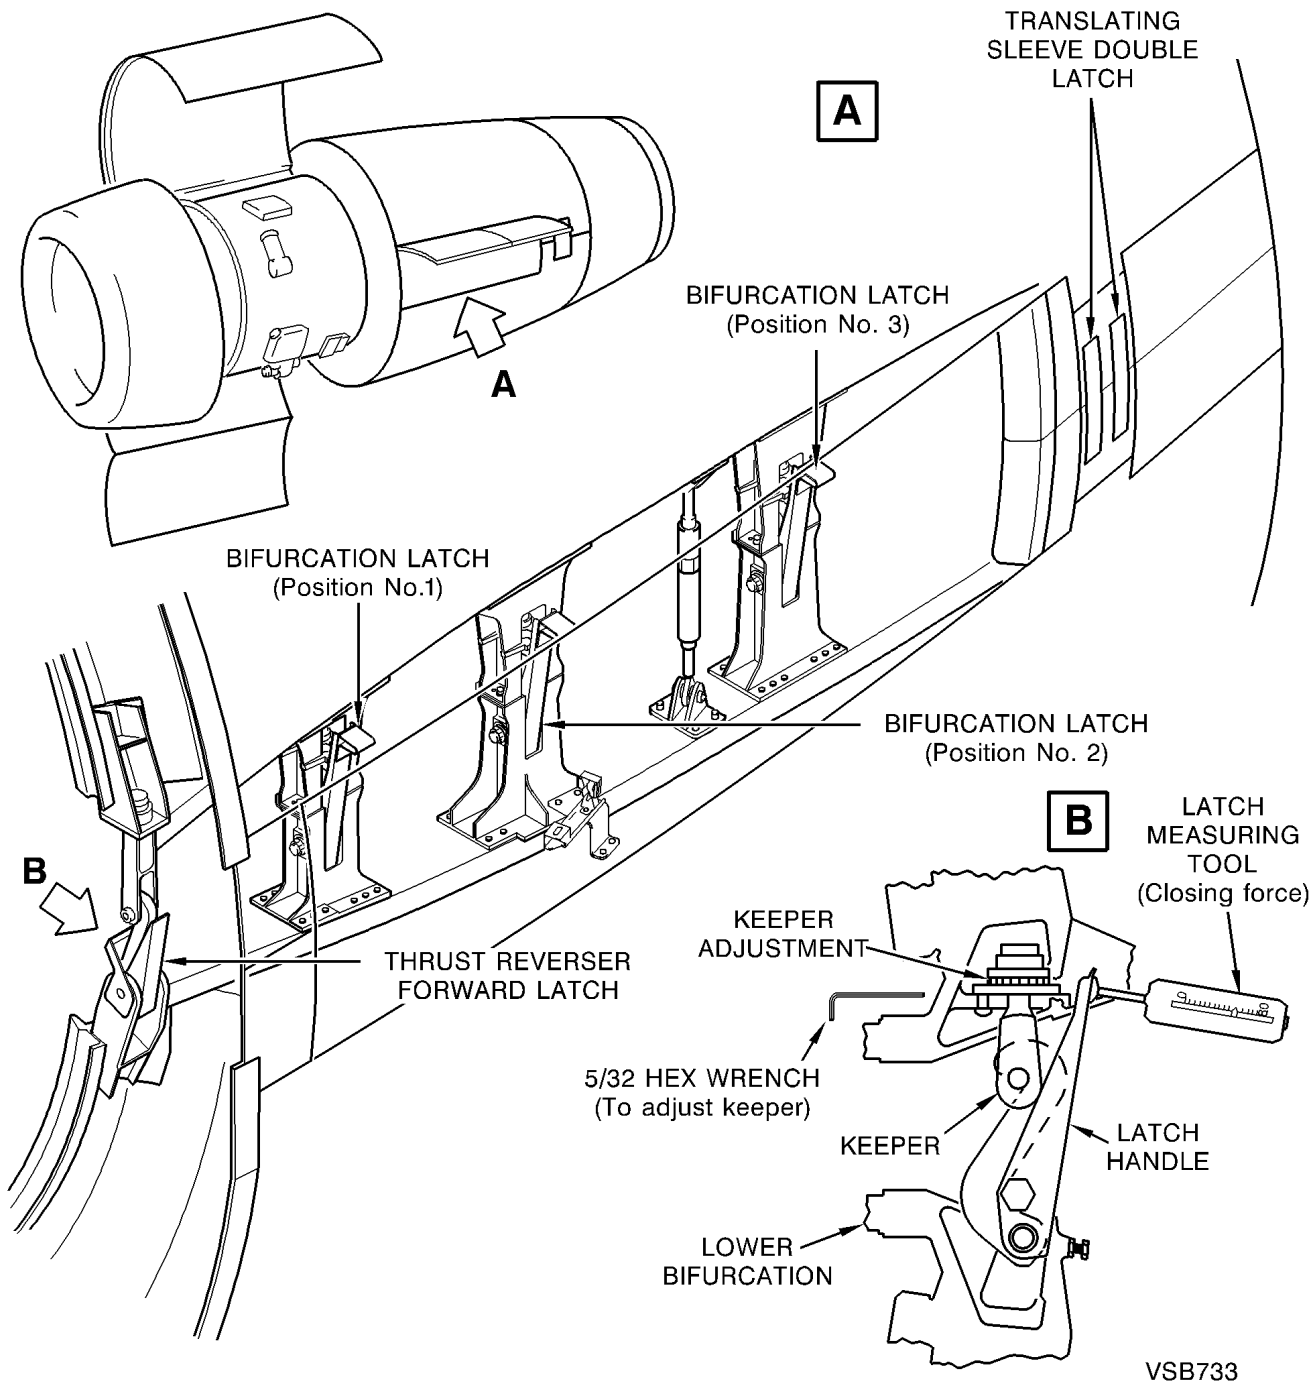
Thrust Reverser Latch Adjustment  
Figure 4

**CAUTION:** IT IS NECESSARY THAT THE CLOSING FORCE OF EACH THRUST REVERSER AND FAN COWL LATCH IS PROPERLY ADJUSTED. GIVE PARTICULAR ATTENTION TO THE THRUST REVERSER NUMBER 1 (V-BLADE) LATCH.

- (2) Check that the closing force of each of the thrust reverser and translating sleeve latches is 45-55 lbf (200-245 N). Start with the forward (v-groove) latch and move aft. Give special attention to the forward (v-groove) latch. Use a push-pull gage. Adjust as necessary. Report if the forward (v-groove) latch required adjustment (Refer to the Report Form at the back of this service bulletin). Refer to Figure 4.

**NOTE:** The closing force of each latch must be measured at the tip of the latch handle and with all other latches engaged with their final closing force.
