SERVICE BULLETIN

NACELLE - STARTING - AIR SUPPLY DUCT- ALIGNMENT MARK - ALTERATION OF - CATEGORY CODE 4
- MOD.NAC-80-0006

(1) Airplane: Airbus A320

(2) Nacelle: V2500-A1Nacelles

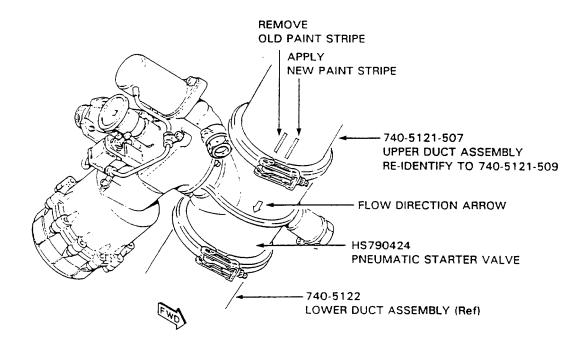
TO REPOSITION ALIGNMENT MARK ON UPPER DUCT (Starter system) Fig.1

The alignment marks on the upper starter duct and the starter are not in line with each other when the duct is properly installed.

A new pneumatic starter valve was introduced which has a repositioned electrical connector. To ensure clearance with the fan cowl door the starter valve has to be rotated slightly, thus offsetting the alignment mark with the upper starter duct.

A new alignment mark is painted on the upper starter duct to line up with the flow direction arrow/alignment mark on the pneumatic starter valve. The old alignment mark on the upper starter duct is then removed.

- A. Pre-requisite Instructions
 - (1) Open the right hand fan cowl door as specified in the A320 Aircraft Maintenance Manual, Task 71-13-00-010-010.
 - (2) Find the paint stripe/alignment mark on the 740-5121-507 upper duct assembly at the HS790424 pneumatic starter valve. (Refer to figure 1.)
- B. Rework or Modification Instructions
 - (1) Make a paint stripe on the 740-5121-507 upper starter air supply duct at 100.2 deg from the lower mounting lug of the duct (approximately 0.6 inch (15.2 mm) from the old paint stripe). (Refer to Figure 2.) Make sure the new stripe lines up with the stripe on the stater valve. (Refer to Figure 1.)
 - (2) Apply the new paint stripe as follows:
 - WARNING: METHYL ETHYL KETONE (MIBK) IS FLAMMABLE AND VAPOR IS HARMFUL.
