V2500-A5/D5 SERIES PROPULSION SYSTEM NON-MODIFICATION SERVICE BULLETIN

NON MODIFICATION SERVICE BULLETIN - AIR - REQUIREMENT TO FLUSH A VARIABLE STATOR VANE ACTUATOR (VSVA) 2607 UNIT FOLLOWING REPAIR OR RECONDITION AT AN APPROVED MAINTENANCE FACILITY

NON MODIFICATION SERVICE BULLETIN NUMBER VSVA 2607-75-005

PROCEDURE TO FLOW FLUSH A VSVA 2607 UNIT TO REMOVE ANY BUILT-IN CONTAMINATION AFTER REPAIR OR RECONDITION

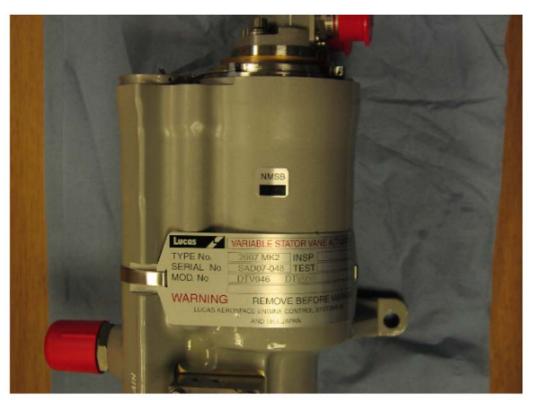
Identification Label Position Figure 1

- (b) Use a cloth that has no lint and Iso-propyl Alchohol to clean the surface where the identification label will be installed.
- (c) Install the identification label to the VSVA 2607 assembly body. Refer to Figure 1.
- (d) If an identification label has been installed before, it will be necessary to remove it. The installed identification label can be removed with the use of an applicable tool. If the surface of the VSVA is damaged during removal of the identification label, use process LP-5 to repair the damaged surface, ref. Goodrich Processes and Standard Practices Manual L-OP.

- (4) When this Non Modification Service Bulletin has been completed, put the Non Modification Service Bulletin number on an identification label. Use the procedure that follows:
 - (a) Use the applicable procedure to make sure that Non Modification Service Bulletin number is shown on the identification label as follows:
