ENGINE - POWER PLANT - INCORPORATION OF MODIFICATION REQUIREMENTS FOR THE E.E.C. AND
IGNITION SUPPLY HARNESS - CATEGORY CODE 4 - MOD.ENG-71-0107

V2500-ENG-71-0107

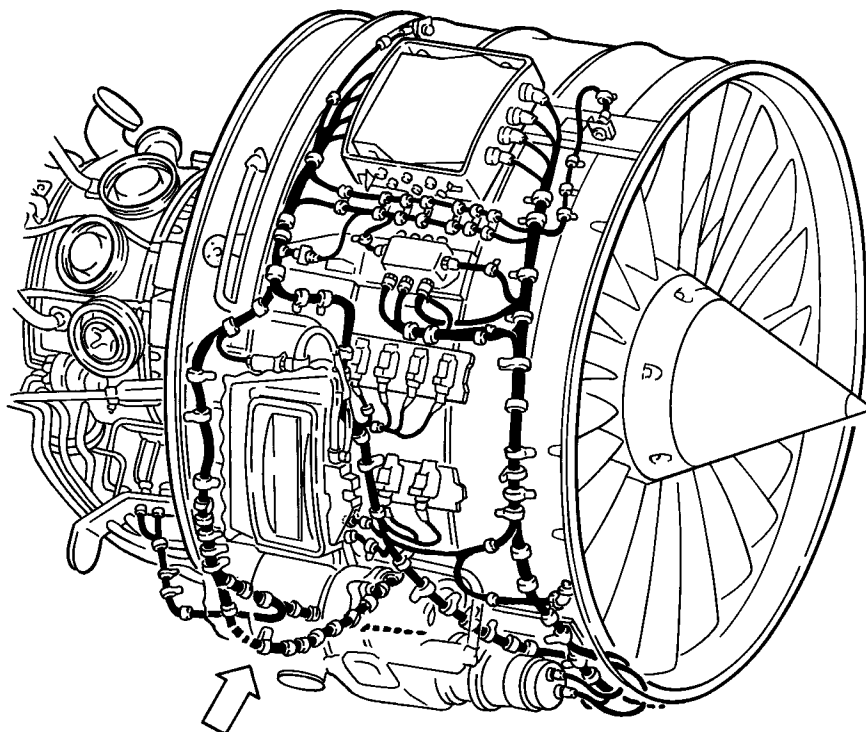
Location of E.E.C. harness and ignition supply harness
Fig.1 (Sheet 2 of 2)

- (a) Chafing of the E.E.C. and ignition supply harness may occur in the region of the bifurcation panel, between clipping points 0252 and 0544.
- (b) A foul may occur between the fan cowl No.4 latch and the fuel metering unit limb of the E.E.C. harness.
- (c) Engine vibration may cause a foul between the union nut on the P2/T2 tube and the limb from the E.E.C. harness to the relay box connector, 4100KS-A.
- (d) A foul may occur between clipping point 1082 and the limb from the E.E.C. harness to the fuel temperature sensor connector 4017KS-A.

- (7) Remove the 4W0104 bolt, 5W1086 washer, TA025074-17 or AS61915 clamp and the 4W0001 nut from the clipping point 0539.
- (8) Find the clipping points CP0544, CP1086, CP0248, CP0249, CP0250, CP0251, CP0252 and CP0254 (refer to Fig.1 (Sheet 1 of 2) and Fig.2).
