## SERVICE BULLETIN

POWER PLANT - BRACKETS AND RACEWAYS, HARNESS SUPPORT, FAN - INTRODUCTION OF MODIFIED  
SUPPORT BRACKET AND SPACER FOR HARNESS RACEWAY ADJACENT TO EEC - CATEGORY CODE 6 -  
MOD.ENG-71-0116

V2500-ENG-71-0116

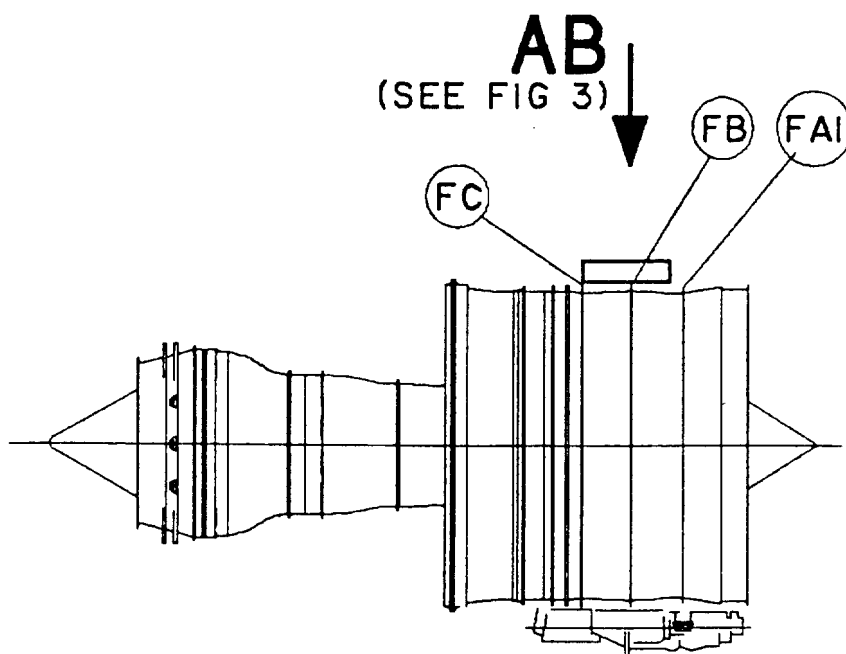
Diagrammatic view on RH side of engine  
Fig.1

Installation of the EEC harness Loom A can be difficult.

The problem is caused by the support tube and clip points CP2432 and CP2277 which do not align correctly.
