V2500-A5 SERIES PROPULSION SYSTEM SERVICE BULLETIN

V2500-ENG-71-0311
Transmittal - Page 1 of 1

ENGINE – INSTALLATION OF CABLE WRAP ON THE ENGINE SYSTEM DRAIN PIPES (FOR CONTROLLED
SERVICE USE)(BANGKOK AIRWAYS ONLY)

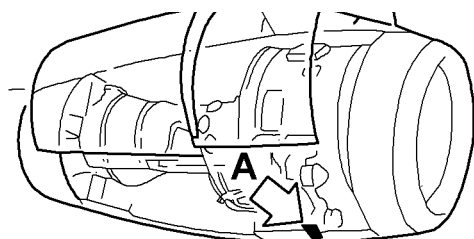
Installation of the Spirap to the Drain Tube
Figure 1

Airlines have experienced excessive wear of the Hydraulic Pump Drains Line in way of the #3 Latch on the Fan Cowl Door.

- (4) Use a clean lint free cloth (CoMat 02-099) made moist with solvent (CoMat 01-076 or CoMat 01-124) and remove dirt and grease from the surfaces of the drain pipes identified in Figure 1. Wipe the area dry before the solvent becomes dry.
- (5) Apply two layers of spirap, P/N 500024-1 around the pipe between the pipe union and the first clipping point.
- (6) Secure the spirap to the pipe with two tie wraps, P/N MS3367-1-9 fitted approximately 0.75in. (19,0 mm) from the Pipe Union and approximately 0.75in. (19,0 mm) from the first clipping point.
- (7) Close the Fan Cowl Doors as instructed in the A320/V2500-A1 A319/A320/A321/V2500-A5 Aircraft Maintenance Manual, Task 71-13-00-410-010.

Use a clean lint free cloth (CoMat 02-099) made moist with solvent (CoMat 01-076 or CoMat 01-124) and remove dirt and grease from the surfaces of the drain pipes identified in Figure 1. Wipe the area dry before the solvent becomes dry.
