ENGINE - INTERMEDIATE STRUCTURE - REWORK THE FAN FRAME ASSEMBLY TO INCLUDE FILLER COMPOUND IN THE REAR INNER FLANGE AREA - CATEGORY CODE 3 - MOD.ENG-72-0009

V2500-ENG-72-0009

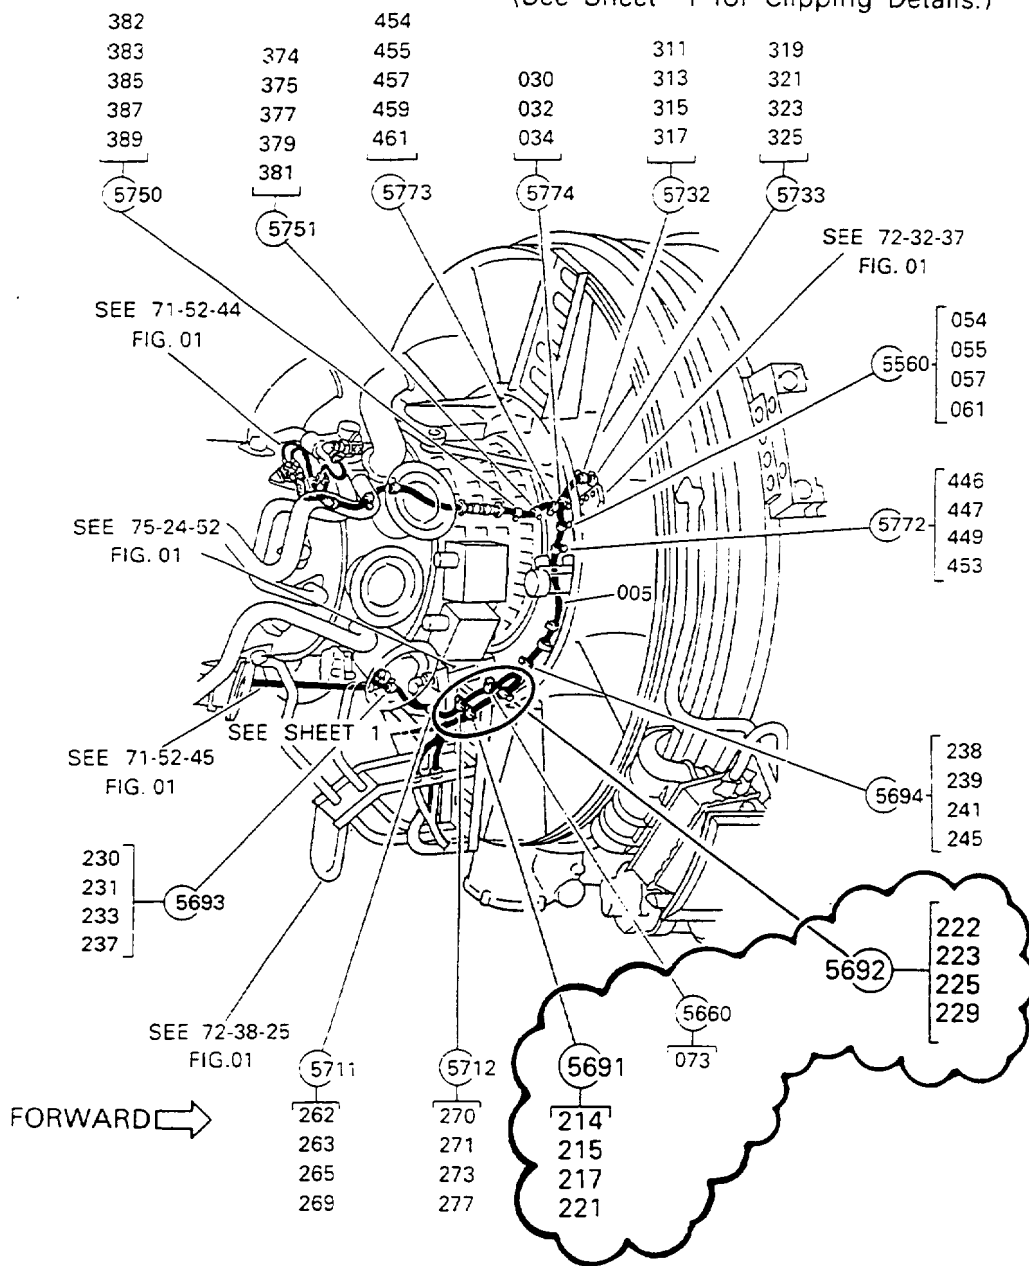
Location of the harness clipping parts to be removed and installed
Fig.2(Sheet 2 of 5)

CP5691 AND CP5692 ON RIGHT HAND SIDE.
(See Sheet 1 for Clipping Details.)

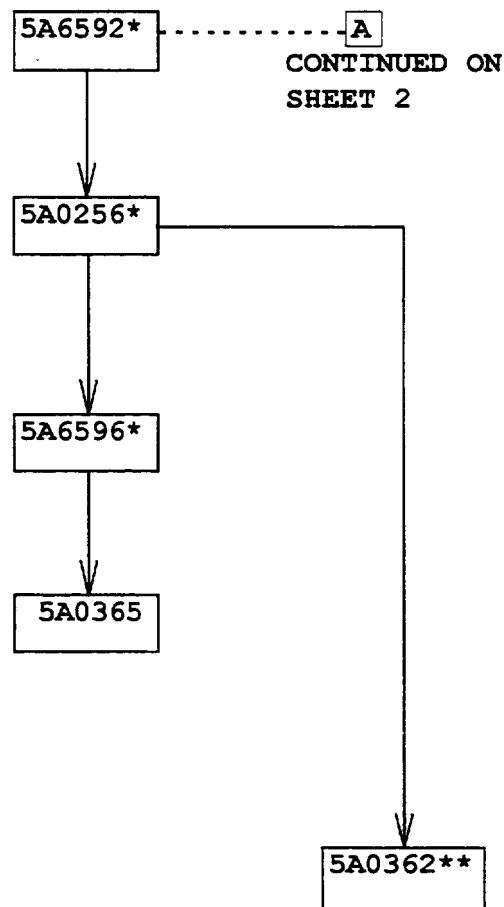
Family Tree - Fan Frame Assembly Ref. Catalog Sequence No. 72-32-03, Fig. 03, Item 100
Fig.5(Sheet 1 of 2)

* Shows that part number is no longer in service
** Shows that fan frame has been reworked

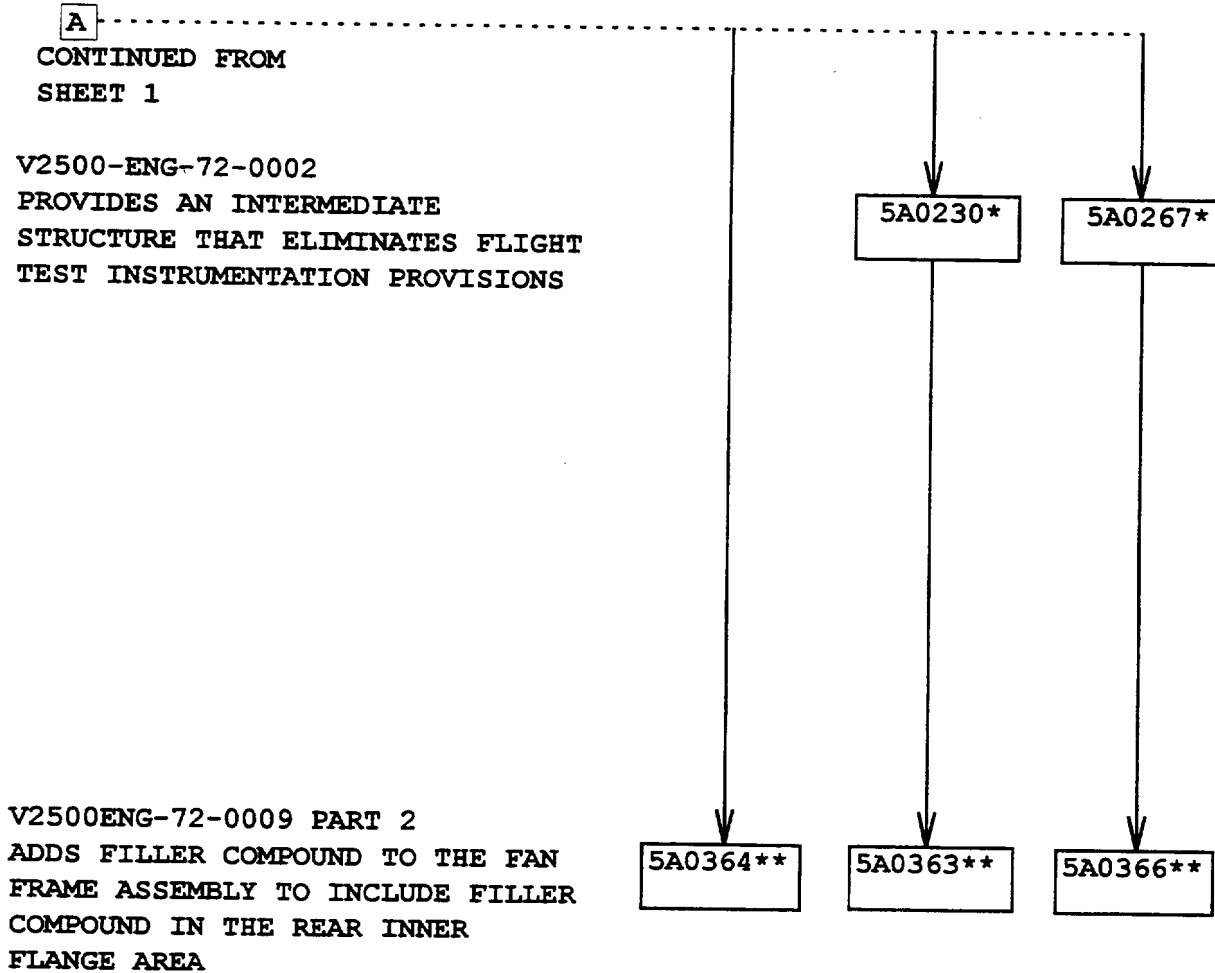
Family Tree - Fan Frame Assembly Ref. Catalog Sequence No. 72-32-03, Fig. 03, Item 100
Fig.5(Sheet 2 of 2)

- * Shows that part number is no longer in service
- ** Shows that fan frame has been reworked
