SERVICE BULLETIN

ENGINE - H.P. COMPRESSOR STAGE 7 AND 8 ROTOR PATHS WITH REDUCED SPRAYED THICKNESS ABRADABLE LININGS - CATEGORY CODE 6 - MOD.ENG-72-0030

(1) Aircraft: Airbus A320

(2) Engine: V2500 A1 Engines prior to Serial No.V0071, excluding V0061,

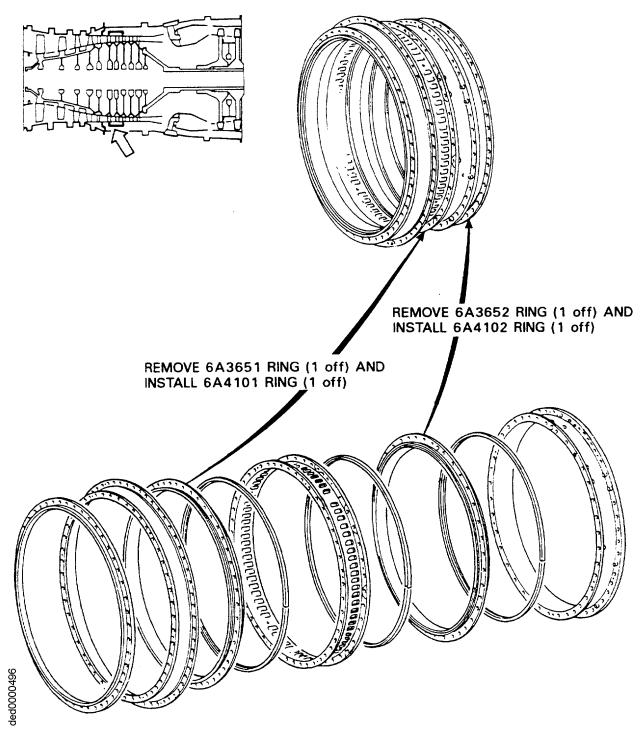
Location of H.P. compressor stages 7 and 8 rotor paths Fig.1 $\,$

Boroscope examination of the rotor paths and subsequent strip of engine V0021 showed that the abradable lining on the stage 8 rotor path has become detached from the parent ring over an arc of 270 degrees.

Laboratory investigation concluded that excessive sprayed thickness of lining material was the cause of this separation, and recommended a reduction in the sprayed thickness. Although there has been no evidence of lining separation occurring in the stage 7 rotor path, this modification is applied to the stage 7 as it has the same sprayed lining material as the stage 8 rotor path.

- (1) New rotor paths are introduced at stage 7 and 8 of the HP compressor.
- (2) The changes introduced by this Service Bulletin are as follows:
 - (a) Stage 7 has a total lining thickness, as sprayed and including the bonding coat of 0.048 to 0.058in. (1,21 to 1,47 mm).
 - (b) Stage 8 has a total lining thickness, as sprayed and including the bonding coat of 0.055 to 0.065in. (1,39 to 1,65 mm).
- (3) Existing HP compressor cases can be reworked, see Figure 1 to 4.

- (1) New 6A4101 and 6A4102 HP compressor with reworked stage 7 and 8 rotor paths are interchangeable with in use HP compressor cases.
- (2) Assemble new 6A4101 and 6A4102 HP compressor case with reworked stage 7 and 8 rotor path linings in accordance with approved procedures. Engine Manual, 72-41-00 and 72-41-20, Assembly.
