ENGINE - DIFFUSER AND COMBUSTOR GROUP - SHOTPEEN THE NO.4 BEARING SUPPORT - CATEGORY  
CODE 5 - MOD.ENG-72-0040

V2500-ENG-72-0040

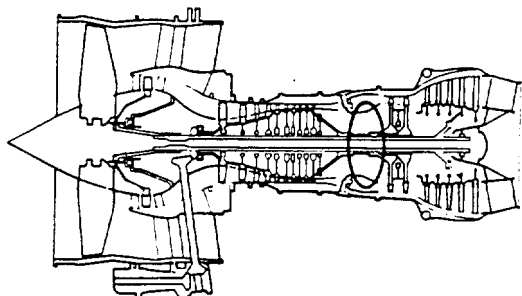
A cracked No.4 Bearing Support was found on an experimental engine and a test rig.

Analysis showed that a crack can occur because supports were not peened and there were stress concentrations.

REMOVE THE PN 2A0846 No.4 BEARING  
SUPPORT ASSEMBLY (1 Off) DO A  
MODIFICATION, IDENTIFY, AND INSTALL  
AS PN 2A2038 No.4 BEARING SUPPORT  
ASSEMBLY (1 Off)
