## SERVICE BULLETIN

ENGINE – HP TURBINE ROTOR AND STATOR ASSEMBLY – PROVIDE A NEW FIRST STAGE HPT BLADE AND FIRST STAGE HPT COOLING DUCT ASSEMBLY – CATEGORY CODE 6 – MOD.ENG-72-0046

# V2500-ENG-72-0046

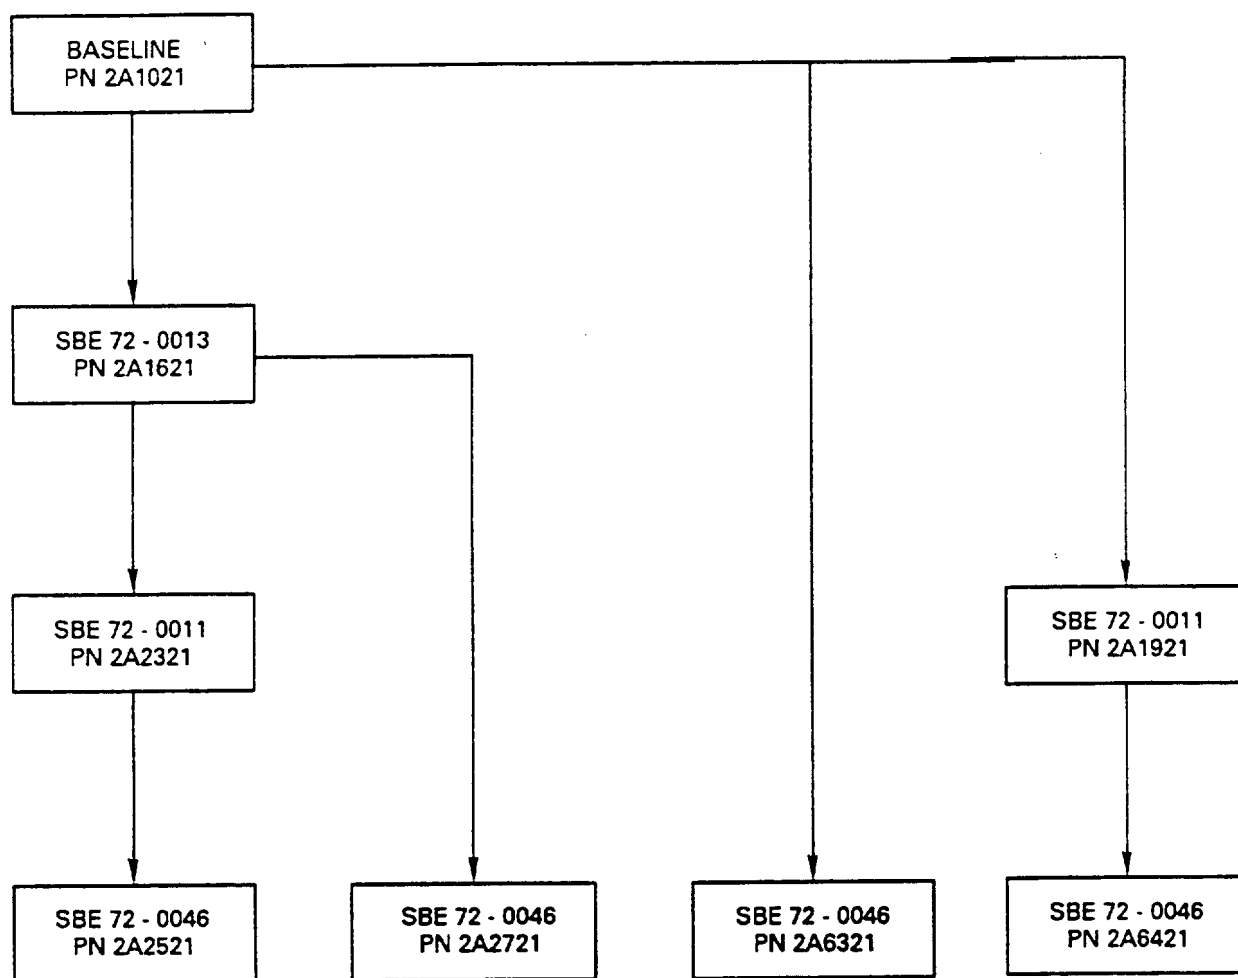
Location of stage 1 HPT blades  
Fig.3

REPLACE PN 2A1721 STAGE 1  
HPT BLADES (64 Off) WITH  
PN 2A2421 STAGE 1 HPT  
BLADES (64 Off)

- (2) Send the 2A1721 Stage 1 HPT Blades (see Reference (2), 72-45-14, Figure/Item No.01-010) to the approved vendor given in the Material Information Section for a modification and identification to 2A2421 Stage 1 HPT Blades. See Figure 3.

- (1) Replace the 2A1721 Stage 1 HPT Blades (64 off) with 2A2421 Stage 1 HPT Blades, by the approved procedure in Reference (3), Chapter/Section 72-45-10, Assembly. See Figure 3.
- (2) Identify the new Stage 1 Turbine Rotor Assemblies as follows:
- (a) Identify the 2A2321 Stage 1 Turbine Rotor Assembly as 2A2521.
- (i) Use the approved procedure given in Reference (4), Control No./TASK No.70-09-00-400-501, Marking of Parts.
- (ii) Use the vibration peen method.
- (b) Identify the 2A1621 Stage 1 Turbine Rotor Assembly as 2A2721.
