## SERVICE BULLETIN

ENGINE - DIFFUSER AND COMBUSTION GROUP - REPLACE A NO.4 BEARING COMPARTMENT TUBE  
BRACKET (CP 5756) - CATEGORY CODE 4 - MOD.ENG-72-0072

V2500-ENG-72-0072

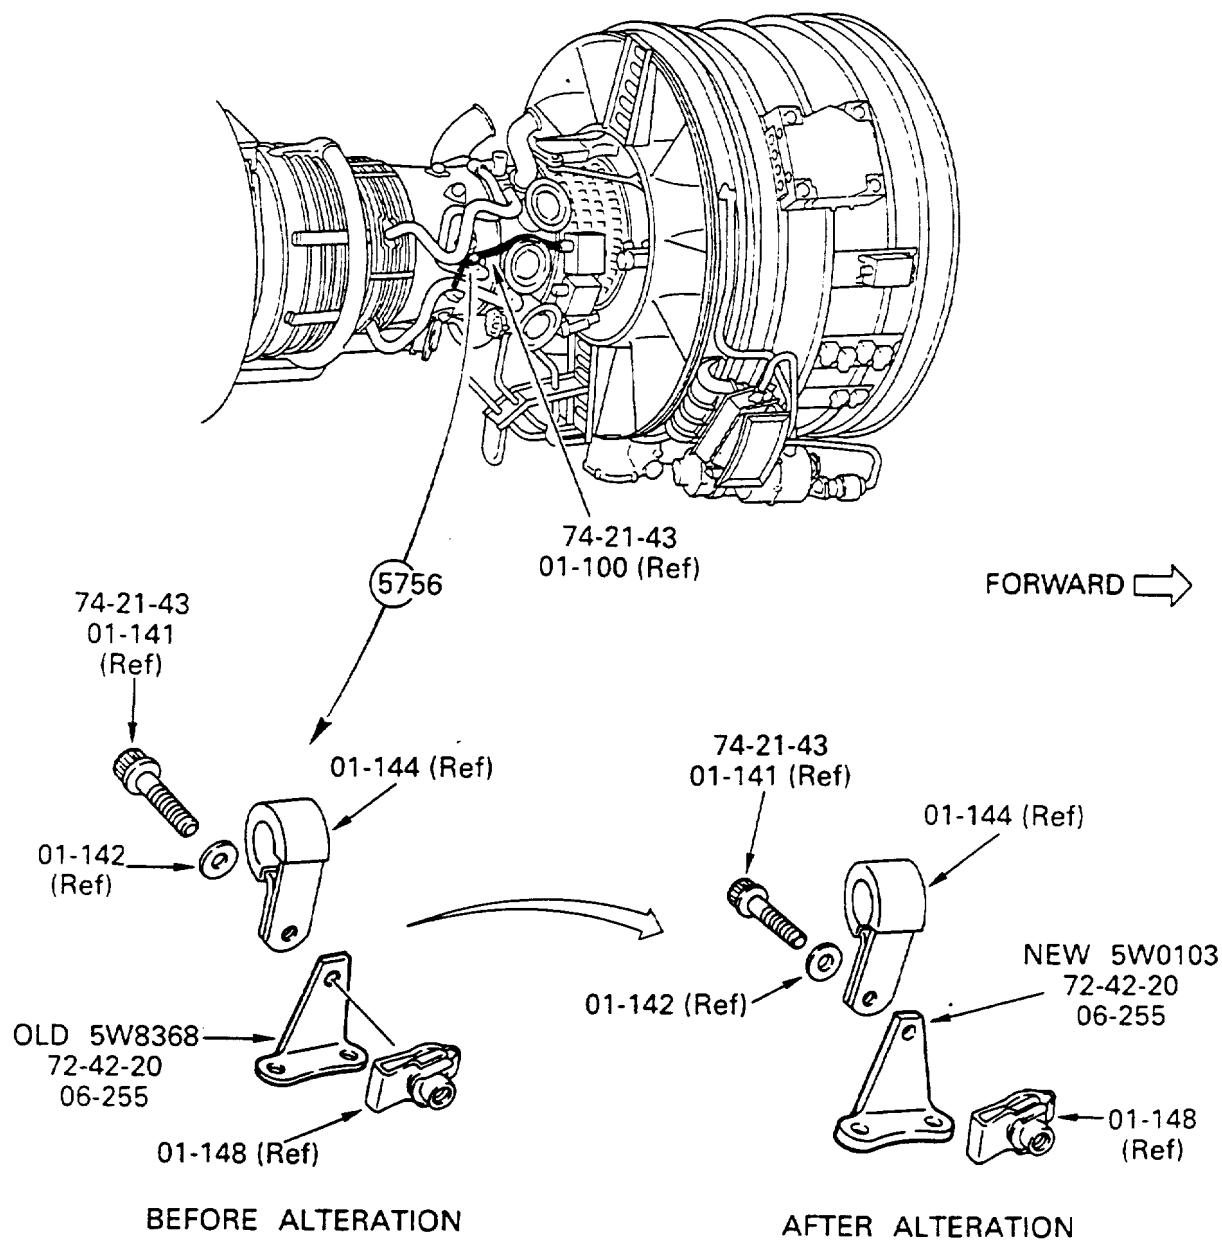
CLIPPING POINT 5756  
Fig.1 Sheet 2 of 2

Insufficient clearance may exist between the bolt at the clipping point 5756 and PS3 cooling air tube.

To obtain the sufficient clearance between the bolt-end and the tube to prevent possible interference.

(a) The bending angle of the bracket is slightly changed.

(b) The thickness of the new bracket is increased from 0.047in. (1,2 mm.) to 0.063in. (1,6 mm.)

- (1) Remove 5W8368, Bracket (72-42-20, 06-255), refer to Figures 1 and 2.

- (1) Install 5W0103 Bracket (72-42-20, 06-255), refer to Figures 1 and 2.
