ENGINE - DIFFUSER AND COMBUSTOR GROUP - PROVIDE A NEW NO.4 BEARING SUPPORT ASSEMBLY
WITH INCREASED DURABILITY - CATEGORY CODE 5 - MOD.ENG-72-0112

V2500-ENG-72-0112

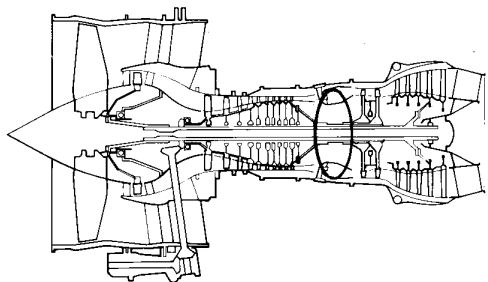
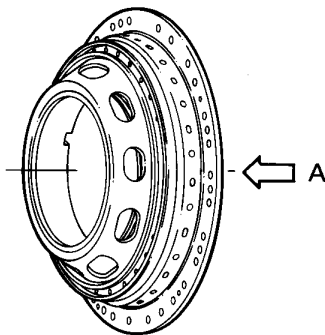
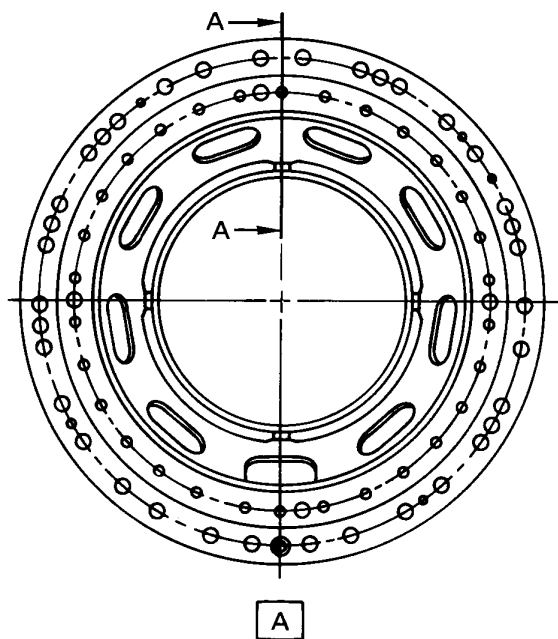
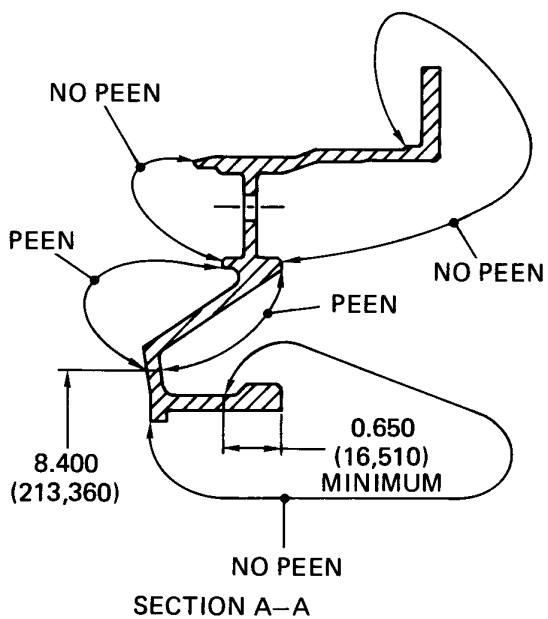
Modification of No.4 bearing support assembly
Fig.5

(b) The No.4 Bearing support has eight slots based on nine equally spaced slots and one rectangular oil drain slot at the six o'clock position. A higher than anticipated stress concentration has been found in the corners of the rectangular slot.

(b) A analytical review has determined that the rectangular oil drain slot corners have an increase in stress concentration. This could reduce the durability of the No.4 Bearing support.

- (a) Do the applicable modification to the 2A0846 No.4 Bearing Support Assembly for any Engine with 2800 cycles or less and identify the assembly as 2A2461.
- (b) Replace the 2A0846 No.4 Bearing Support Assembly with a new 2A2064 No.4 Bearing Support Assembly, on all Engines that have more than 2800 cycles.

(c) Mark the New part Number adjacent to the Old Part Number. Use the vibration peen method.	OLD PART NO.	NEW PART NO.
	2A0846	2A2461
	Refer to Figure 2 and Figure 3, Sheet 2 requirements Refer to Reference (3) Control No./Task No. 70-09-00-400-501.	
Replace the 2A0846 No.4 Bearing Support Assemblies (Reference (1) Fig/Item No. 01-010) with more than 2800 engine cycles. Use a 2A2064 No.4 Bearing Support Assembly. Refer to Figure 2.
