ENGINE - HP COMPRESSOR - DELETION OF THE HEAT SHIELD AT THE OUTLET GUIDE VANE INNER
CASE LOCATION - CATEGORY CODE 6 - MOD.ENG-72-0143

V2500-ENG-72-0143

SERVICE BULLETIN

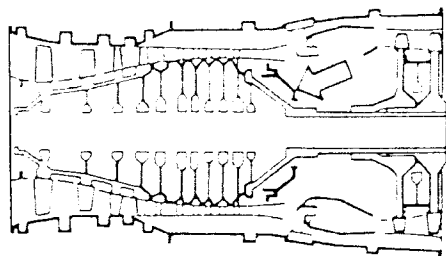
MODULE 40

- (a) The heat shield at the outlet guide vane case inner location is deleted.
- (b) The 30 bihex head bolts securing the shield to the diffuser case are replaced with lower profile plain hex. head bolts whose projection is less than half that of the existing bolts.
