ENGINE - HP COMPRESSOR - INTRODUCE A NEW STAGE 3 HPC ROTOR BLADE WITH A CUT BACK CLAPPER - CATEGORY CODE 6 - MOD.ENG-72-0201

V2500-ENG-72-0201

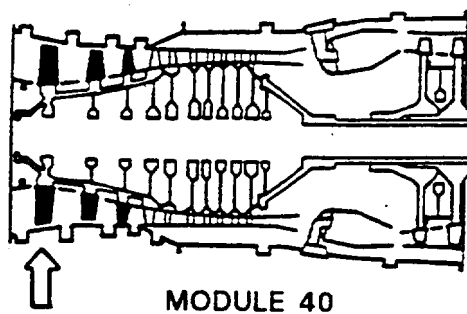
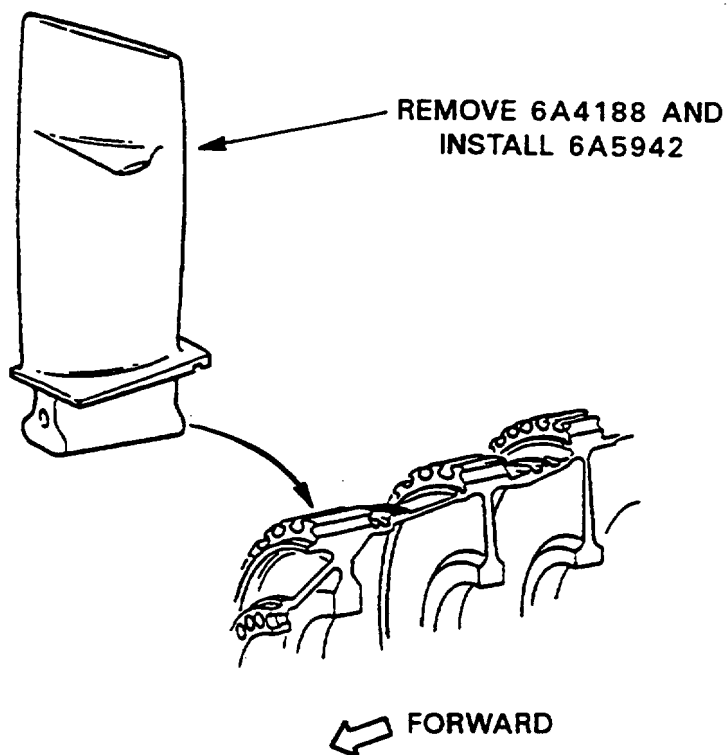
Fig.1

HP compressor stage 3 rotor blades have experienced clapper cracking.

Isolated instances of stage 3 rotor blade clapper load face cracking have been found on development engines.

Testing has confirmed that increasing the radius on the clapper leading edge corner is an effective solution to reduce stresses and improve fatigue capability.

Existing blades can be reworked by machining.
