ENGINE - DIFFUSER AND COMBUSTOR GROUP - PROVIDE A NEW BRACKET ASSEMBLY WHICH HAS
ADDITIONAL SUPPORT FOR THE FIRE DETECTION RAIL - CATEGORY CODE 3 - MOD.ENG-72-0206

V2500-ENG-72-0206

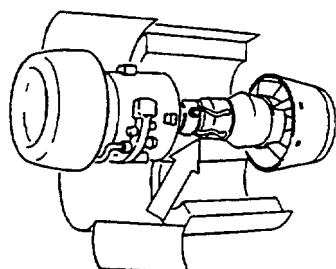
Location of the Loop Clamp Bracket Assembly
Fig.2

The original bracket did not give sufficient support to the fire detection rail.

- (1) The Loop Clamp Bracket that supports the No. 4 bearing tube and the the fire detection rail is replaced with a Loop Clamp Bracket Assembly. This Loop Clamp Bracket Assembly has a reinforcing rail and provides added support for the fire detection rail.

To provide a stronger Loop Clamp Bracket Assembly that includes a reinforcing rib. This stronger Loop Clamp Bracket Assembly will give added support to the fire detection rail.
