V2500-A1/A5/D5 SERIES PROPULSION SYSTEMS SERVICE BULLETIN

This document transmits Revision 3 to Service Bulletin EV2500-72-0227

V2500-ENG-72-0227

ENGINE - LP TURBINE - PROVIDE A NEW BLIND CAP WITH DECREASED SEAL LAND HEIGHT

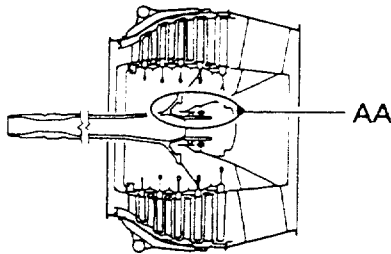
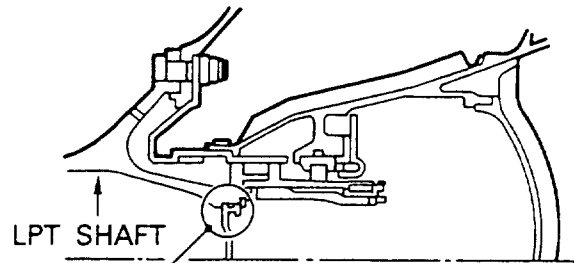
MODULE 50

VIEW ON AA

5A1515(*) OR 5A1697(*)
5A1516(**)
SEALING RING

- (2) Examine the Sealing Ring for damage, deformation and twist by the approved procedures in 1.K.(2), Chapter/Section 72-00-50, Installation-02.
- (3) Install the Blind Cap to the LP Turbine Shaft by the approved procedures in 1.K.(2), Chapter/Section 72-00-50, Installation-02.
- (4) Install the Retaining Ring by the approved procedures in 1.K.(2), Chapter/Section 72-00-50, Installation-02.
