SERVICE BULLETIN

ENGINE - LP COMPRESSOR - MOVE THE MARK OF THE LASH VALUE ON THE PTO PINION BEVEL
GEARSHAFT - CATEGORY CODE 6 - MOD.ENG-72-0270

V2500-ENG-72-0270

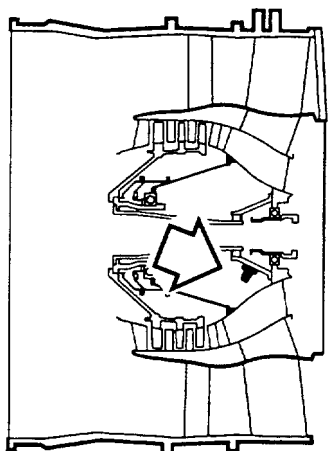
5A6232 (72-32-16,01-750)
PTO PINION BEVEL GEARSHAFT

The mark of the lash value at the existing position on the PTO Pinion Bevel Gearshaft is not readable in the assembled condition.

This Service Bulletin instructs to move the mark of the lash value on to a new readable position on the PTO Pinion Bevel Gearshaft.
