DATE ~~R~~ Oct.21/02**V2500-A1/A5/D5 PROPULSION SYSTEMS SERVICE BULLETIN**

This document transmits Revision 1 to Service Bulletin EV2500-72-0282

ENGINE – PROVIDE NEW FRONT AND REAR NO. 4 BEARING FACE SEALS1. Planning InformationA. Effectivity

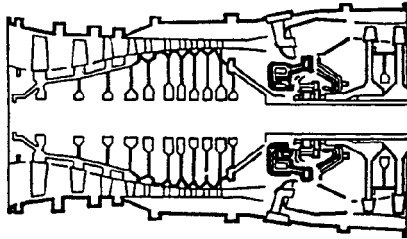
No. 4 bearing front seal assembly
Fig 1

(1) Problem: Multiple No. 4 refurbished carbon seals fractured during engine green run at overhaul. The root cause was suspected to come from the repair process. As a consequence of this, the repair process was removed and no refurbished carbon seal could be used.

REPLACE NO. 4 BEARING
FRONT CARBON SEAL
2A2918 WITH 2A3517

- (1) Disassemble the No. 4 Front Seal Assembly by the approved procedures in reference (5) or (6), Chapter/Section task 72-42-33-040-001.
 - (a) Replace the Carbon Seal Assembly PN, 2A2918 with PN, 2A3517.
