## V2500 A5/D5 SERIES PROPULSION SYSTEMS SERVICE BULLETIN

This document transmits Revision 7 to Service Bulletin EV2500-72-0302

# V2500-ENG-72-0302

ENGINE – HP TURBINE ROTOR AND STATOR ASSEMBLY – INTRODUCE FIRST AND SECOND STAGE  
TURBINE BLADES WHICH HAVE PROTECTIVE COATING IN THE DAMPER POCKET AREA UNDER THE  
PLATFORM

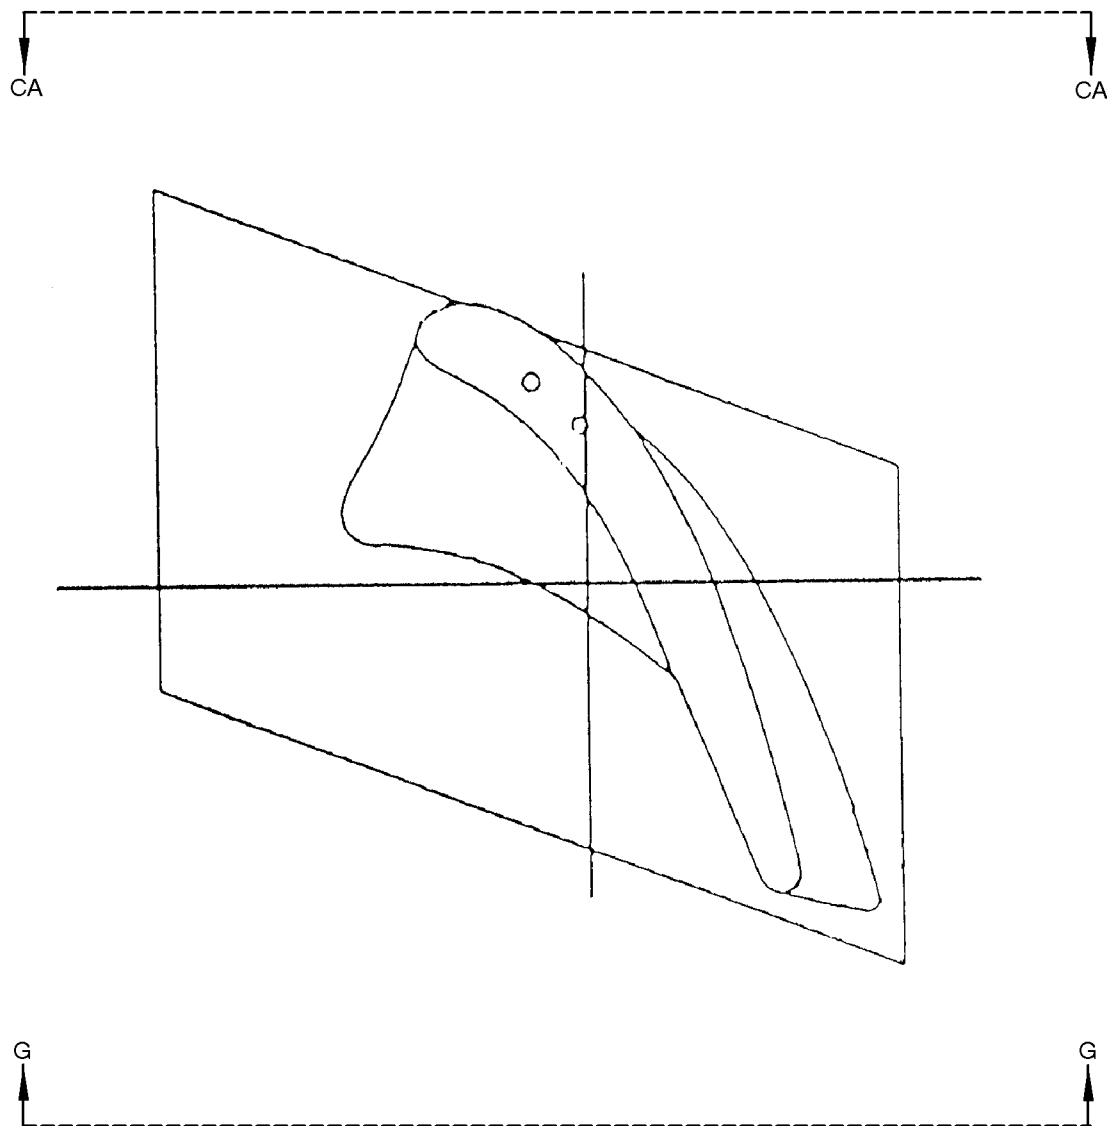
Modification of the Stage 1 High Pressure Turbine Blade Assembly  
Figure 2 (Sheet 3)

VIEW OF STAGE 1 HIGH PRESSURE  
TURBINE BLADE WHEN YOU LOOK  
FROM THE TOP

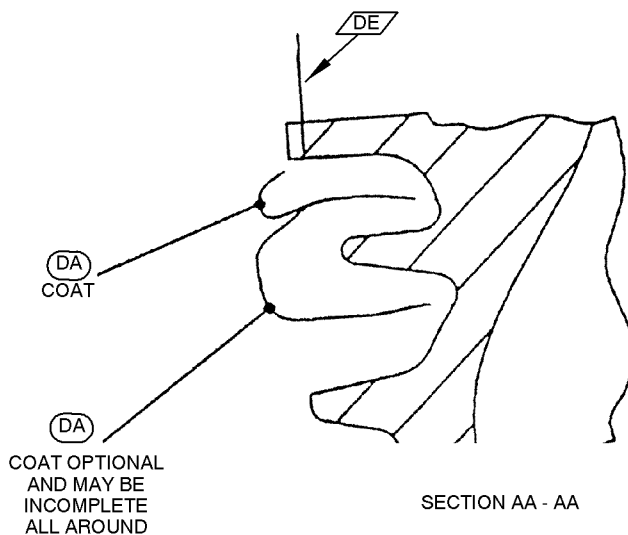
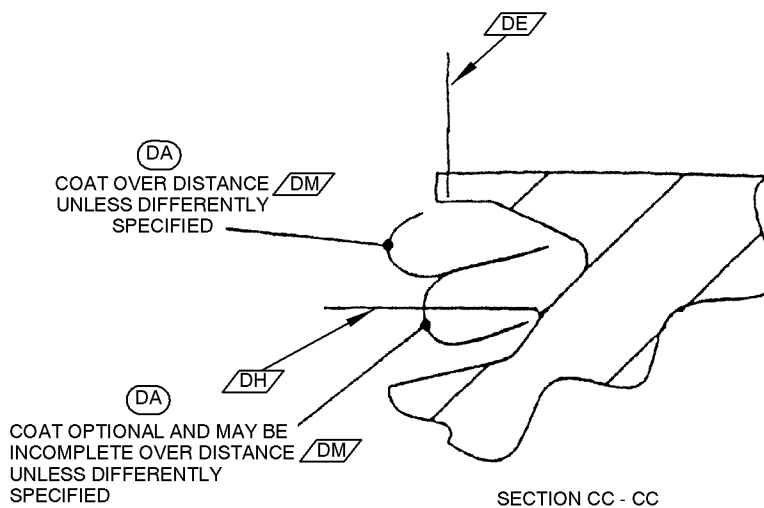
Modification of the Stage 1 High Pressure Turbine Blade Assembly  
Figure 2 (Sheet 5)

(DA) COAT IN THE APPLICABLE AREA BY THE PROCEDURE SPECIFIED IN THE TEXT

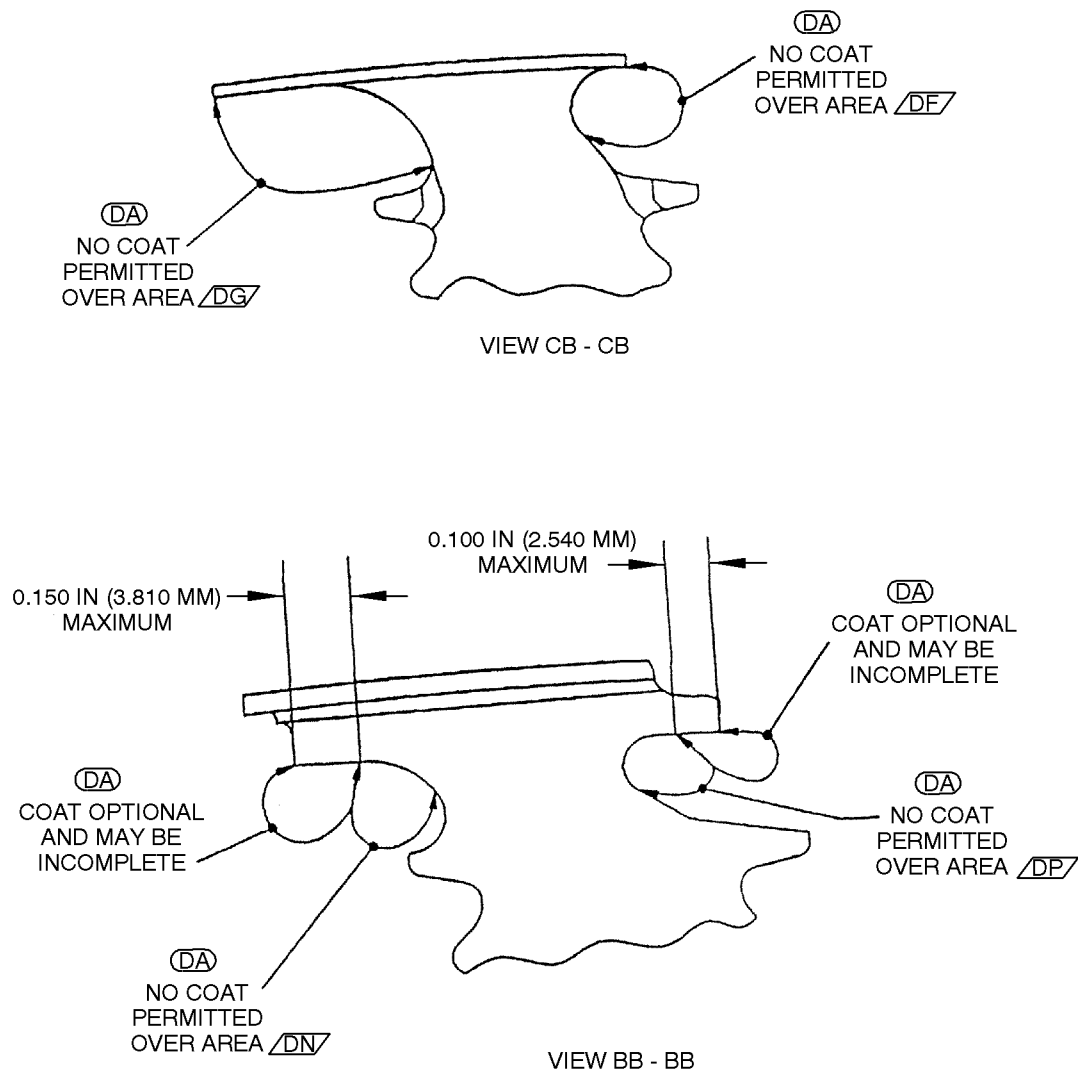
**Modification of the Stage 1 High Pressure Turbine Blade Assembly**  
**Figure 2 (Sheet 7)**

(DA) COAT IN THE APPLICABLE AREA BY THE PROCEDURE SPECIFIED IN THE TEXT

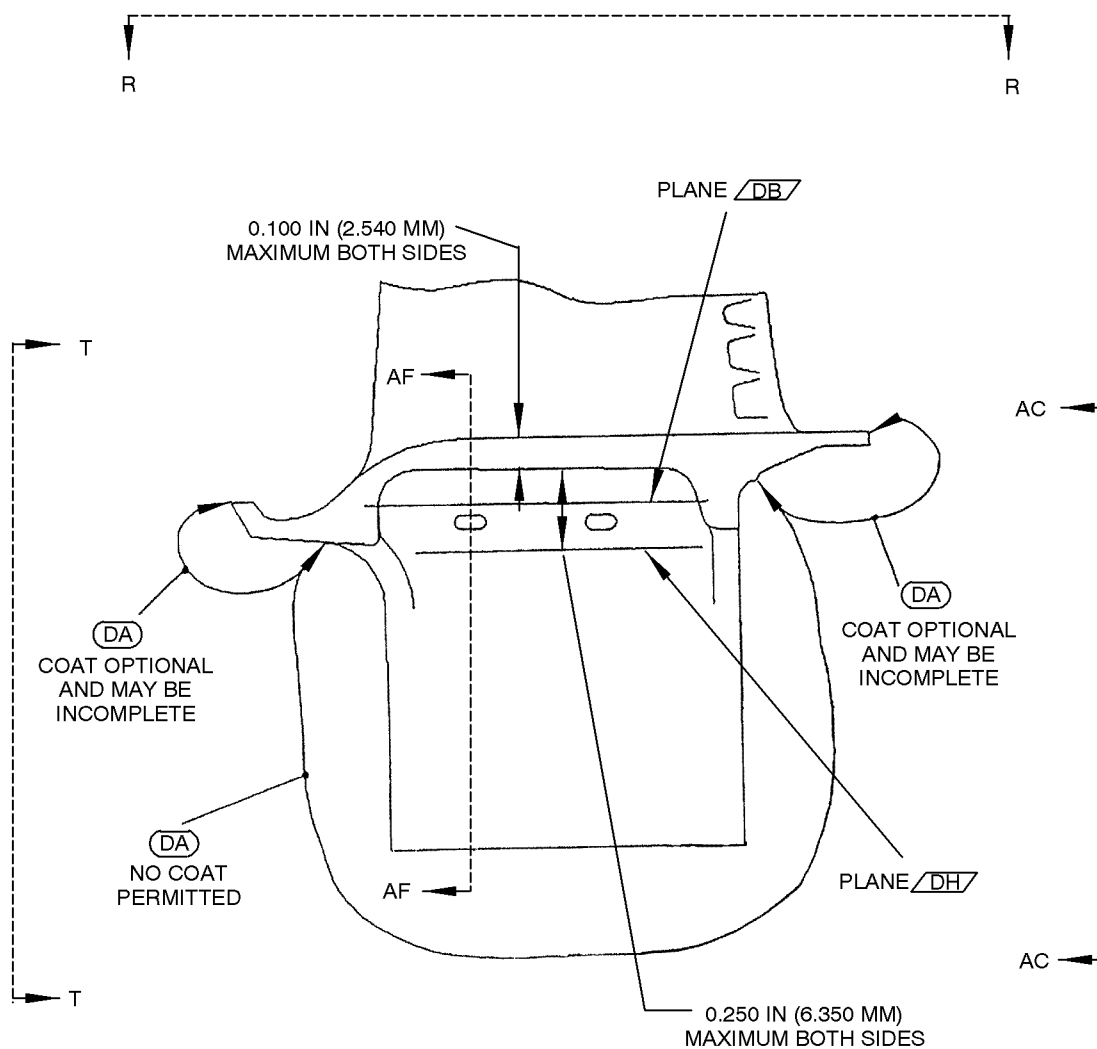
Modification of the Stage 2 High Pressure Turbine Blade Assembly  
Figure 4 (Sheet 1)

(DA) COAT IN THE APPLICABLE AREA BY THE PROCEDURE SPECIFIED IN THE TEXT

Refer to Reference (9) Chapter/Section 70-38-26, Surface Treating. See Figure 4.

Refer to Reference (9) Chapter/Section 70-37-03, Heat Treating. See Figure 4.

Refer to Reference (9) Chapter/Section 70-37-03 Heat Treating. See Figure 4.

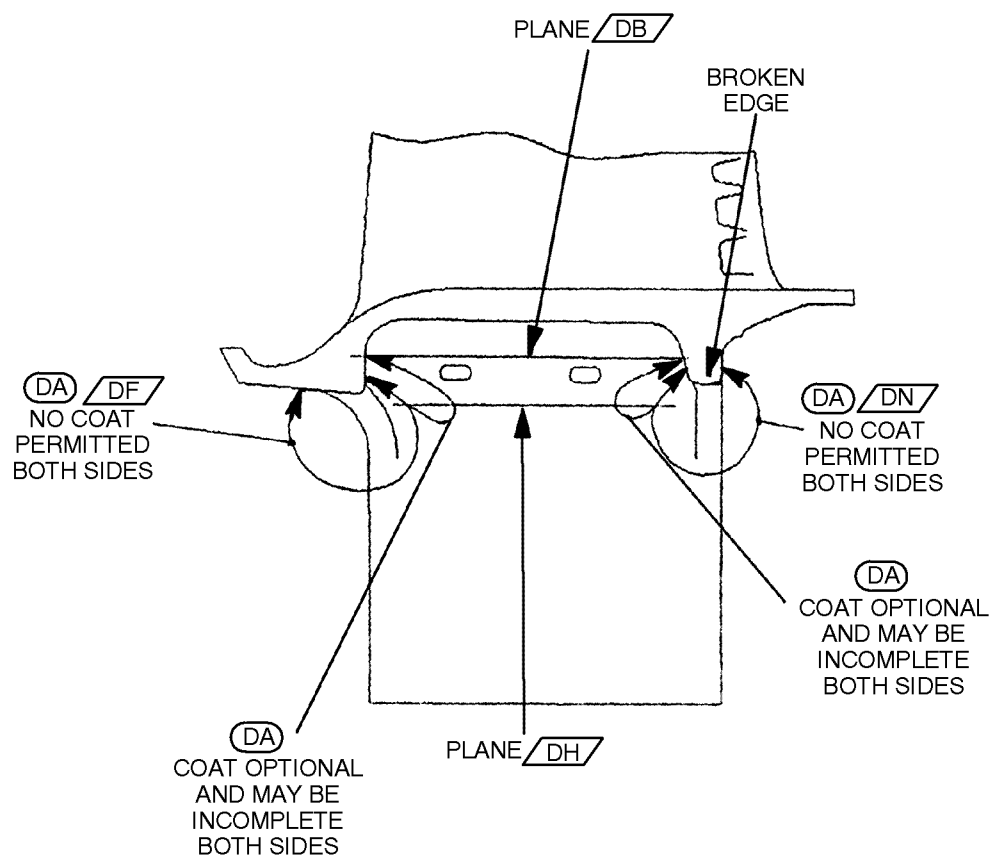
Modification of the Stage 2 High Pressure Turbine Blade Assembly  
Figure 4 (Sheet 2)

VIEW OF STAGE 2 HIGH PRESSURE  
TURBINE BLADE ROOT

(DA) COAT IN THE APPLICABLE AREA BY THE PROCEDURE SPECIFIED IN THE TEXT

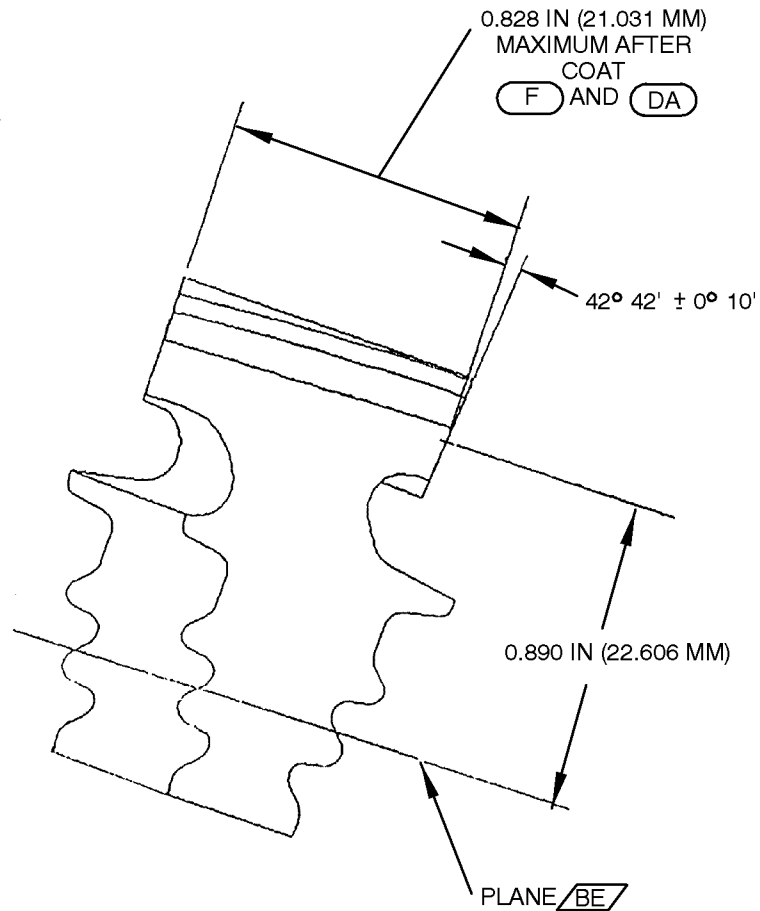
Modification of the Stage 2 High Pressure Turbine Blade Assembly  
Figure 4 (Sheet 4)

VIEW P - P

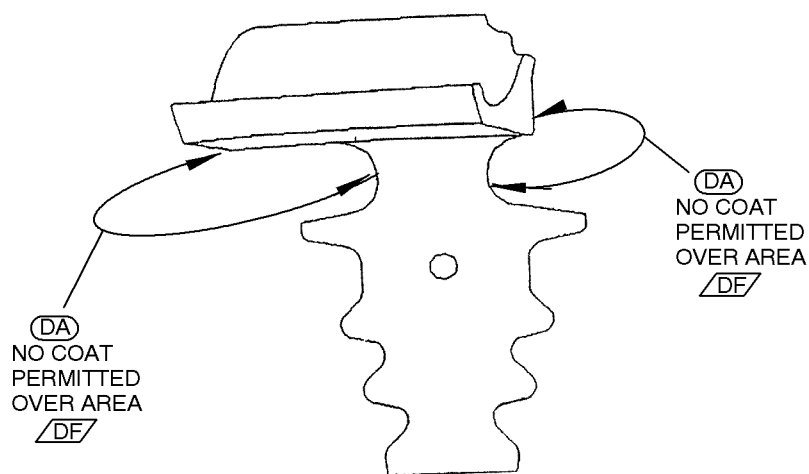
Modification of the Stage 2 High Pressure Turbine Blade Assembly  
Figure 4 (Sheet 5)

VIEW T - T

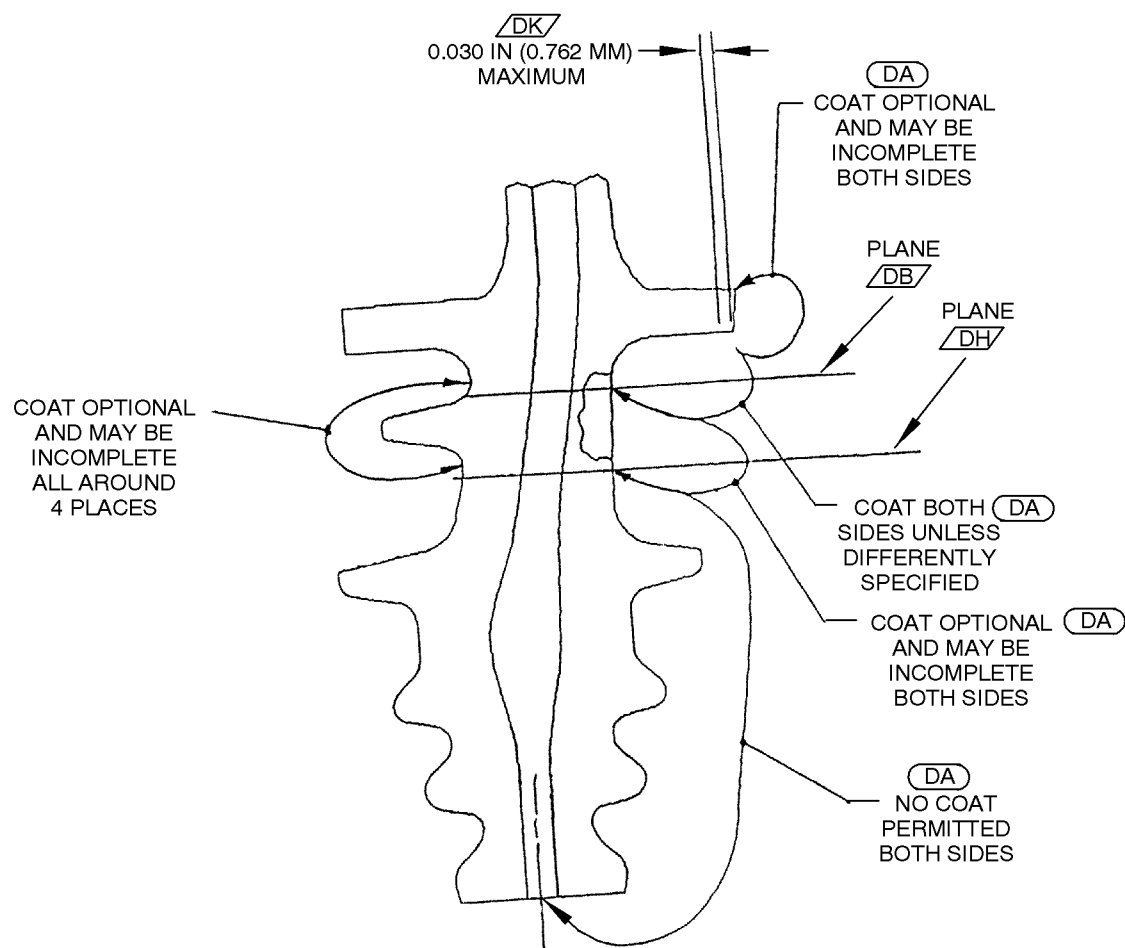
Modification of the Stage 2 High Pressure Turbine Blade Assembly  
Figure 4 (Sheet 6)

SECTION AF - AF
