Subject: Transmittal of Revision 1 To Service Bulletin Number
V25000-ENG-72-0321

ENGINE - HP TURBINE ROTOR AND STATOR ASSEMBLY - INTRODUCE NEW FIRST AND SECOND
STAGE TURBINE BLADES WITH UNDER PLATFORM COATING

MODEL APPLICATION

V2500-ENG-72-0321

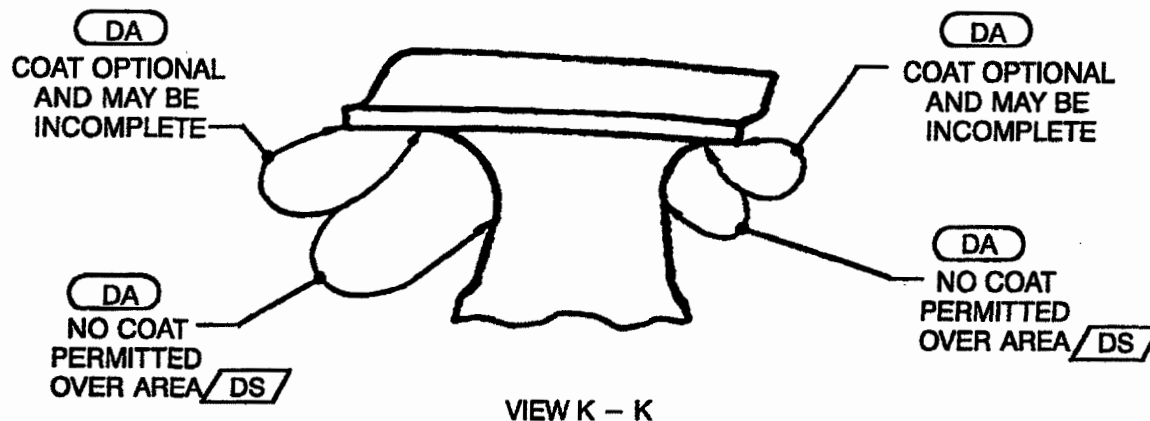
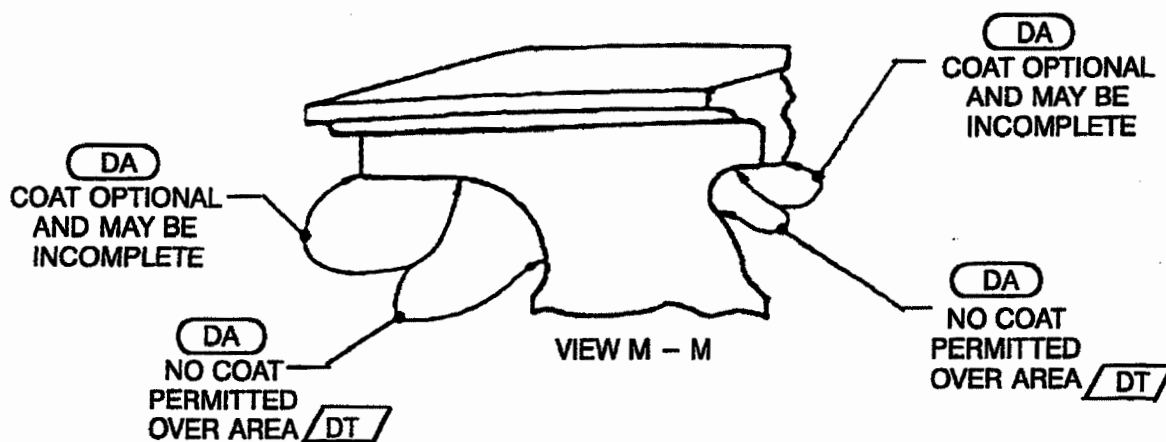
E8139

COAT OVER DISTANCE
UNLESS DIFFERENTLY
SPECIFIED

(DA) COAT IN THE APPLICABLE AREA BY THE PROCEDURE SPECIFIED IN THE TEXT

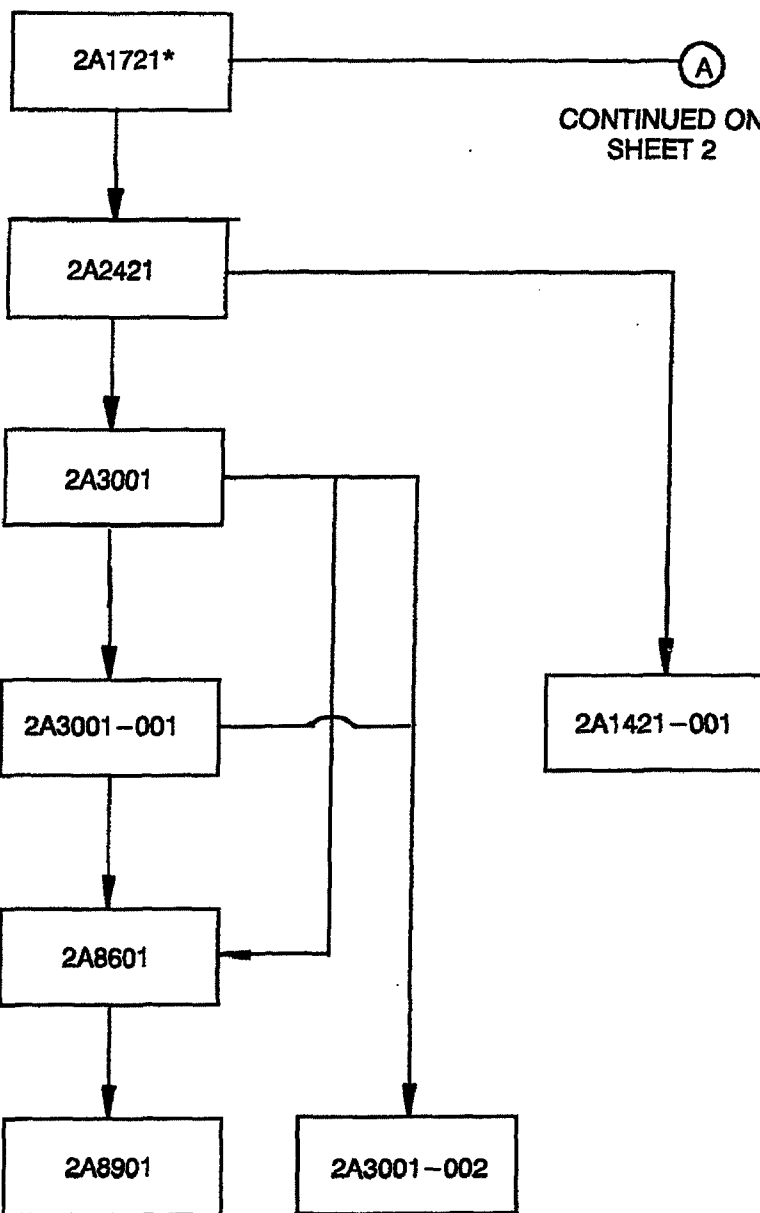
Family Tree - Stage 1 High Pressure Turbine Blades
Ref. Catalog Sequence No 72-45-14. Fig. 01 Item 010
Figure 5 (Sheet 1)

*2A1221 DOES NOT HAVE PLATFORM
COOLING HOLES BUT 2A1721 DOES

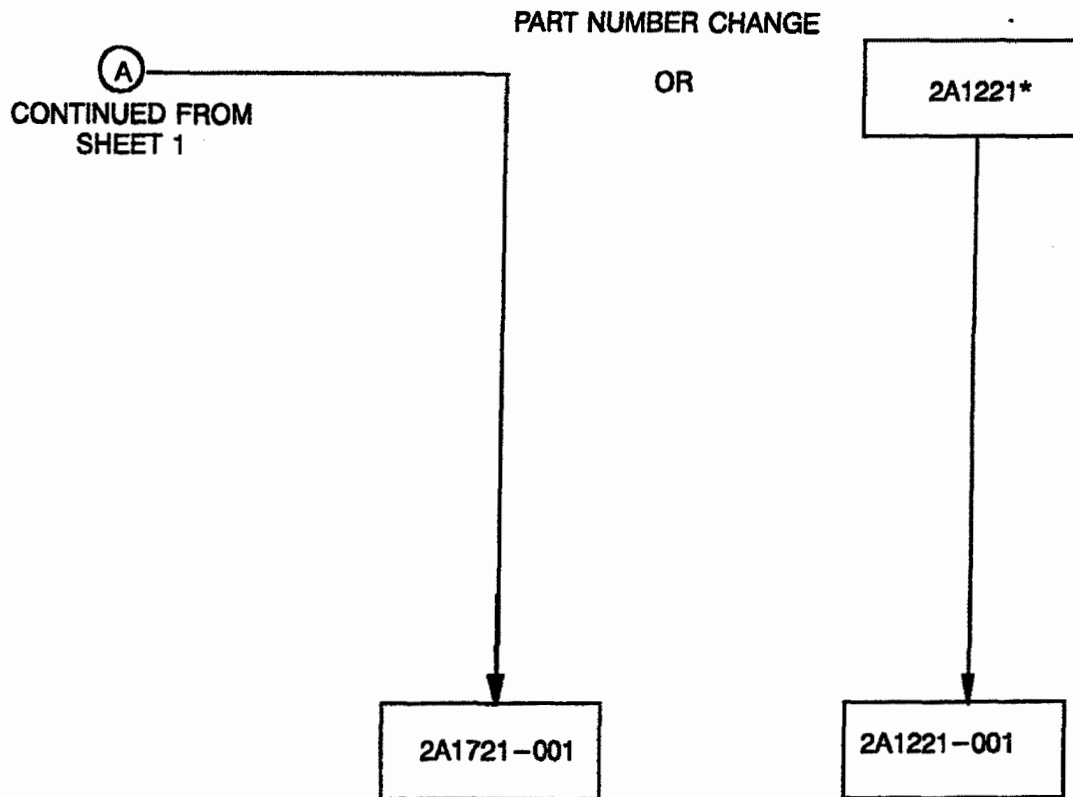
Family Tree - Stage 1 High Pressure Turbine Blades
Ref. Catalog Sequence No 72-45-14. Fig. 01 Item 010
Figure 5 (Sheet 2)

*2A1221 DOES NOT HAVE PLATFORM
COOLING HOLES BUT 2A1721 DOES
