V2500-A5/D5 PROPULSION SYSTEMS SERVICE BULLETIN

ENGINE – HIGH PRESSURE TURBINE ROTOR AND STATOR ASSEMBLY – INTRODUCE A NEW STAGE 2
HIGH PRESSURE TURBINE BLADE RETAINING PLATE

V2500-ENG-72-0328

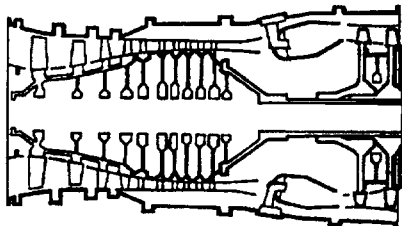
MODULE 40

(1) Condition: High operational stresses in the HP Turbine Stage 2 Blade Retaining Plate limit the potential life of the part.

INSTALL THE 2A3437 STAGE 2
HIGH PRESSURE TURBINE BLADE
RETAINING PLATE (1 OFF)
