V2500-A5/D5 PROPULSION SYSTEMS SERVICE BULLETIN

This document transmits Revision 4 to Service Bulletin EV2500-72-0357 and the Initial Issue of the Supplement

V2500-ENG-72-0357

ENGINE – HP TURBINE ROTOR ASSEMBLY – INTRODUCE NEW FIRST STAGE TURBINE BLADES WITH
PROTECTIVE COATING ON THE INTERNAL CAVITIES

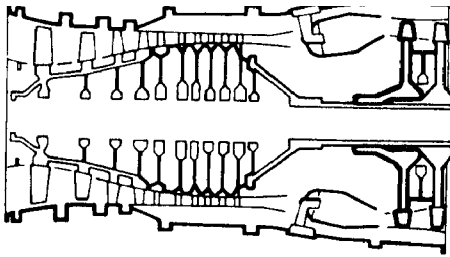
Location of the Stage 1 HPT Blade
Figure 1

REPLACE THE STAGE 1 HPT BLADE
WITH THE APPLICABLE NEW
STAGE 1 HPT BLADE

* DO NOT USE IN V2533-A5 ENGINE

- (5) Assembly Procedure
- (a) For V2522-A5, V2524-A5, V2527-A5, V2527E-A5, V2527M-A5, V2530-A5, and V2533-A5 Engines. Replace the Stage 1 HPT Blades (64 off) by the approved procedure given in Reference (4), Chapter/Section 72-45-10, Assembly-01 and Figure 1.

- (b) For V2525-D5 and V2528-D5 Engines. Replace the Stage 1 HPT Blades (64 off) by the approved procedure given in Reference (5), Chapter/Section 72-45-10, Assembly-01 and Figure 1.

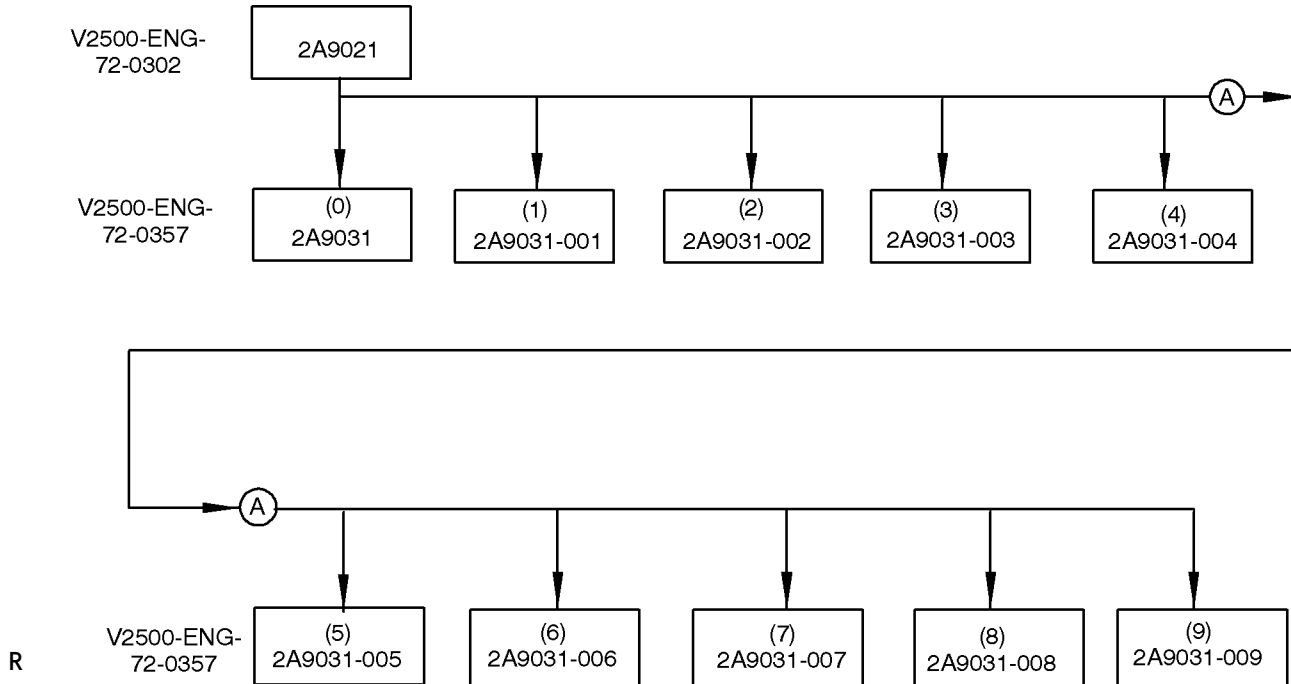
Family Tree – Stage 1 Turbine Rotor Assembly
Ref. Catalog Sequence No. 72-45-10. Fig. 01 Item 010
Figure 2

- (0) CONTAINS 64 BLADES 2A9101 (ALL A5/D5 ENGINES)
- (1) CONTAINS 64 BLADES *2A2621-004 (ALL A5/D5 ENGINES EXCEPT A5-33)
- (2) CONTAINS 64 BLADES 2A8521-005 ALL A5/D5 ENGINES EXCEPT A5-33)
- (3) CONTAINS 64 BLADES *2A2621-004 (ALL A5/D5 ENGINES EXCEPT A5-33)
- (4) CONTAINS 64 BLADES 2A8321-004 (ALL A5/D5 ENGINES EXCEPT A5-33)
- (5) CONTAINS 64 BLADES 2A8321-004 (ALL A5/D5 ENGINES EXCEPT A5-33))
- (6) CONTAINS 64 BLADES 2A8521-004 (ALL A5/D5 ENGINES EXCEPT A5-33)
- (7) CONTAINES 64 BLADES 2A8701-002 (ALL A5/D5 ENGINES EXCEPT A5-33)
- (8) MAY CONTAIN ANY MIXTURE OF 2A9101, *2A2621-004, 2A8321-004, 2A8521-004, 2A8521-005, OR 2A8701-002 (ALL A5/D5 ENGINES EXCEPT A5-33)
- (9) MAY CONTAIN ANY MIXTURE OF 2A9101 OR 2A8521-005 (ALL A5/D5 ENGINES EXCEPT A5-33)

* BLADES 2A2621-004 MUST BE USED WITH TOBI DUCT 2A2141-01

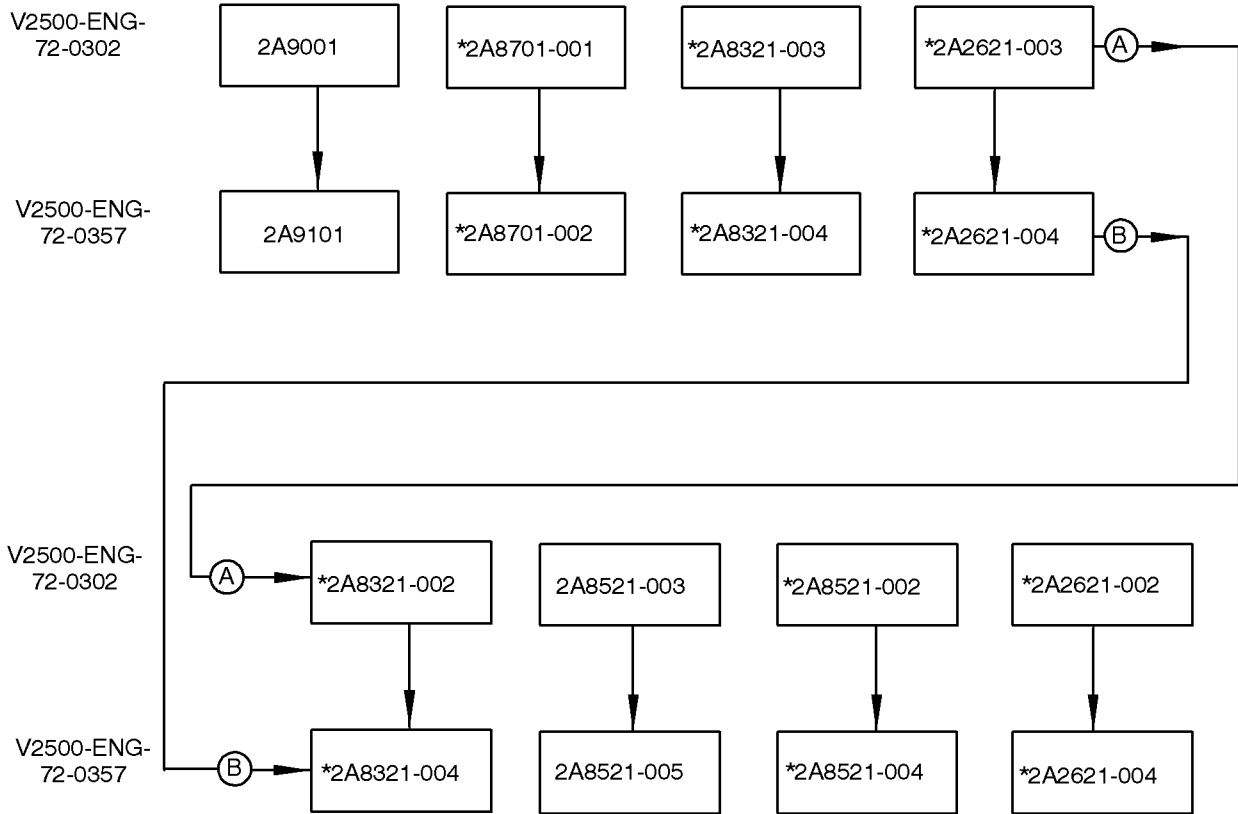
Family Tree - Stage 1 HPT Blade
Ref. Catalog Sequence No. 72-45-14. Fig. 01 Item 010
Figure 3

* DO NOT USE THIS BLADE IN V2533-A5 ENGINE
