## V2500-A5/D5 PROPULSION SYSTEMS SERVICE BULLETIN

# V2500-ENG-72-0403

ENGINE – HP COMPRESSOR SHAFT – INTRODUCTION OF REVISED HP COMPRESSOR REAR SHAFT  
ASSEMBLY WITH NO.4 BEARING LOCATION COATING (A5 & D5 MODELS)

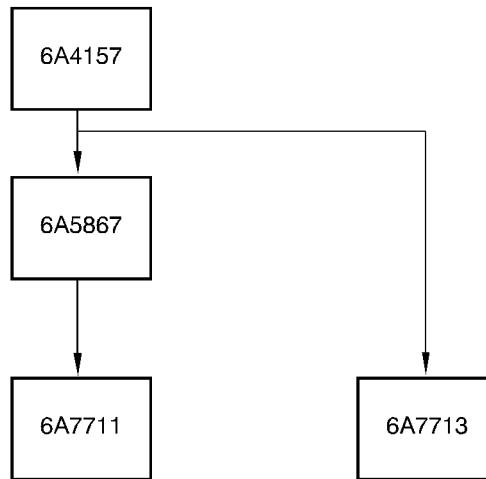
V2500-A5 and D5 family tree  
Fig 3

V2500-ENG-72-0202  
Introduction of strengthened HP  
compressor rear shaft and new  
mating rear rotating seal

V2500-ENG-72-0403  
Introduction of revised HP  
compressor rear shaft assembly  
with No 4 bearing location coating
