## V2500-A1 PROPULSION SYSTEMS SERVICE BULLETIN

This document transmits the Revision 1 of Service Bulletin V2500-ENG-72-0404.

ENGINE – HP COMPRESSOR SHAFT – INTRODUCTION OF REVISED HP COMPRESSOR REARSHAFT  
ASSEMBLY WITH NO.4 BEARING LOCATION COATING (A1 MODEL)

**V2500-ENG-72-0404**

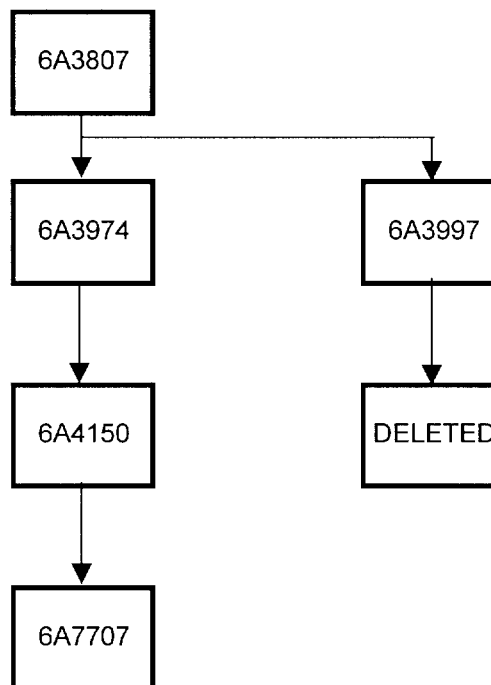
V2500-A1 family tree  
Fig 3

Introduction of a revised HP Comp  
rear shaft assembly with No.4  
bearing location diameter coating
