DATE ~~R~~ Aug.20/02**V2500-A5/D5 PROPULSION SYSTEMS SERVICE BULLETIN**

**V2500-ENG-72-0405**  
 Transmittal - Page 1 of 2

ENGINE – PROVIDE NEW NUMBER FOUR BEARING FRONT AND REAR SEALS

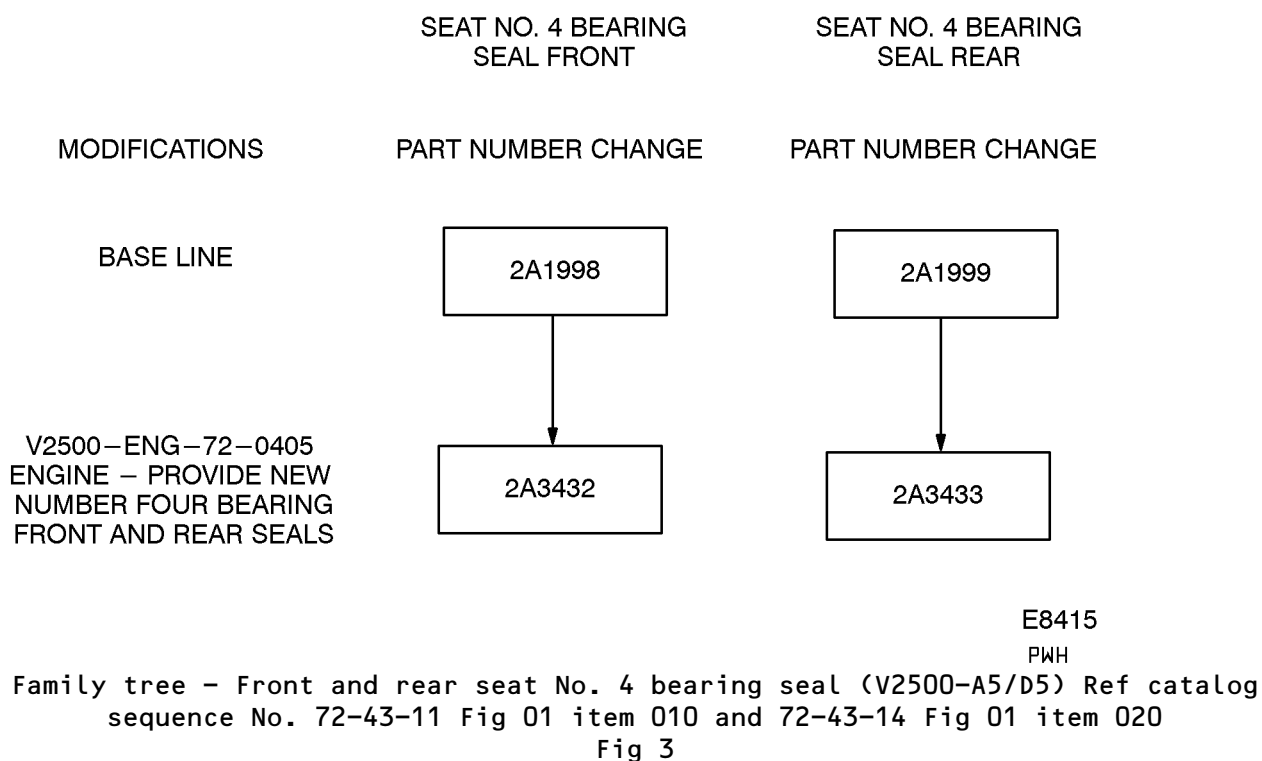
REPLACE SEAT NO. 4 BEARING  
SEAL FRONT PN 2A0066 OR  
2A1998 WITH 2A3432

REPLACE SEAT NO. 4 BEARING  
SEAL REAR PN 2A0067 OR  
2A1999 WITH 2A3433

- (a) Replace the Seat, No. 4 Bearing Seal Front, PN 2A0066 or 2A1998 with 2A3432.
- (b) Replace the Seat, No. 4 Bearing Seal Rear, PN 2A0067 or 2A1999 with 2A3433.
