V2500-A1/A5/D5 SERIES PROPULSION SYSTEMS SERVICE BULLETIN

This document transmits Revision 1 to Service Bulletin EV2500-72-0411

ENGINE – LP COMPRESSOR – INTRODUCTION OF HYDRAULIC SEAL WITH REVISED OIL DRAIN
FEATURE

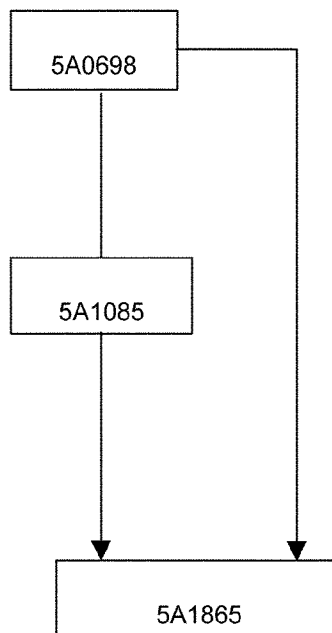
Family tree - Seal, A/O hydraulic (72-32-19, Fig 01 Item 100)
Fig.2 (Sheet 1 of 2)

V2500-ENG-70-0172
ENGINE - LP COMPRESSOR -
NEW HYDRAULIC SEAL ASSEMBLY
-CATEGORY 7

V2500-ENG-72-0411 Part 1 and 2
ENGINE - LP COMPRESSOR -
INTRODUCTION OF HYDRAULIC
SEAL WITH REVISED OIL DRAIN FEATURE
-CATEGORY 6
