International Aero Engines

V2500-A5/D5 PROPULSION SYSTEMS SERVICE BULLETIN

V2500-ENG-72-0412

ENGINE - PROVIDE ADDITIONAL OIL DRAIN HOLE IN 2ND STAGE TURBINE AIR SEAL

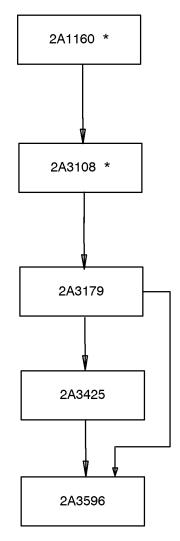
* DO NOT USE IN V2533-A5 ENGINES

Family tree stage 2 high pressure turbine air seal Ref. Catalog Sequence No. 72-45-00, Fig 01 Item 082
Fig 2

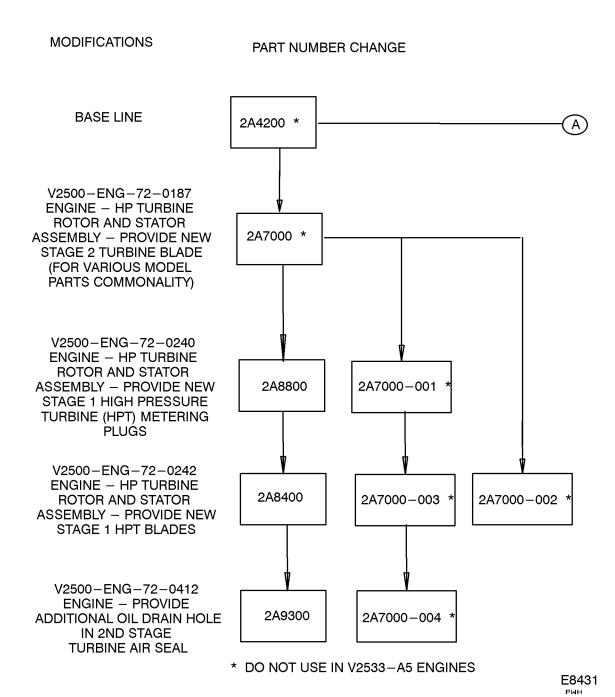
Fig 3 (sheet 1)

Family tree Rotor and stator assembly HPT module V2522-A5, V2524-A5, V2527-A5, V2527E-A5, V2527M-A5, V2530-A5 and V2533-A5 engines

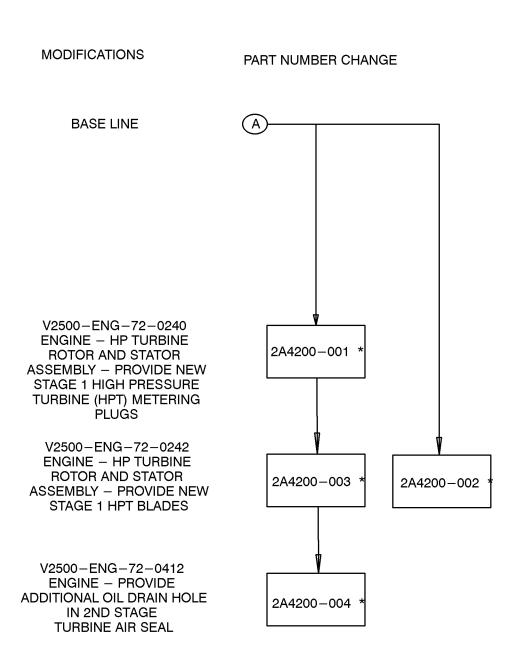
* DO NOT USE IN V2533-A5 ENGINES

F8432
Family tree Rotor and stator assembly HPT module V2522-A5, V2524-A5, V2527-A5, V2527E-A5, V2527M-A5, V2530-A5 and V2533-A5 engines
Fig 3 (sheet 2)

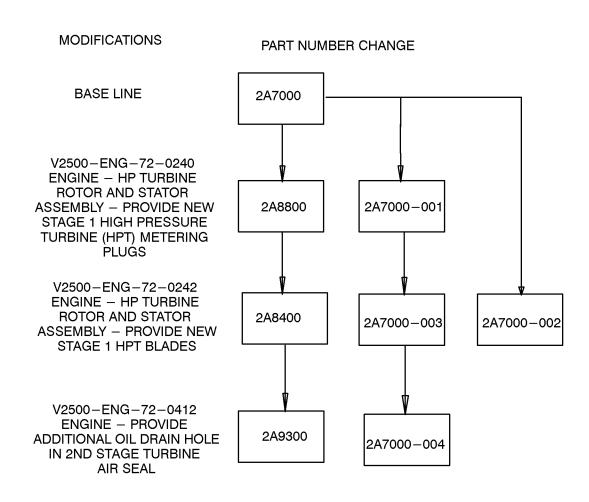
Family tree Rotor and stator assembly HPT module V2525-D5 and V2528-D5 engines Ref Catalog Seq. No. 72-45-00 Fig 01 Item 001 Fig 4
