V2500-A1/A5/D5 PROPULSION SYSTEMS SERVICE BULLETIN

V2500-ENG-72-0415
Transmittal - Page 1 of 3

ENGINE – PROVIDE NEW FRONT AND REAR NUMBER 4 BEARING DUCTS WITH OIL DRAIN HOLES

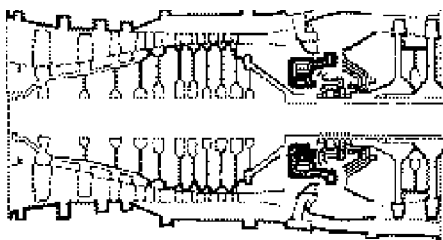
Duct Assembly, Cooling Air, No. 4 Bearing Front
Figure 1 (Sheet 1)

REPLACE DUCT 2A2257-01
OR 2A0892-01 WITH DUCT
2A3810-01 OR 2A0892-001
RESPECTIVELY

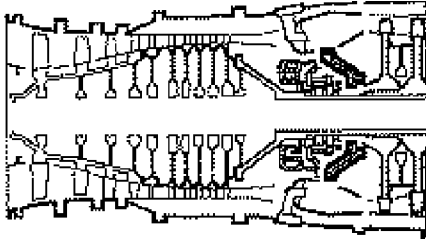
Duct Assembly, Cooling Air, No. 4 Bearing Rear
Figure 2 (Sheet 1)

REPLACE DUCT 2A3078-01,
2A0891-01, OR 2A1205-01
WITH DUCT 2A3808-01,
2A0891-001, OR 2A1205-001
RESPECTIVELY
