**International Aero Engines
NON-MODIFICATION
SERVICE BULLETIN**

ENGINE –INSPECTION OF HPC STAGE 6 METCO 313 ROTOR PATH CONDITION AFTER INACTIVE PERIOD WITHOUT ADHERENCE TO AMM STORAGE PROCEDURES ON AIRCRAFT WITH BOTH ENGINES POST ENG SB 72-0235 AND PRE ENG SB 72-0369

V2500-A5/D5 SERIES PROPULSION SYSTEM NON-MODIFICATION SERVICE BULLETIN

This document transmits Revision 2 of Non-Modification Service Bulletin V2500-ENG-72-0437

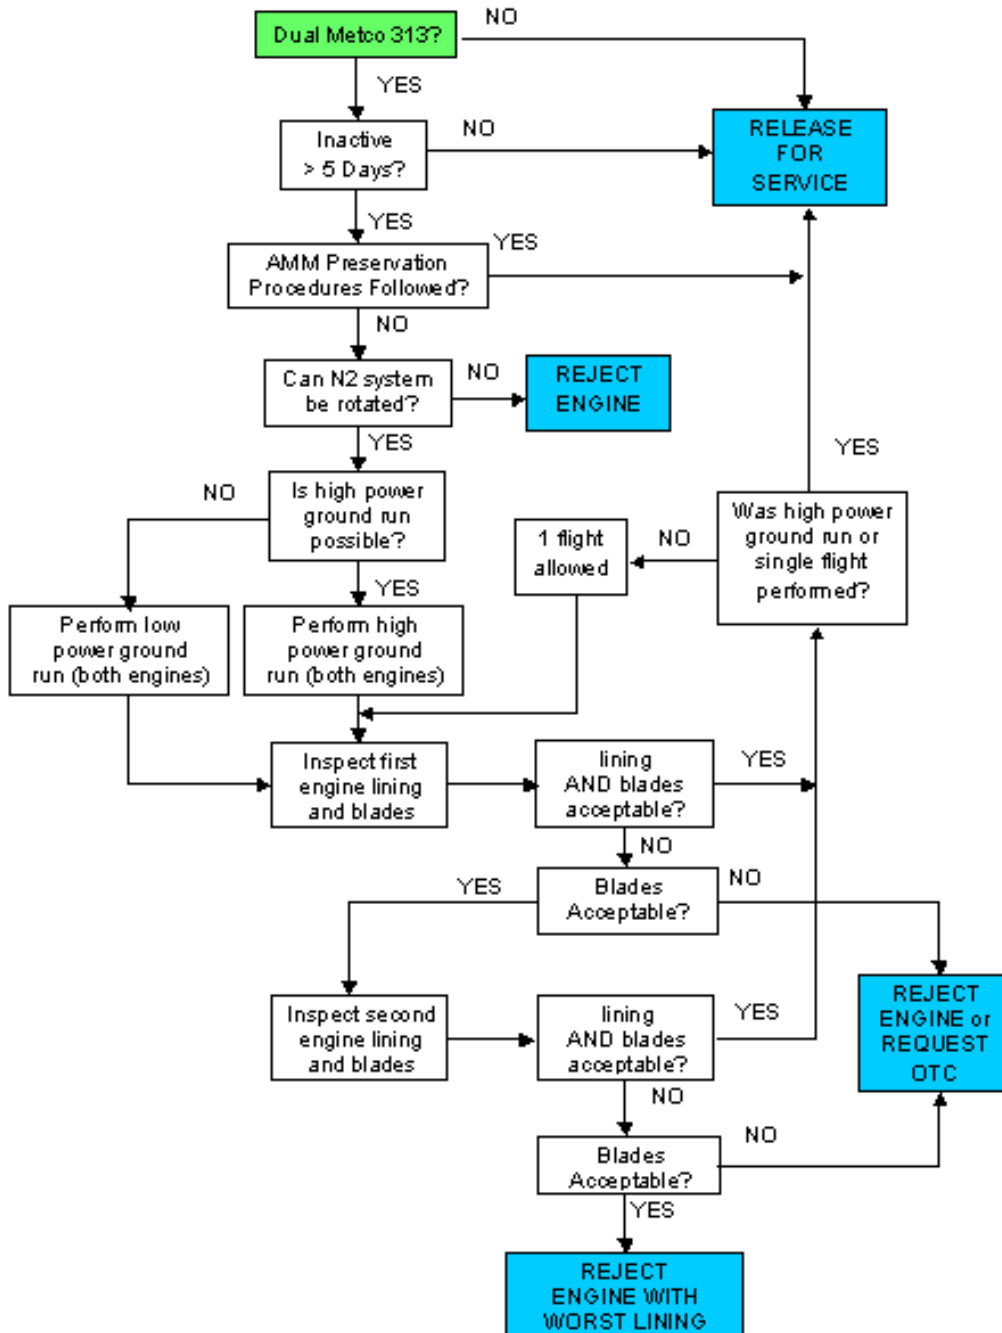
APPENDIX 2

Flow chart for stage 6 inspections prior to resuming service for A/C with both engines to Metco 313 standard following more than 5 days inactivity without adherence to AMM preservation procedures.

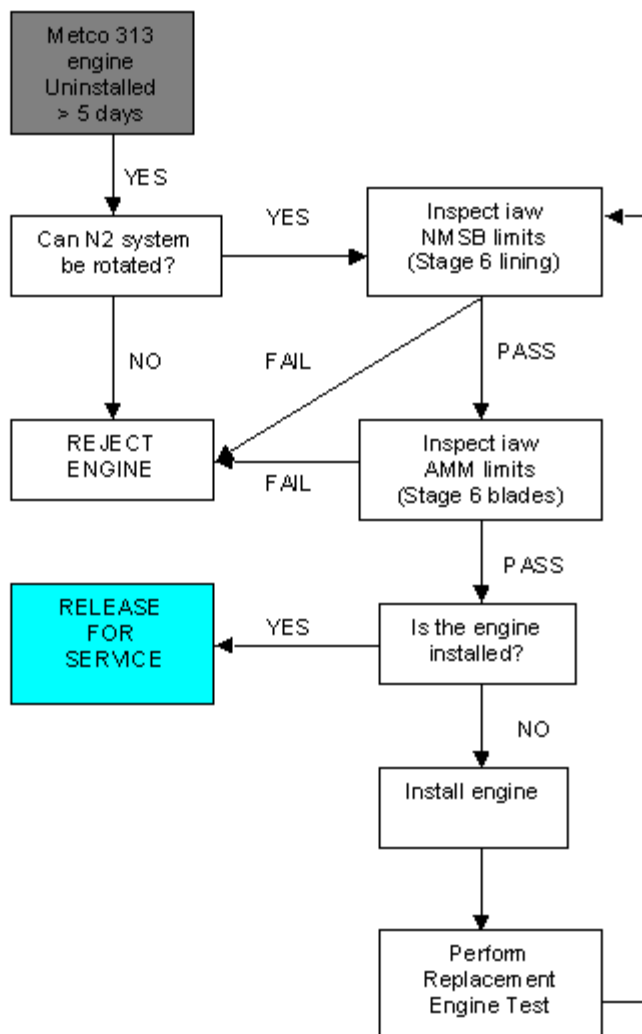
APPENDIX 3

Flow chart for stage 6 inspections prior to installing engines to Metco 313 standard
