DATE: **Apr.28/03****V2500-A1/A5/D5 SERIES PROPULSION SYSTEM SERVICE BULLETIN**

This document transmits the Initial Issue of Service Bulletin EV2500-72-0455

ENGINE – PROVIDE NEW ADAPTER AND TUBE FOR DIFFUSER 10TH STAGE POSITIONS 72 AND 288 DEGREES

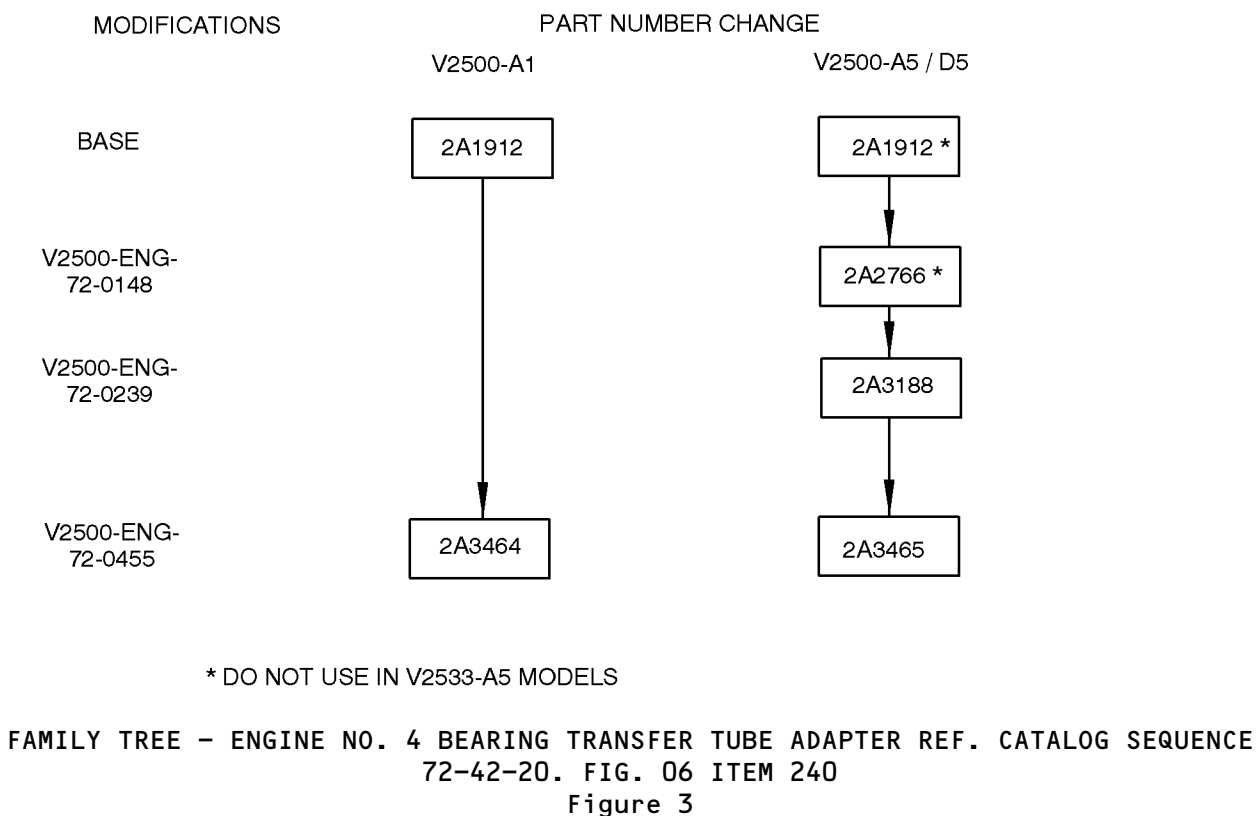
- (1) Problem: Air leakage has been detected at the Diffuser 10th Stage make-up air bosses during new engine testing.
- (2) Background: Tight fits between the 10th Stage make-up air diffuser hardware may not allow the mating Gasket to be properly sealed against the Diffuser Case boss. The resulting vibratory distress on the Gasket results in air leakage.

(a) Replace Tube PN 2A1034 with PN 2A3466, see Figure 1.

(b) Replace Adapter PN 2A1912 with PN 2A3464, see Figure 1.

(a) Replace Tube PN 2A1034 with PN 2A3466, see Figure 1

(b) Replace Adapter PN 2A3188 with PN 2A3465, see Figure 1.
