V2500-A1/A5/D5 SERIES PROPULSION SYSTEMS SERVICE BULLETIN

This document transmits the Initial Issue of Service Bulletin EV2500-72-0462

ENGINE – LP COMPRESSOR – INTRODUCTION OF A REVISED HYDRAULIC SEAL AND A REVISED NO.2 BEARING OIL JET

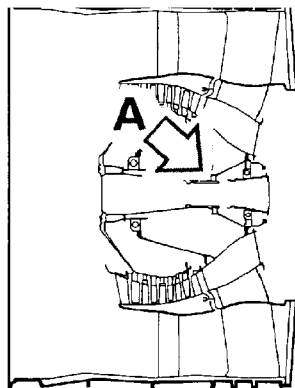
Location of Hydraulic Seal
Figure 5

Oil carbonisation occurs in the Hydraulic Seal Assembly due to high oil temperature in oil bath of the Hydraulic Seal. The oil carbonisation causes sticking of the Seal Ring on groove of the Hydraulic Seal and oil leaks to Front Bearing Compartment Weep Line through HPC Stub Shaft. When FBC Weep Line is clogged and the oil overflow from the weep line, the odour of the oil goes to the Cabin of the Aircraft.

- (3) Assemble the Hydraulic Ring and Seal Ring into the Hydraulic Seal Assembly. Refer to Figure 5 and EM (E-V2500-1IA) 72-32-10, Assembly, Config-01 or Config-02 or EM (E-V2500-3IA) Assembly, except:
